# ***ASBESTOS- CONTAINING MATERIALS SURVEY***

**Building 1  
Department of Veterans Affairs  
Michael Crescenz VA Medical Center  
3900 Woodland Avenue  
Philadelphia, PA 19104**

**August 1, 2022**

**212842**

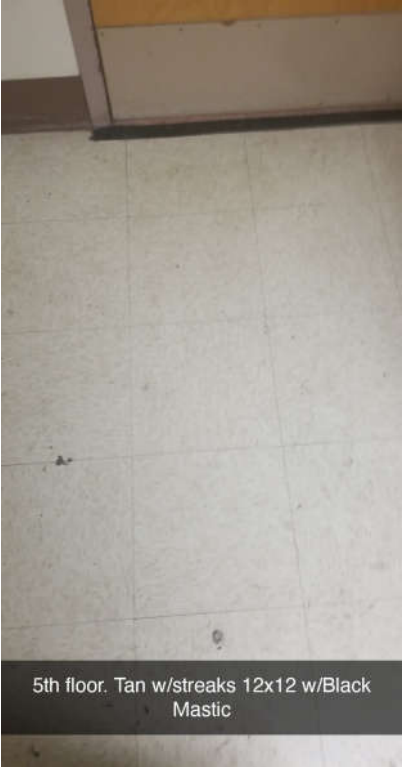
5th floor. Tan w/streaks 12x12 w/Black Mastic

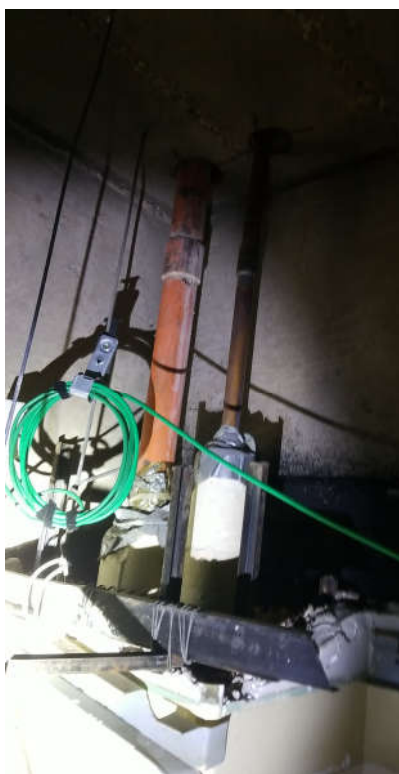
a160 pipe in wall

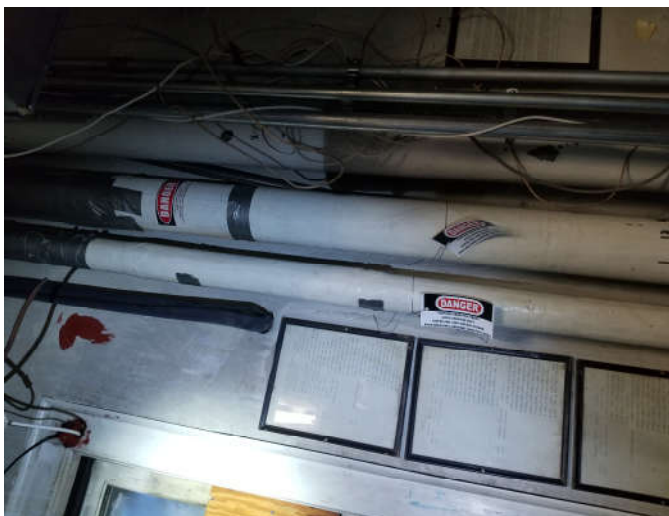
b1 room a4 pipe insulation

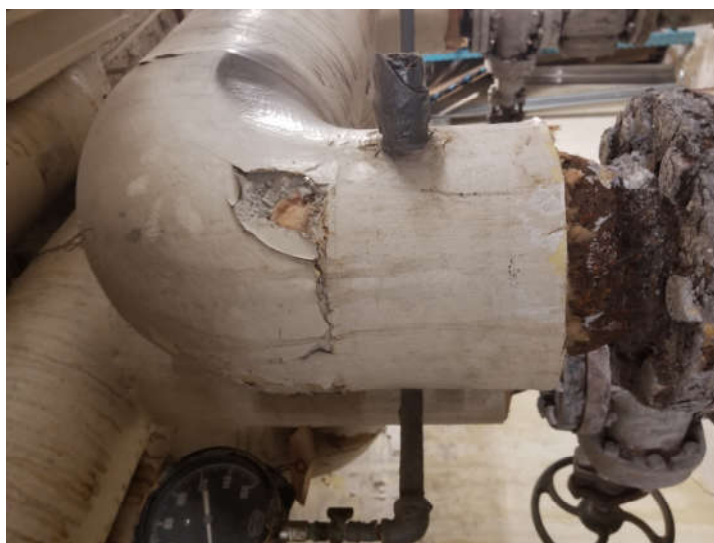
Damaged pipe insulation was observed in several locations throughout the building. These damaged materials should be repaired or removed by an asbestos abatement contractor.

b-2 storage area damaged fittings

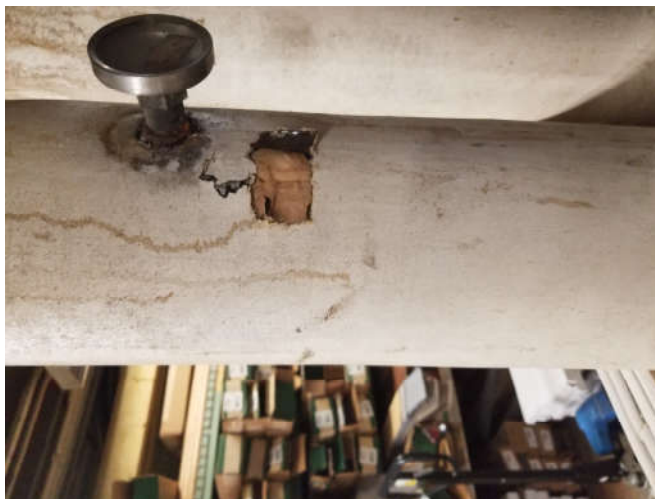
b-2 storage area damaged fittings

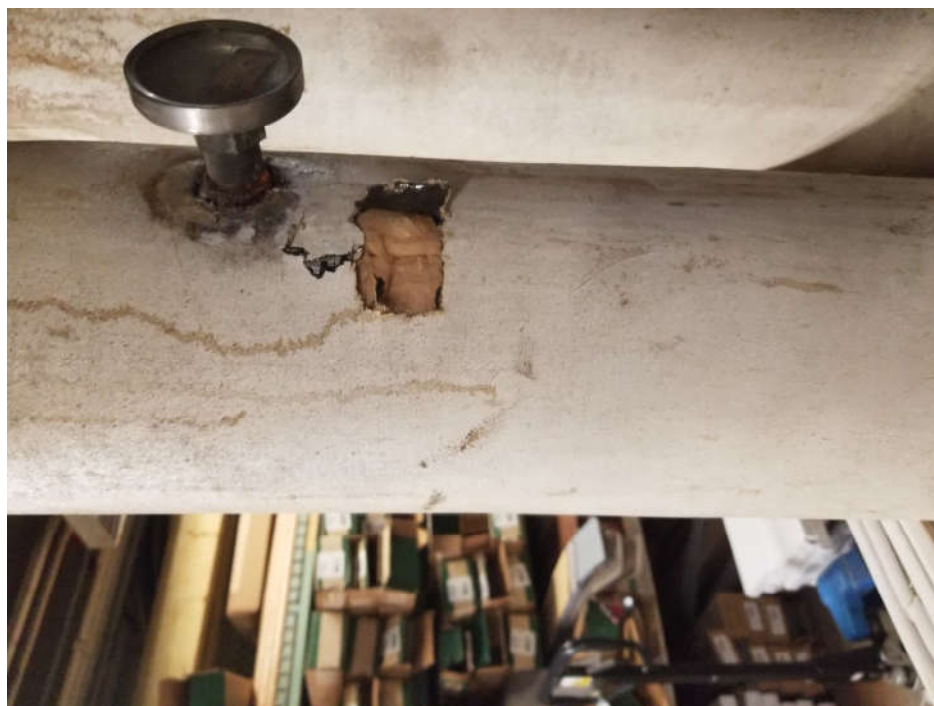
b-2 storage area damaged fittings 2

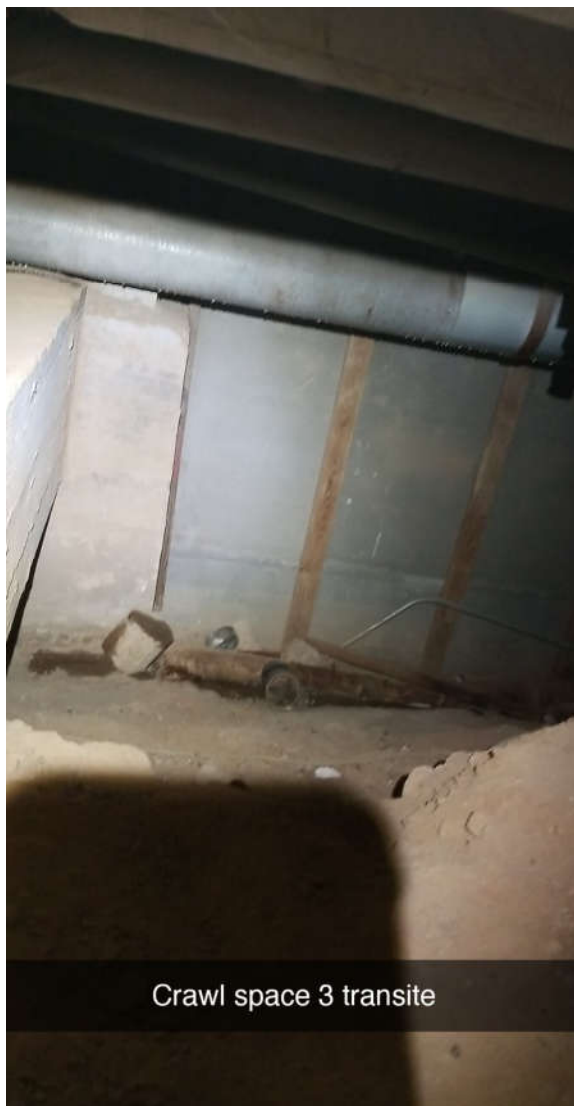
Crawl space 3 transite

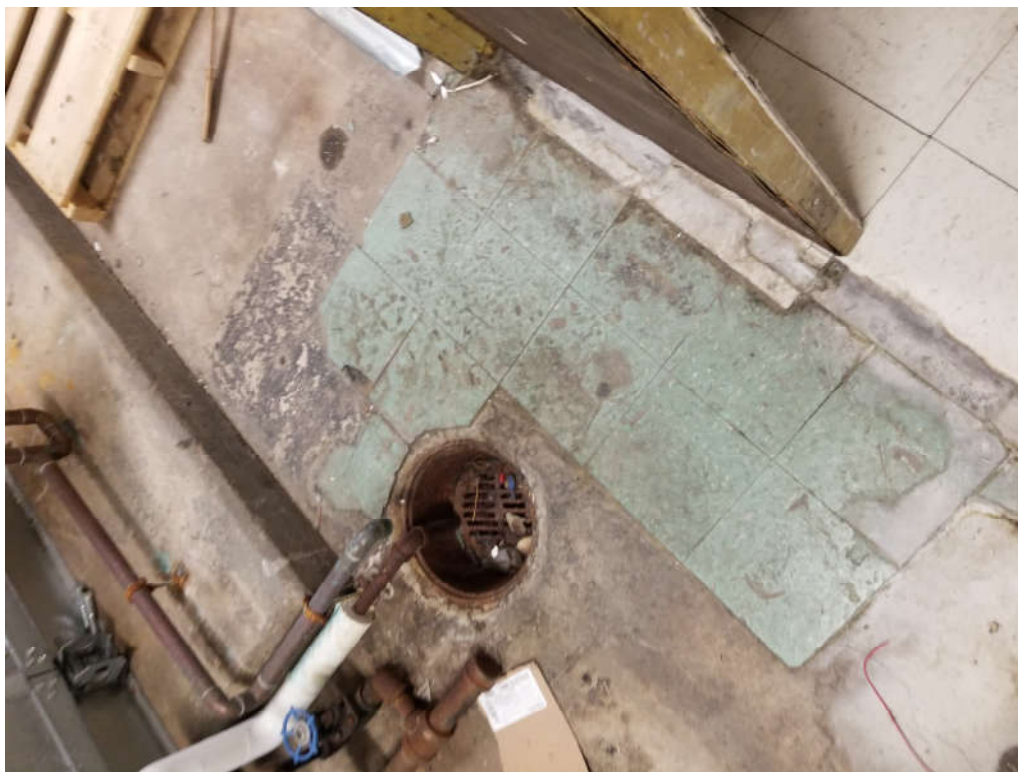
room b9 damaged 9x9 floor tile

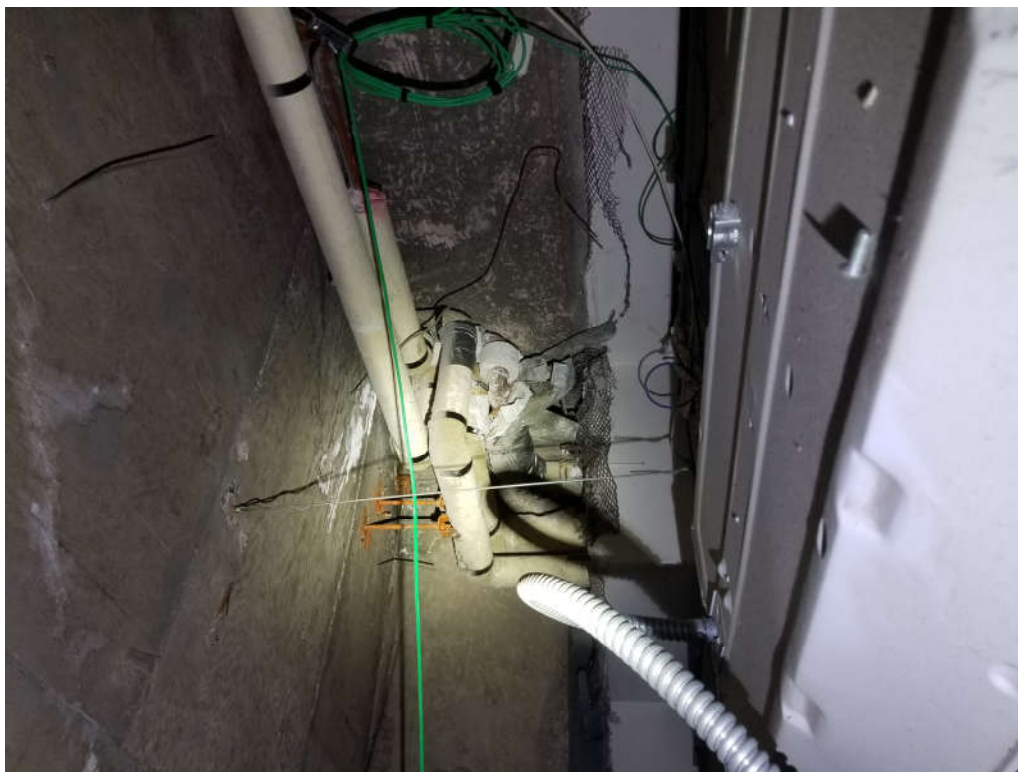
room b19 damaged pipe insulation

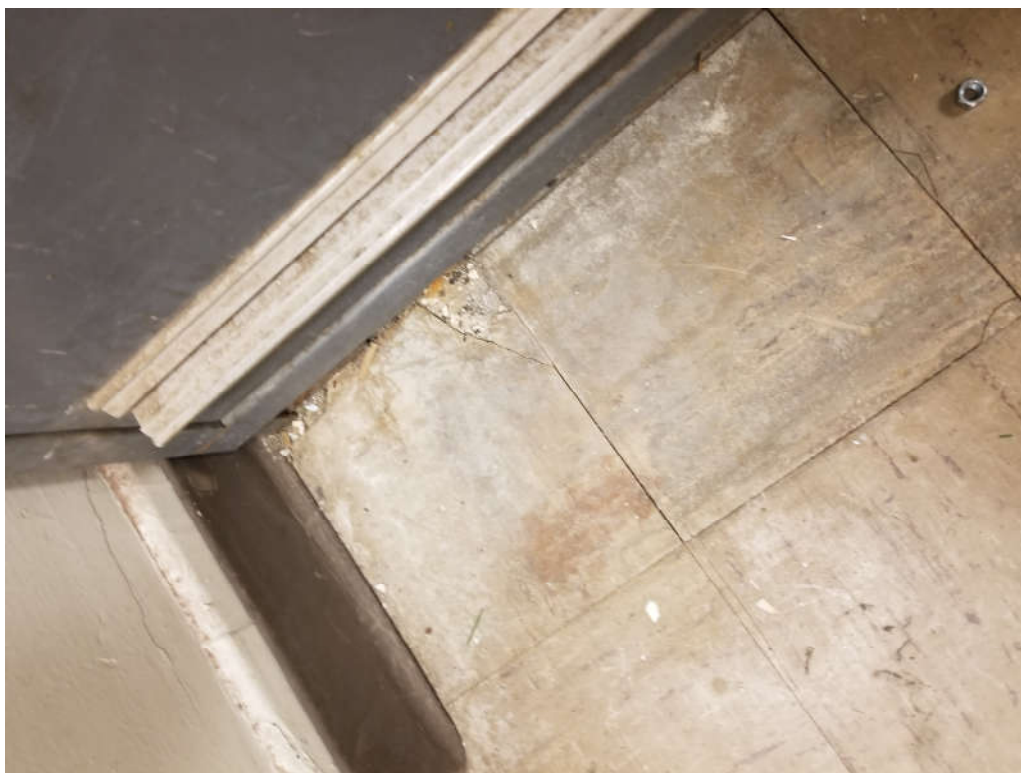
room b28 9x9 floor tile cracked tile

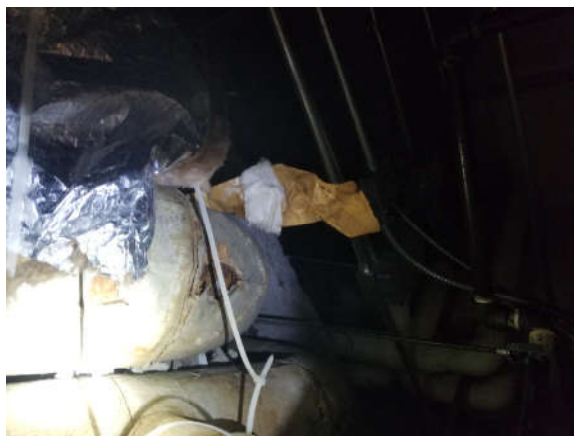
room b430 damaged fitting
