Defense Distribution Susquehanna Pennsylvania

Recording Form for ACBM Physical and Hazard Assessment Data

Building Number: 67	Building Use: Admin General Purpose	
Functional Space: Admin/Common Areas	Location: 1001	
Type of ACBM/Assumed ACBM: <input type="checkbox"/> Surfacing <input type="checkbox"/> TSI <input checked="" type="checkbox"/> Miscellaneous Description: 12"x12" Floor Tile, White, Gray Streaks		
Approximate Amount of Material (linear or square feet): 600 ft ²		
Friability: <input type="checkbox"/> Friable <input checked="" type="checkbox"/> Nonfriable		
Condition: Percent Damage: 0-1% <input type="checkbox"/> Localized <input checked="" type="checkbox"/> Distributed		
Type of Damage: <input type="checkbox"/> Deterioration <input type="checkbox"/> Water <input checked="" type="checkbox"/> Physical Description: None		
Overall Rating: <input checked="" type="checkbox"/> Good <input type="checkbox"/> Damaged <input type="checkbox"/> Significantly Damaged		
Potential for Disturbance: Frequency of Potential Contact: <input type="checkbox"/> High <input type="checkbox"/> Moderate <input checked="" type="checkbox"/> Low Description:

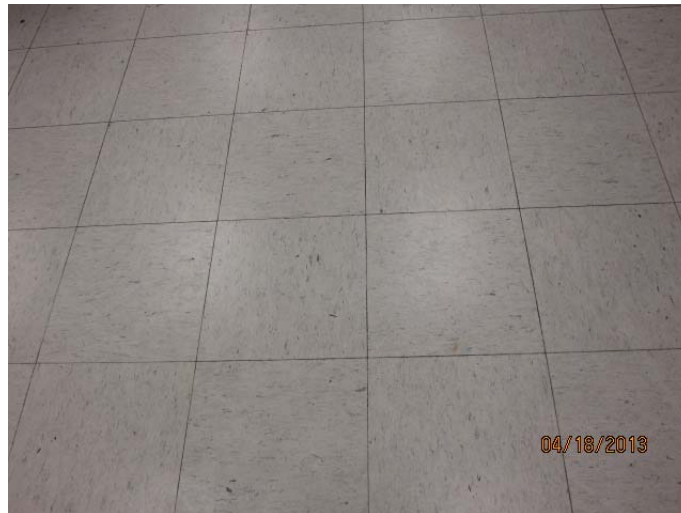
Influence Of Vibration: <input type="checkbox"/> High <input type="checkbox"/> Moderate <input checked="" type="checkbox"/> Low Description:		
Potential for Air Erosion: <input type="checkbox"/> High <input type="checkbox"/> Moderate <input checked="" type="checkbox"/> Low Description:		
Overall Rating: <input type="checkbox"/> Potential for Significant Damage <input type="checkbox"/> Potential for Damage <input checked="" type="checkbox"/> Low Potential		
AHERA Hazard Assessment Ranking: <input checked="" type="checkbox"/> 1 <input type="checkbox"/> 2 <input type="checkbox"/> 3 <input type="checkbox"/> 4 <input type="checkbox"/> 5 <input type="checkbox"/> 6 <input type="checkbox"/> 7 (See back for key)		
Comments: Apply coat of wax		
Signed:

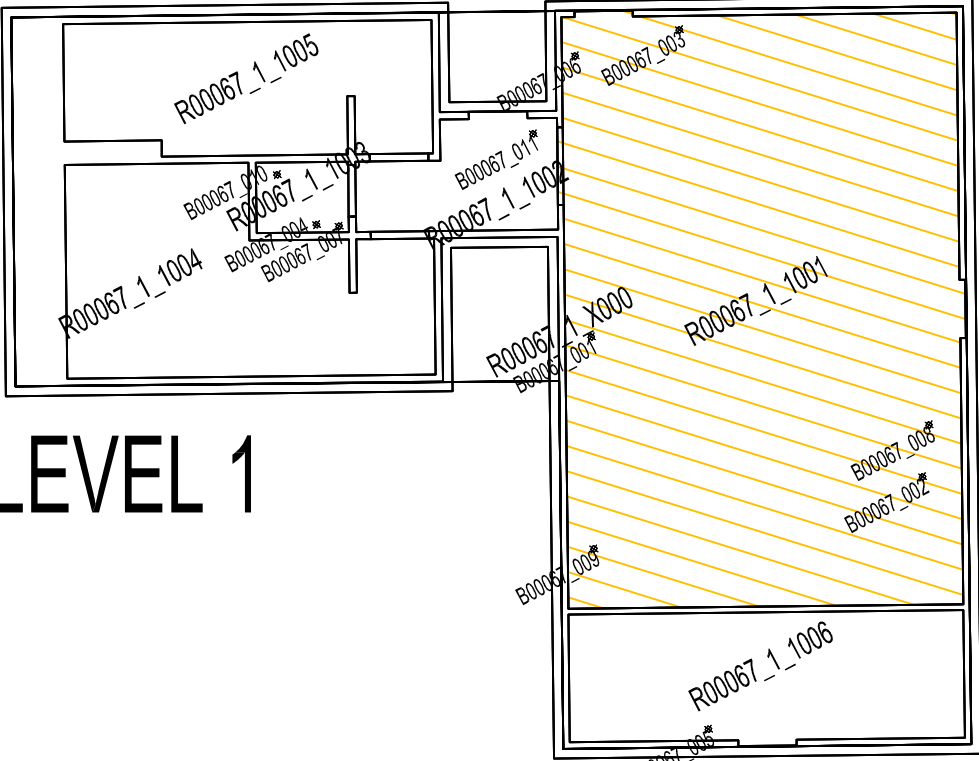
BUILDING 67 (1,340 SF)

HM ID: M00067.004.A - (004.A) 12" x 12" Floor Tile, White, Gray Streaks

Material Location	Material Quantity	Material Condition	Recommended Response Action	Room, ID
Level 1, Room 1001, Office	600 S.F.	Good	O&M Program	R00067.1.1001
