Point of Contact: Daniel Schriever, LS
 Phone Number: (443) 994-7285
 Date Performed: 12/05/2023
 Project Number: MD23-045
 Project Location: Perry Point, MD
 Requested By: AMT Engineering

Project Name: PERRY POINT STEAM
 UPDATE PROJECT

Utility Field Excavation Information

QL-A UTILITY PICTURE REPORT

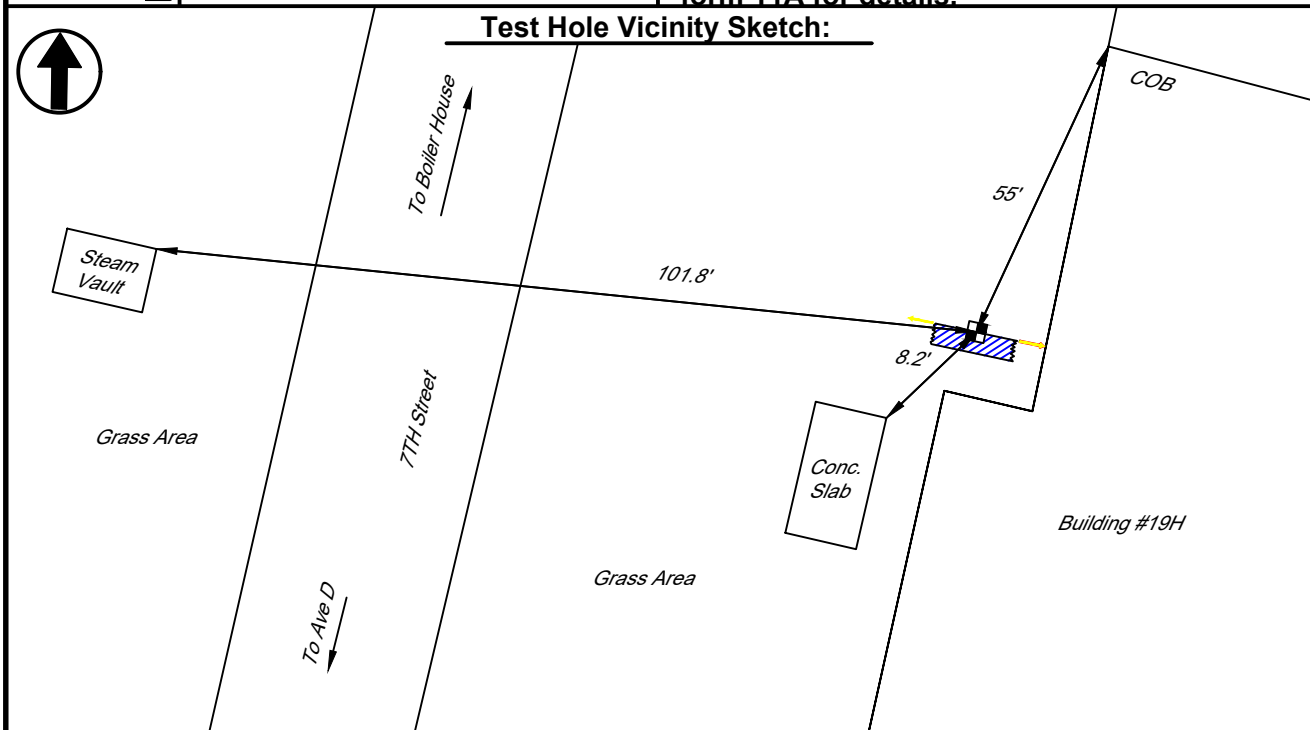
| Hub and tack set over north edge of steam duct. Unable to obtain bottom due to soil conditions. Also unknown utility found. see form 11A for details. | | |

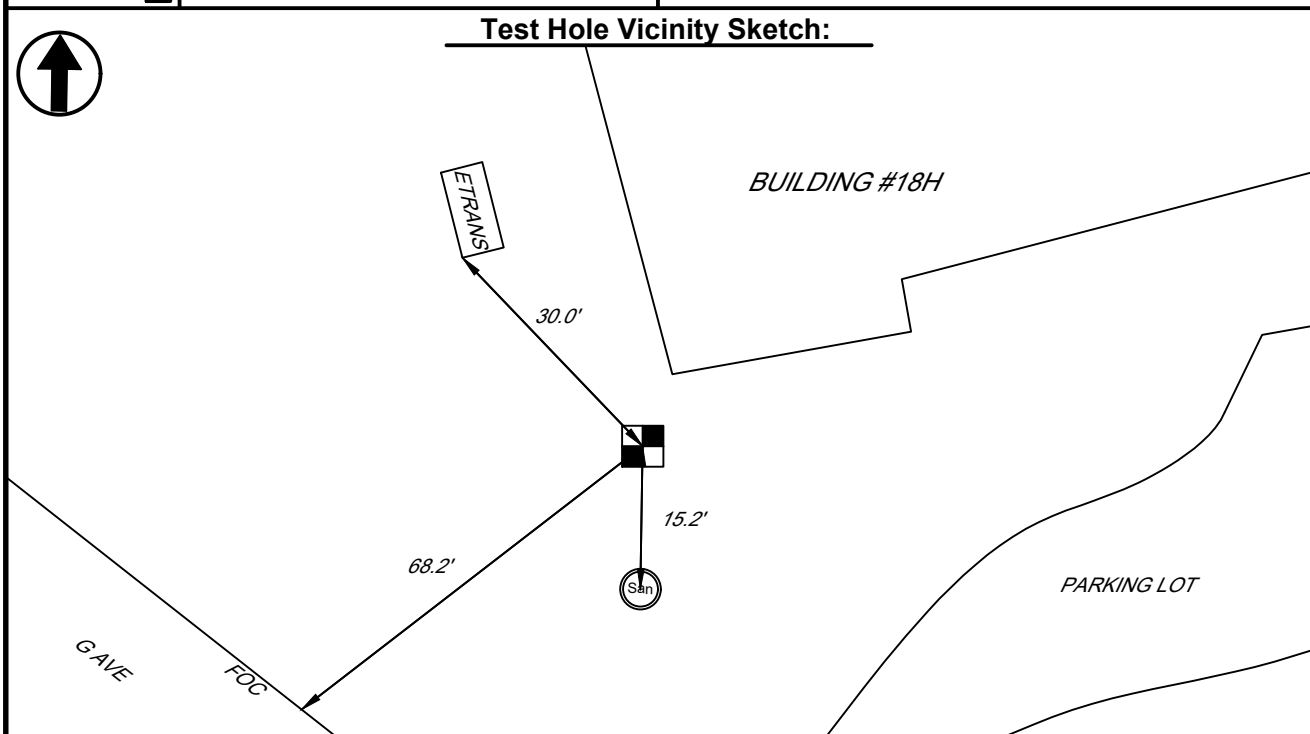
| crews cleared to 6' no utilities were found. | | |
| See form TH-33A for additional information. | | |
