# *ASBESTOS- CONTAINING MATERIALS SURVEY*

**Lebanon VA Medical Center – Building 10  
1700 South Lincoln Avenue  
Lebanon, PA 17042-7529**

**Report Date: January 19, 2015**

**Project Number: 142073**

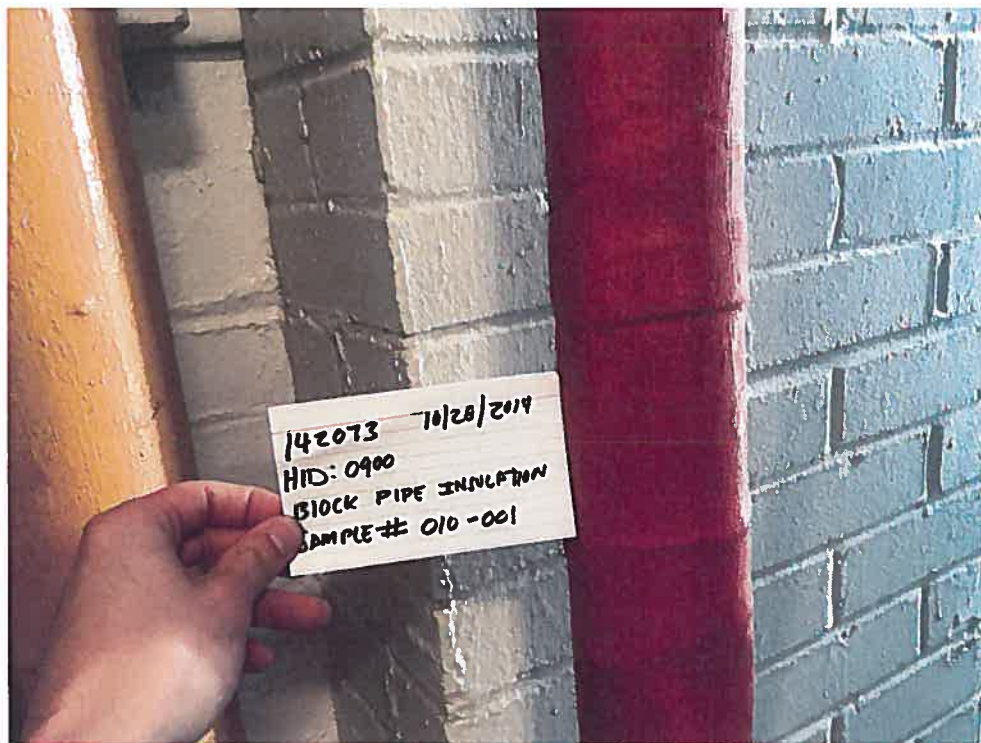
Figure 1: HID#0900 – Block Pipe Insulation

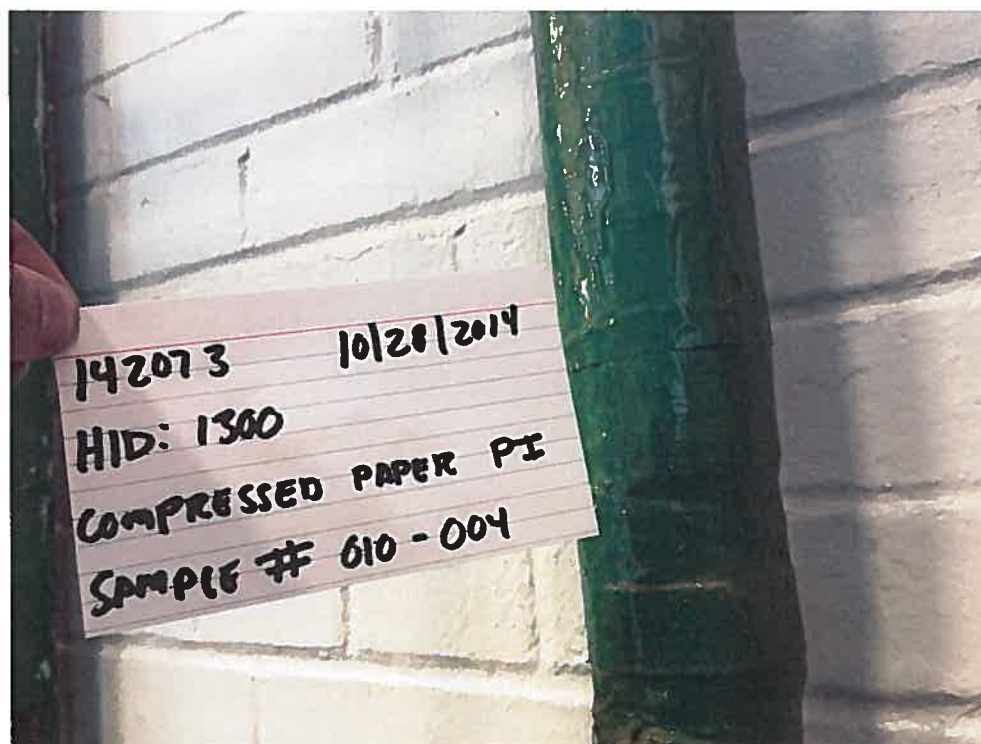
Figure 2: HID#1300 – Compressed Paper Pipe Insulation

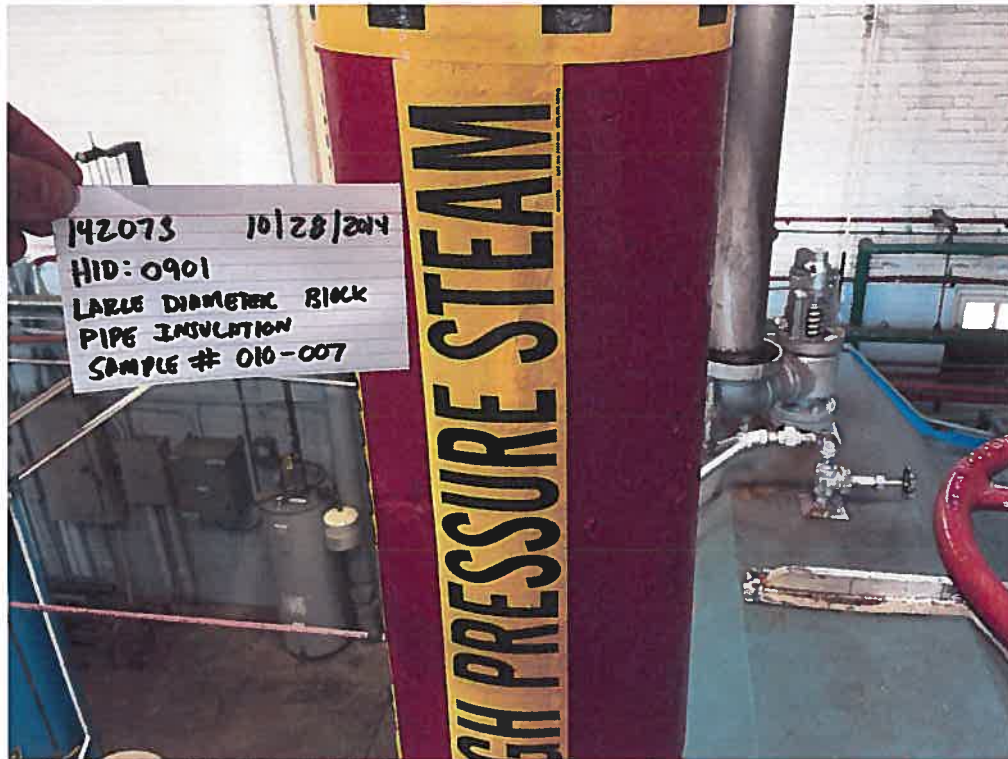
Figure 3: HID#0901 – Large Diameter Block Pipe Insulation

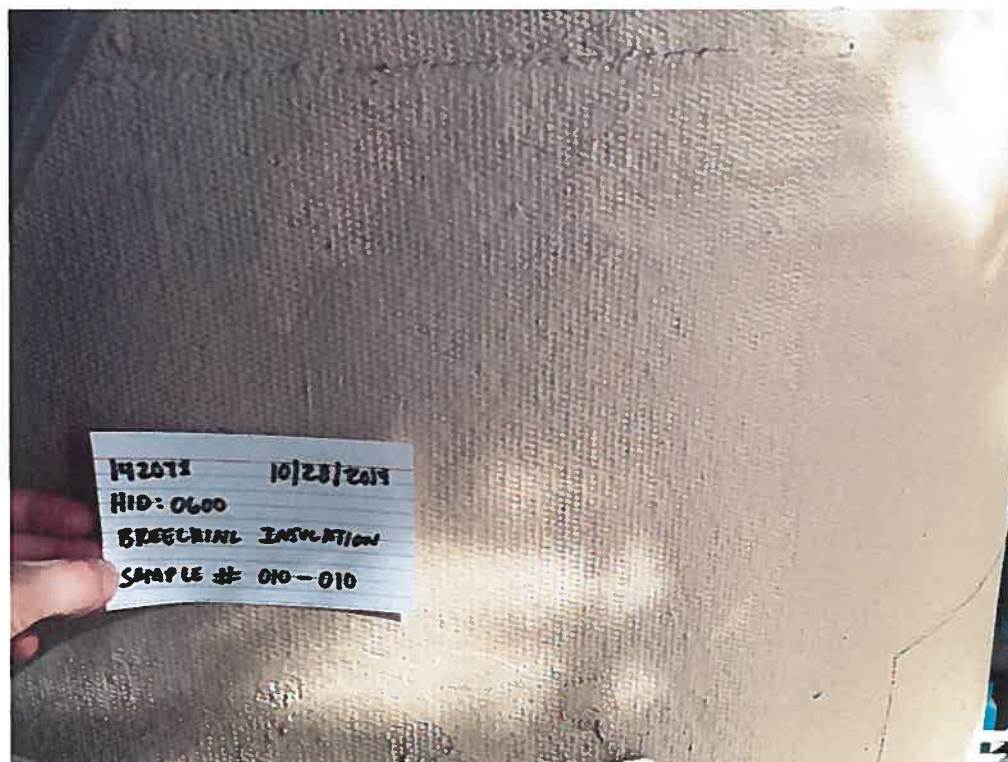
Analysis:	PLM	TEM	Other
Turnaround Time	48 Hrs	Field	US Mail
72 Hrs	Other 3-5 day	Fedex	Other
FS Name-/Work Area: Building 10			
Inspector: C. Gratz / R. Hunter			
Project Manager: Steve Vera			
Sample Date: 10-28-14			
Comments: Total About 3 SF of damage on boiler stacks (breaching) around flanges near bottom of stacks (3 stacks)

Figure 4: HID#0600 – Breeching Insulation

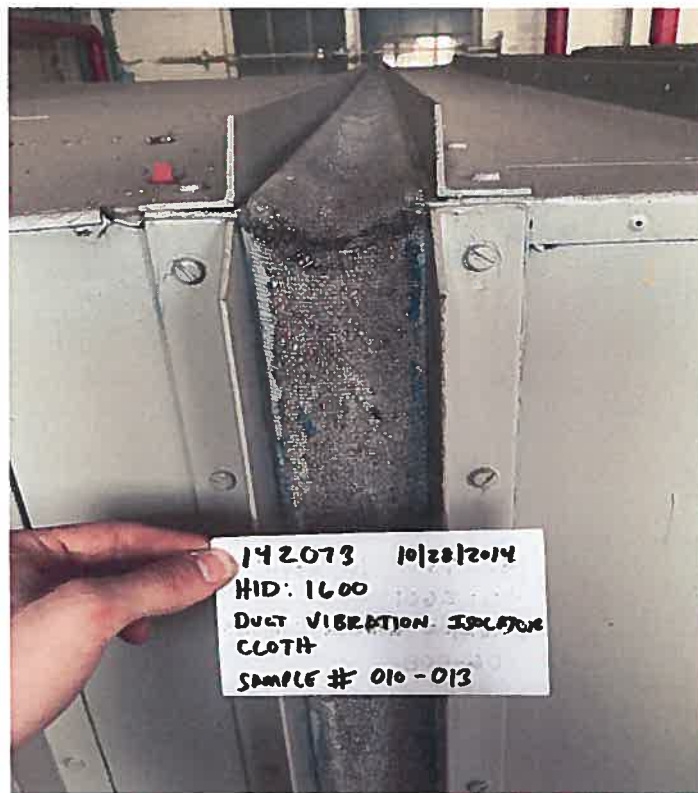
Figure 5: HID#1600 – Duct Vibration Isolator Cloth

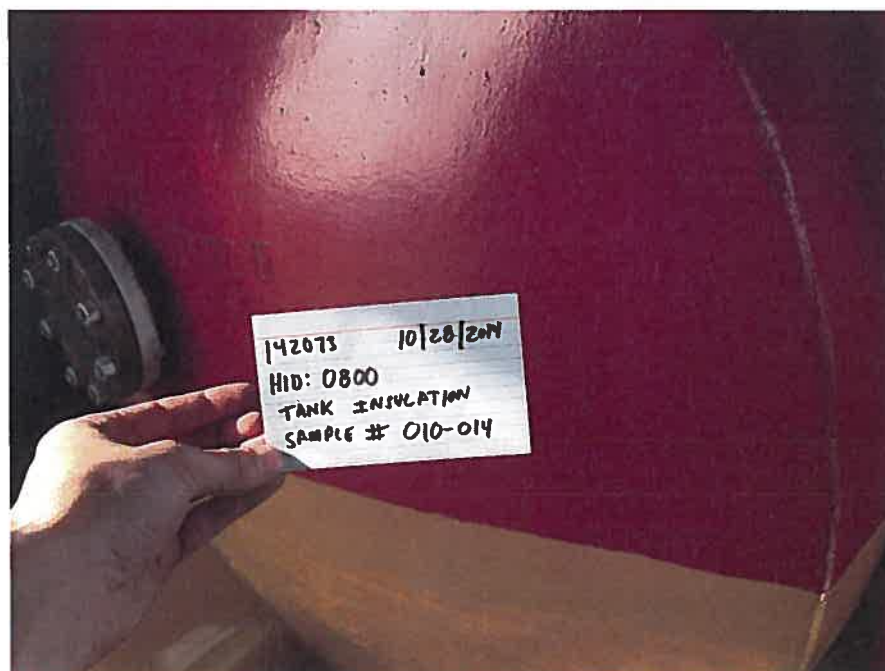
Figure 6: HID#0800 – Tank Insulation

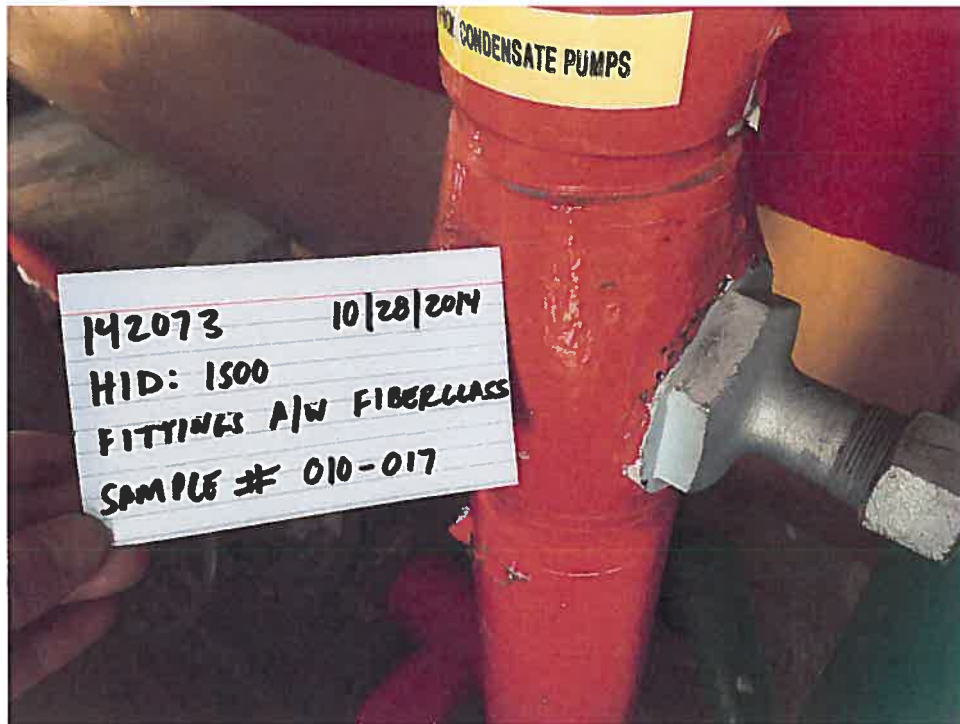
Figure 7: HID#1500 – Fittings Associated with Fiberglass Pipe Insulation

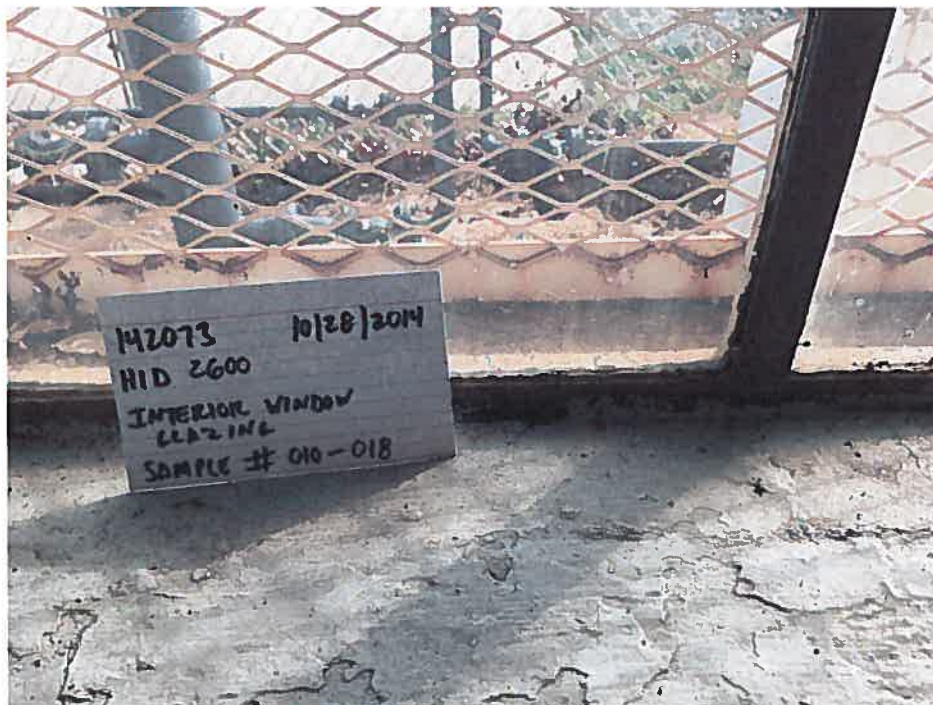
Figure 8: HID#2600 – Interior Window Glaze

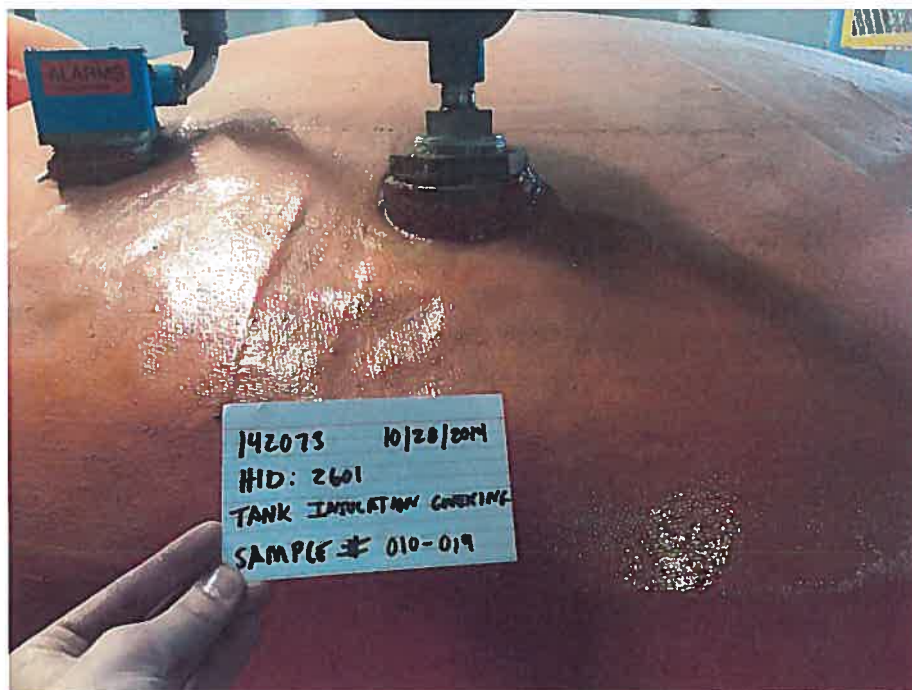
Figure 9: HID#2601 – Tank Insulation Covering Fiberglass

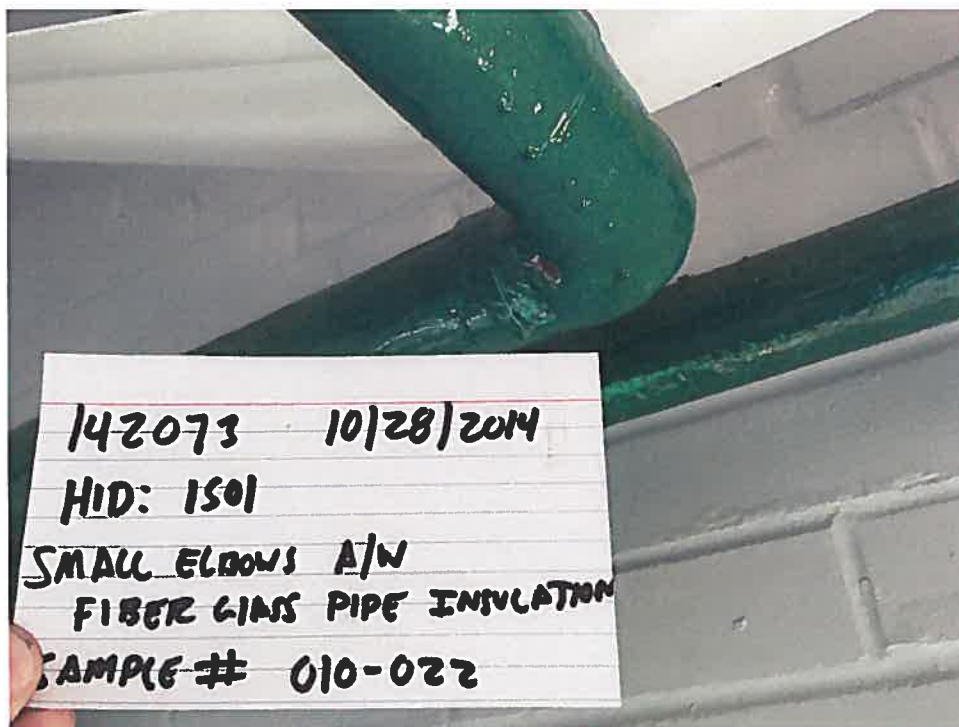
Figure 10: HID#1501 – Small Elbows Associated with Fiberglass Pipe Insulation

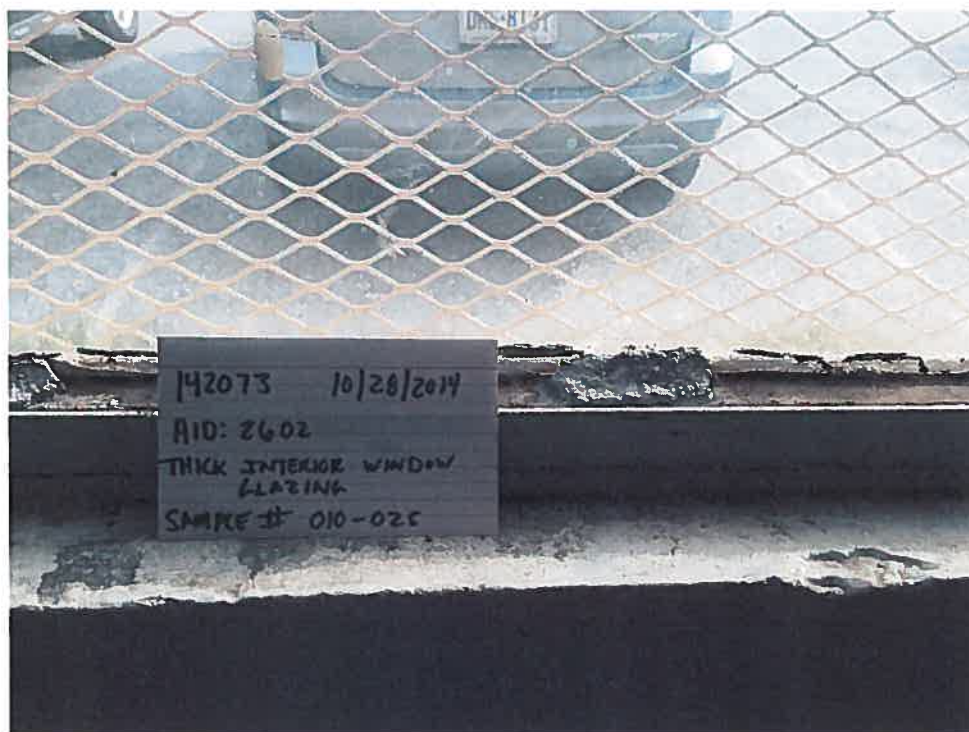
Figure 11: HID#2602 – Thick Interior Window Glazing

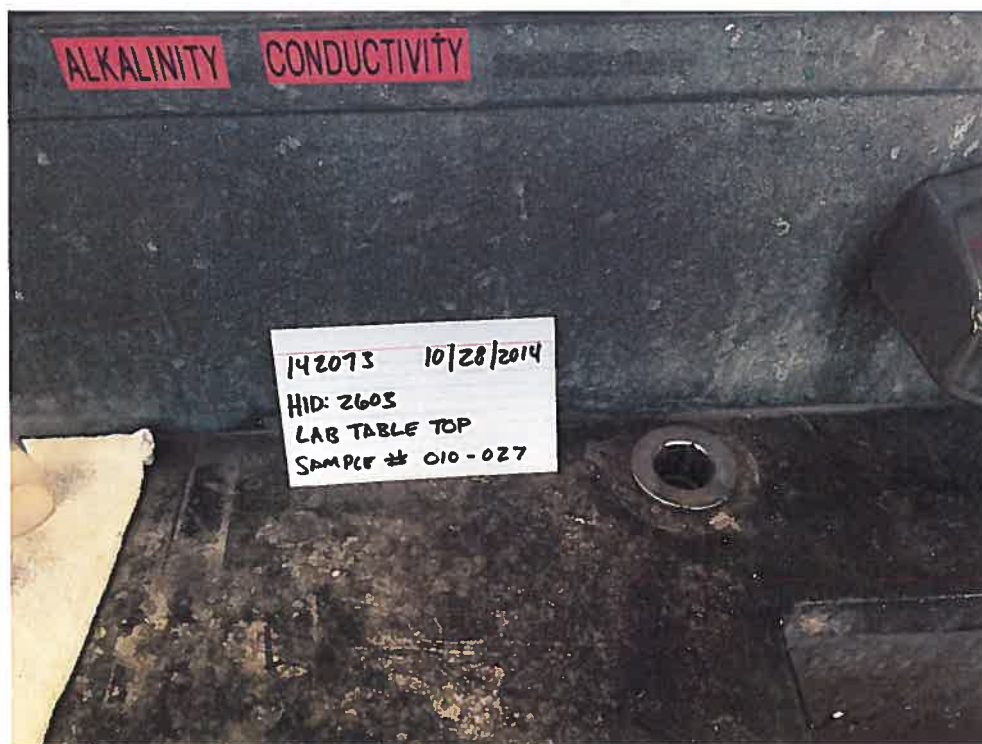
Figure 12: HID#2603 – Transite Counter Top

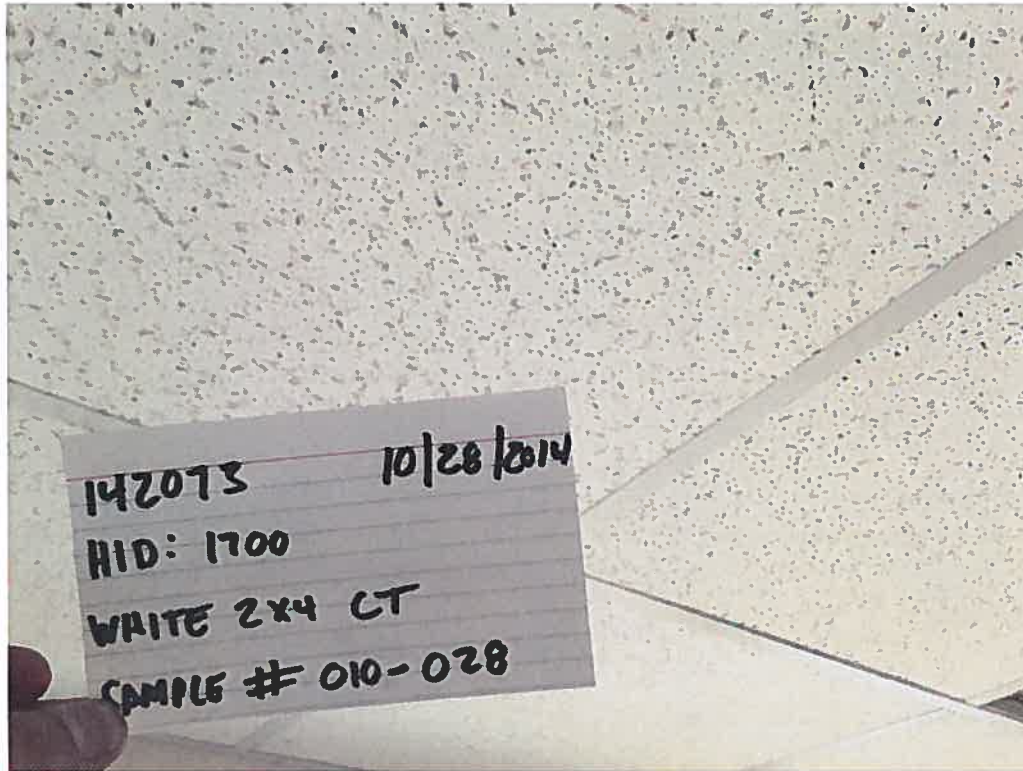
Figure 13: HID#1700 – 2'x4' Lay-In Ceiling Tile

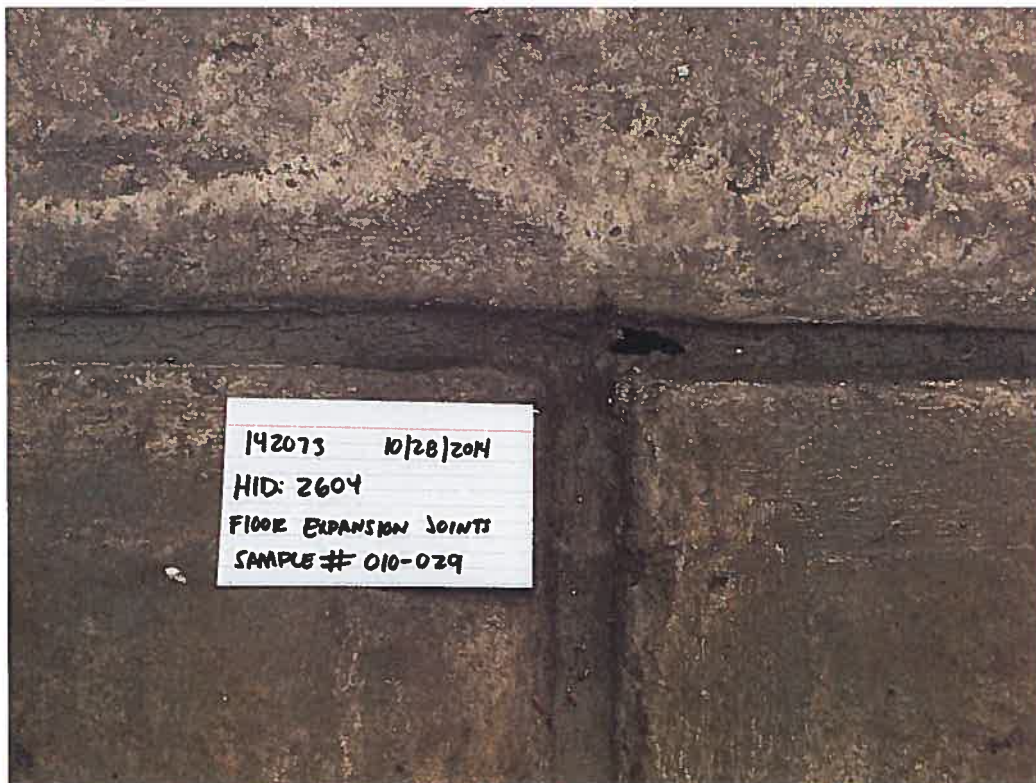
Figure 14: HID#2604 – Floor Expansion Joint
