HAZARDOUS MATERIALS EVALUATION (ASBESTOS AND LEAD BASED PAINT)

**Veterans Affairs Medical Center
Quarters Buildings
Lebanon, PA**

JEI Job No.: 2003-069

September, 2003

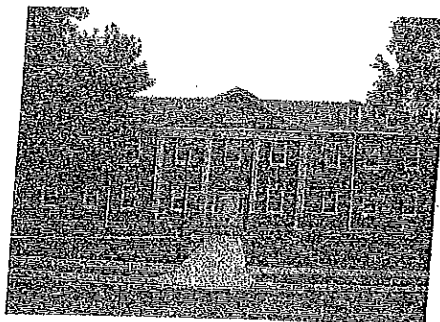
Photo 1

1. Interior and exterior of main entrance (east side) door.
 - a. The inlaid pillars to the right and left of the main entrance door. See Photo 1.
 - b. The door casing.
2. North and South screened porch components.
 - a. Upper exterior wood fascia
 - b. Wood support columns
 - c. Tongue in groove ceilings
3. West side (rear) of building door components. See Photos 3 & 4.
4. Interior black stairwell banisters. See Photo 5.

Exterior view of Building 3

Lead-based paint on exterior - yellow door casing; yellow inlaid pillars; interior of front door

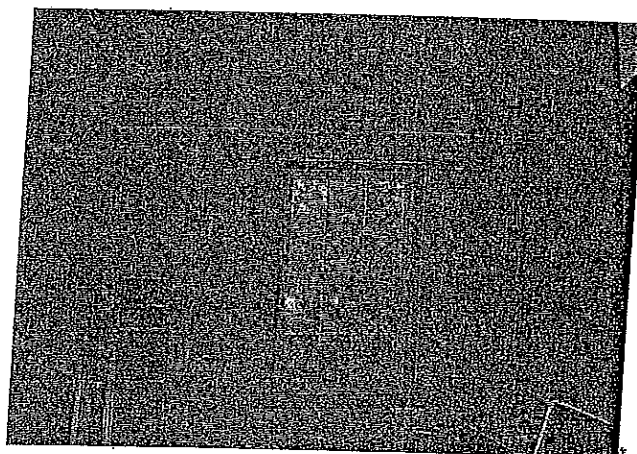
Photo 2

**It should be noted that mold was observed at the north end of the second floor in some of the rooms and in the hallway. Workmen cleaning or working with this material should consider wearing proper Personal Protective Equipment (PPE). See Photo 2.

Building 3 - Second floor - north end
Mold spots visible on wall

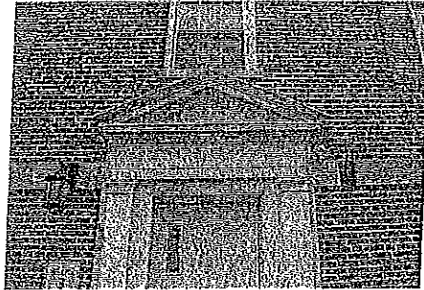
Photo 3
Building 3 - rear west entrance
Lead-based paint on the dental molding

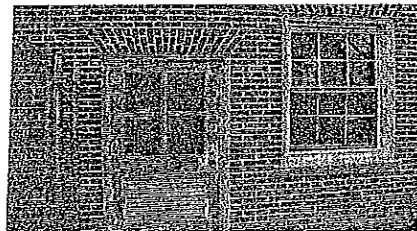
Lead paint stabilization and/or abatement of doors containing lead-based paint is immediately necessary to alleviate the prospect of tracking inside any lead paint chips. Friction points, such as between doors and their hinges, are noteworthy as paint chipping is clearly visible. In occupied residences, chipping and peeling lead based paint poses a direct hazard to young children.

Photo 4
Building 3
Peeling lead-based paint on southwest door

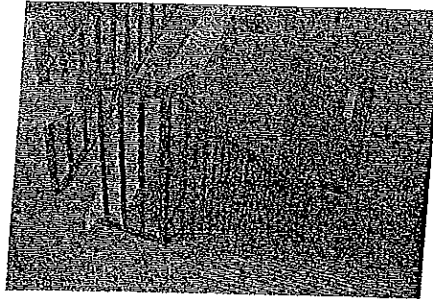
Photo 5
Building 3
Black stairwell banisters with lead-based paint

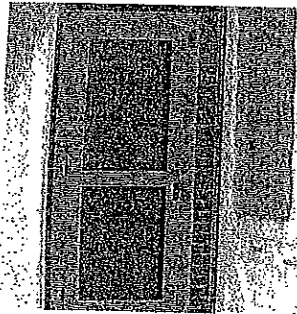
Numerous exterior building components contain lead-based paint. This includes windows, door, screened porches including the ceilings, and foyer area components. See Photos 6 & 7.

Photo 6
Building 5
Secondary interior screen door in foyer area has lead-based paint

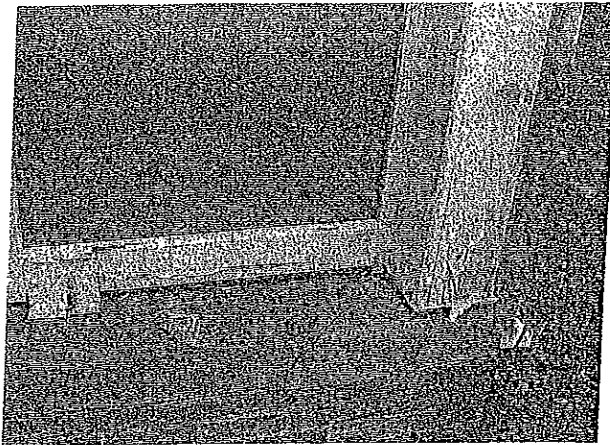
Photo 7
Building 5
Exterior of screened porch has peeling lead-based paint components

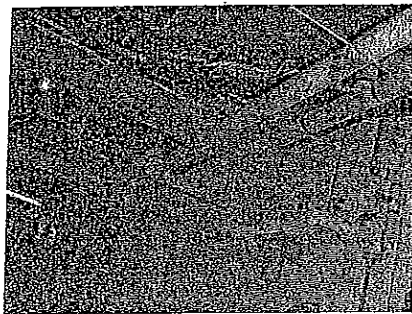
1. Floor tile - approximately 106 SF of vinyl asbestos floor tile (VAT) and mastic was identified in the basement. See Photo 9.
2. All basement pipe insulation and mudded fittings. There is approximately 522 LF of asbestos insulation. See Photo 8

Photo 8
Building 5
Asbestos piping (length and fittings) throughout the basement - typical of all buildings

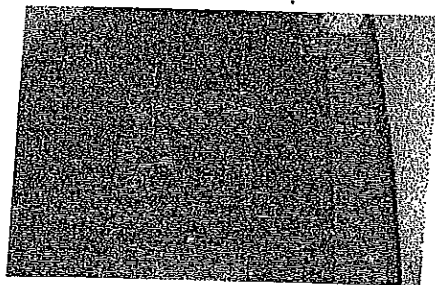
Photo 9
Building 5
VAT in basement - Sample LEB-QTR-1,2,3 (mastic negative)

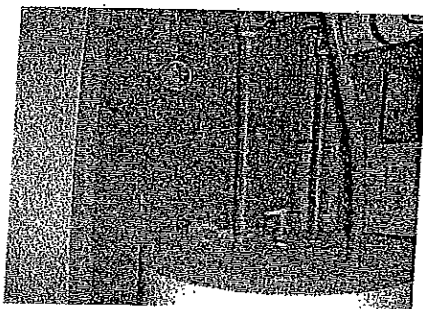
Photo 10
Building 5 - basement
Asbestos debris on top of hot water heater - Sample LEB-QTR-8
Asbestos transite piping also within wall (top of photo)

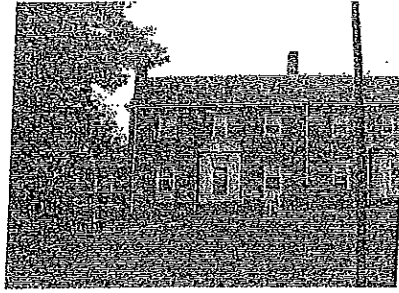
Photo 11

Exterior view of Building 4 (residence 4-2 on right)
Typical exterior features have lead-based paint - windows, screened porches, and foyers

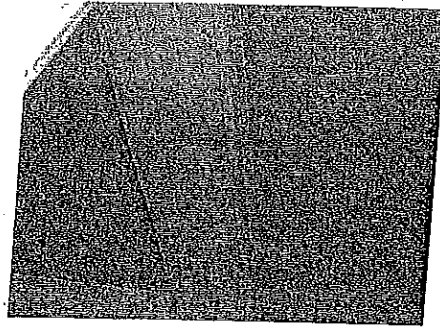
Photo 13
Building 4-2
Peeling lead based paint on 2nd floor bathroom door casing

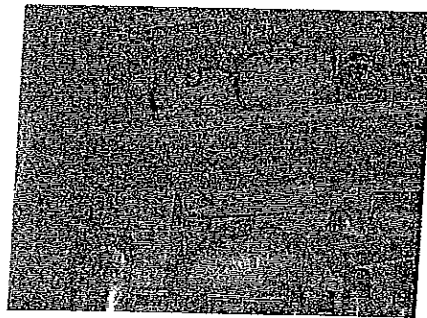
Photo 14
Building 4-2
Peeling lead-based paint in bathroom closet

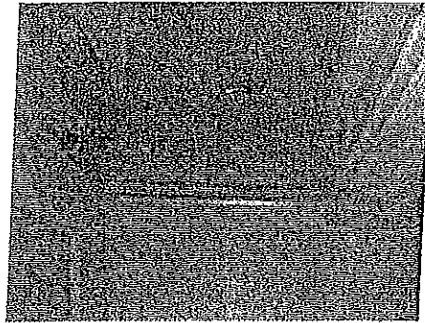
Photo 15
Building 4-2

VAT present underneath kitchen's and connecting hallway's sheetgood material (visible at metal's edge)
VAT assumed present in all buildings' kitchens

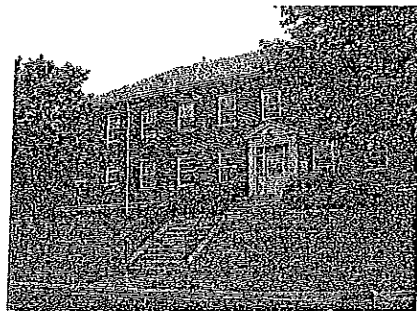
Photo 16
Exterior of Building 26

Typical exterior components have lead-based paint - windows, dental molding, screened porches, foyers

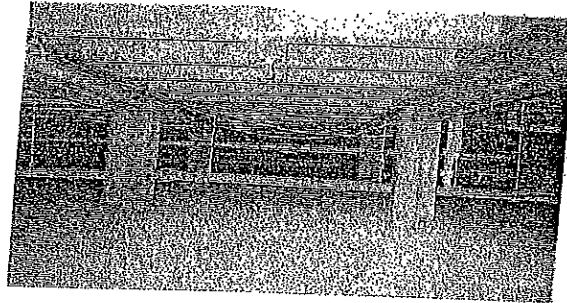
If our assumptions hold true then all piping in the basement will be asbestos containing. The boiler room and several rooms along the rear wall contain approximately 550 LF of asbestos pipe insulation. We estimate there are several thousand linear feet of asbestos pipe insulation in the basement crawlspace. Also, we assume that there is approximately 117 SF of VAT in the kitchen (as it appears in the other building kitchens).

Photo 17
Building 26
Crawl space on Southeast side with several thousand feet of pipe insulation

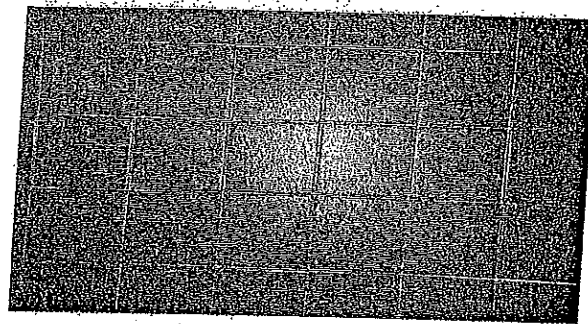
Photo 18
Building 3,4,5,25,26
Lead glazed ceramic bathroom tile found in all buildings

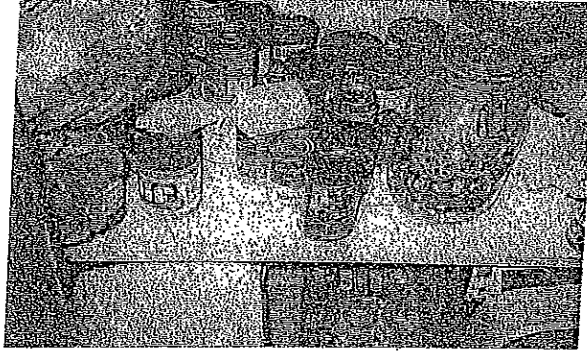
Photo 19
Building 26
Pantry shelf painted with lead based paint in poor condition

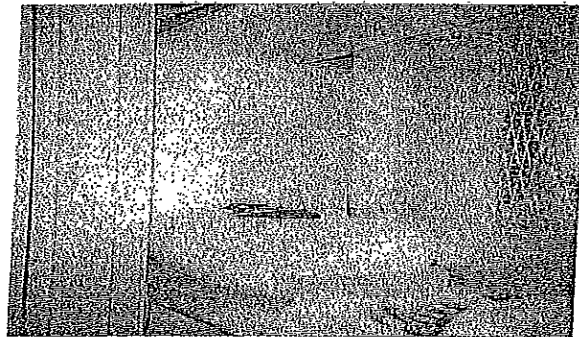
Photo 20
Building 4
Only closet shelf that does not contain lead based paint because of the new air duct unit recently added.

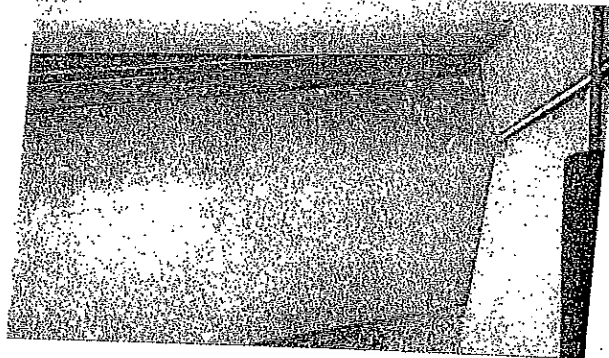
Photo 21
Building 4

Lead paint chips found on the floor under a friction point (door jam and door) in the threshold.
