# ***ASBESTOS- CONTAINING MATERIALS SURVEY***

**Lebanon VA Medical Center – Building 23  
1700 South Lincoln Avenue  
Lebanon, PA 17042-7529**

**Report Date: January 27, 2015**

**Project Number: 142073**

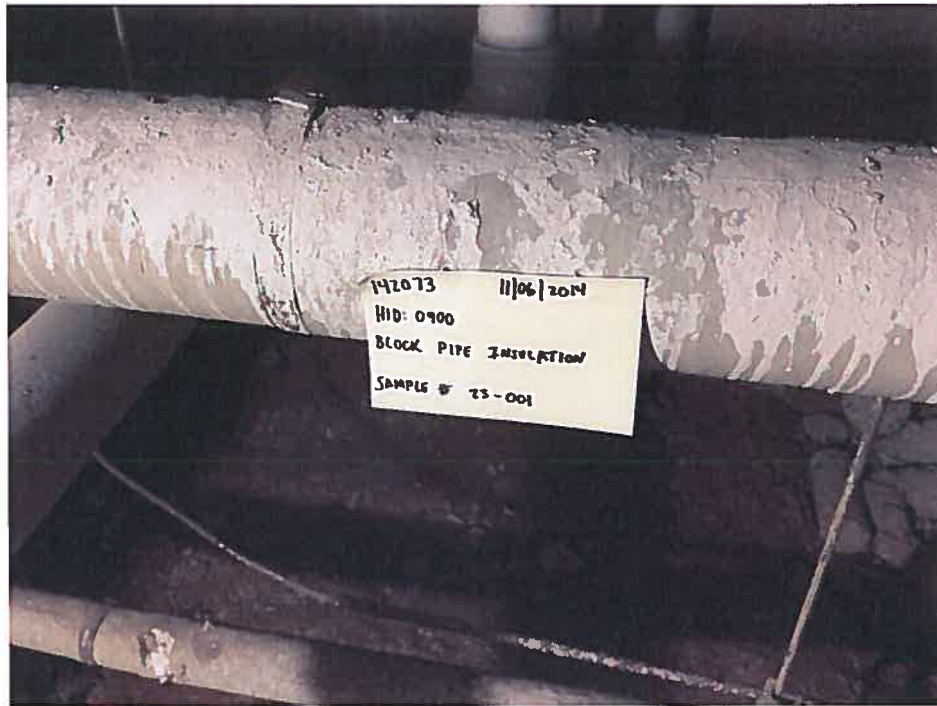
142073-23-007 Block Pipe Insulation Building 23 - Basement - Crawlspace	1	Cellulose-15	60	Chrysotile	25

Figure 1: HID#0900 – Block Pipe Insulation

Any asbestos-containing material that will be disturbed by planned renovations should be first removed by a licensed abatement contractor.

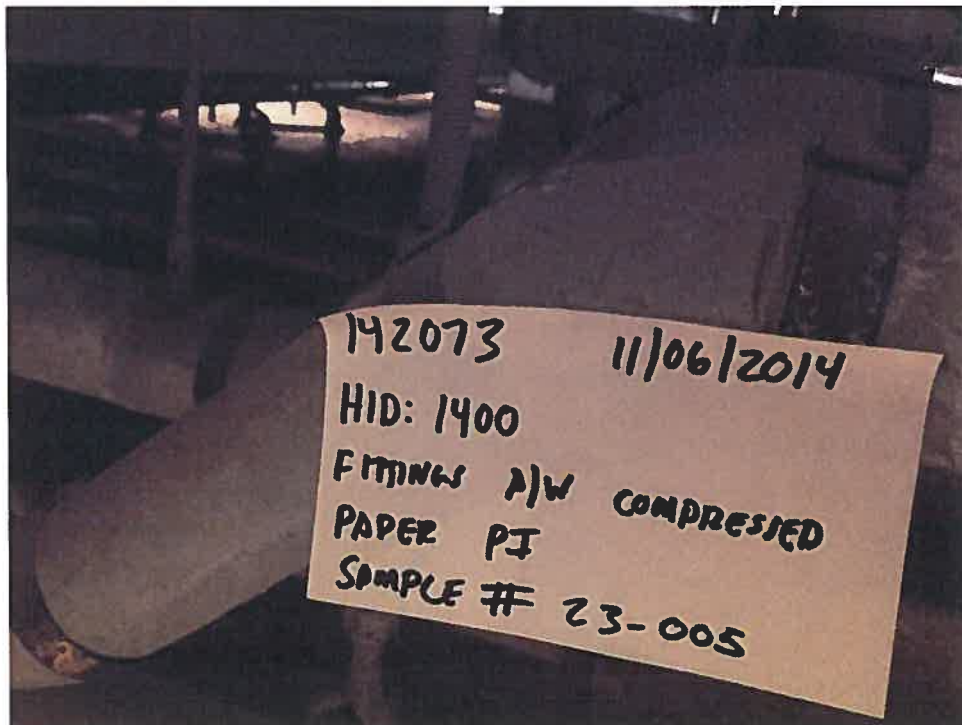
Figure 2: HID#1400 – Fittings Associated with Compressed Paper Pipe Insulation

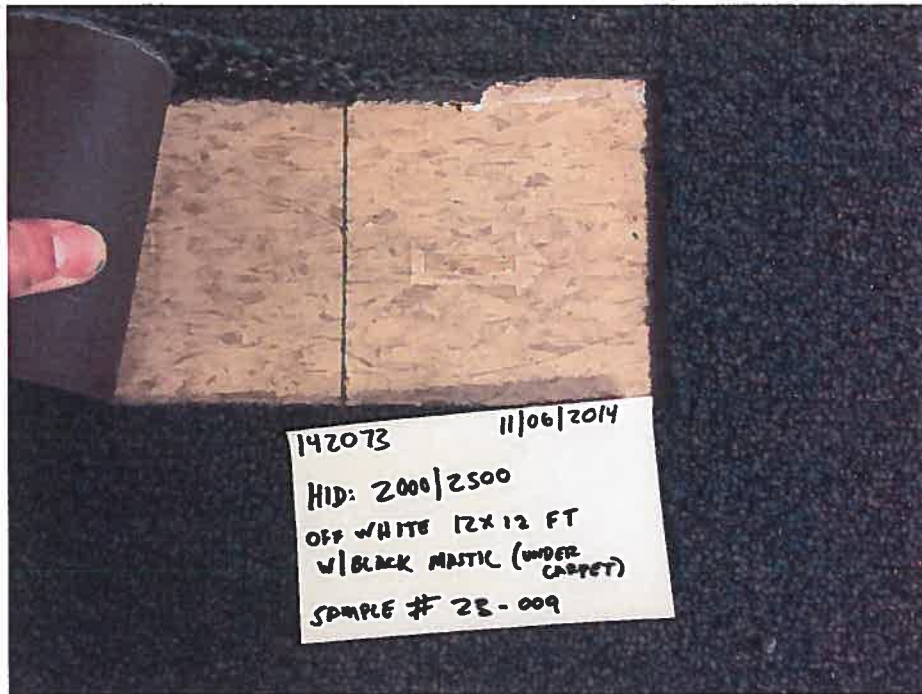
Figure 3: HID#2000/2500 – Off-White 12"x12" Floor Tile with Black Mastic

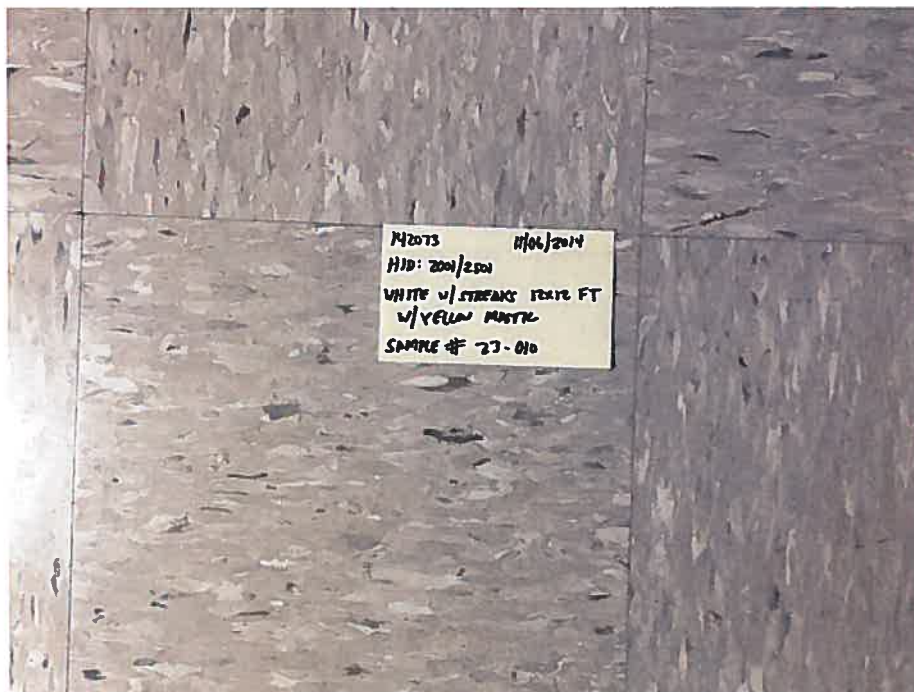
Figure 4: HID#2001/2501 – White with Streaks 12"x12" Floor Tile with Yellow Mastic

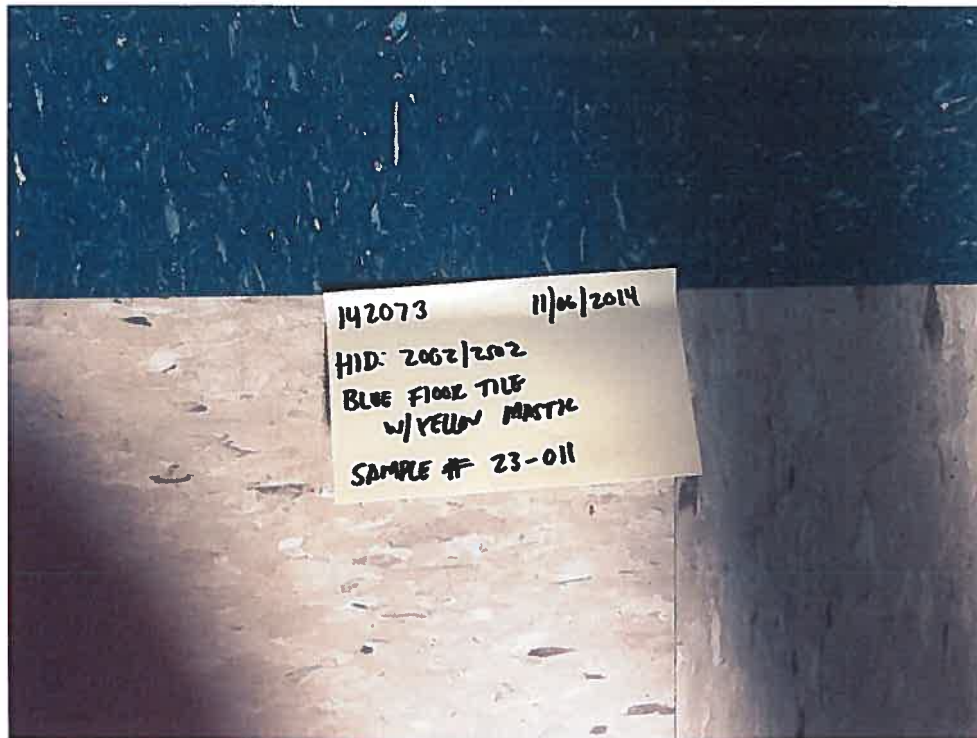
Figure 5: HID#2002/2502 – Blue Floor Tile with Yellow Mastic

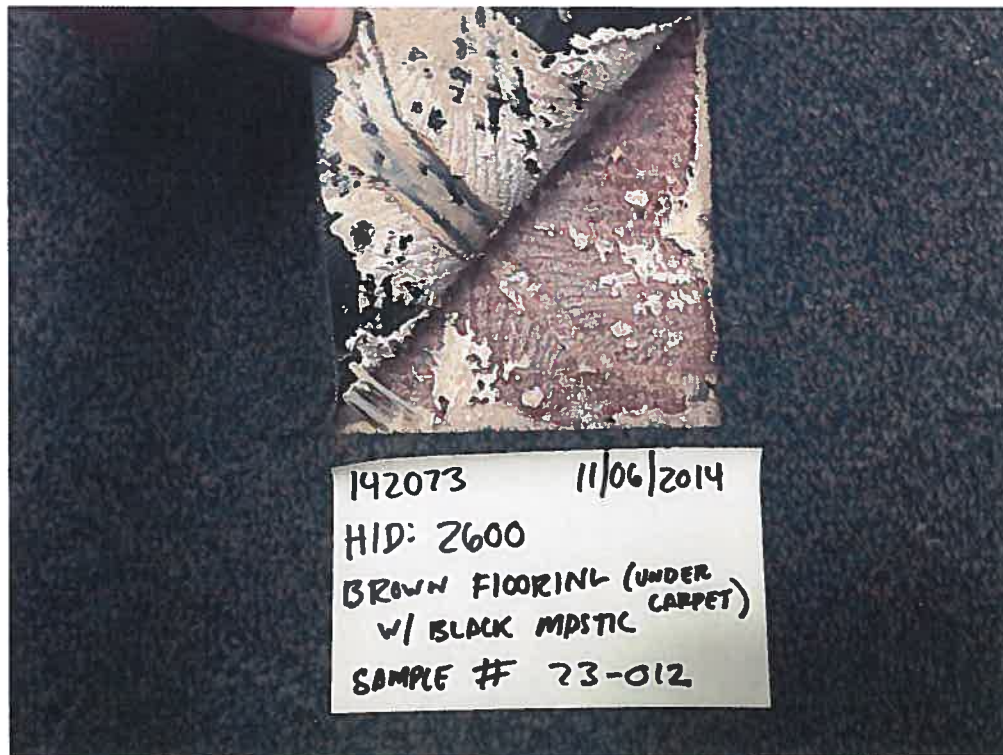
142073-23-012 Brown Flooring Building 23 - 1st Floor - Room 123	1	---	98	Chrysotile	2

Figure 6: HID#2600 – Brown Flooring Material with Black Mastic

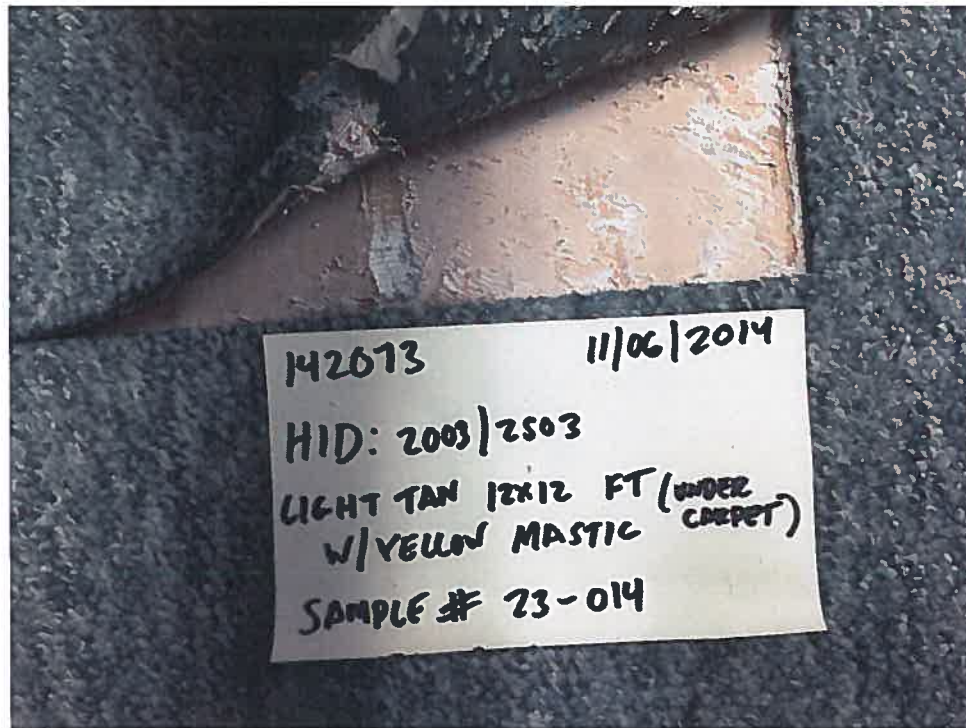
Figure 7: HID#2003/2502 – Light Tan 12"x12" Floor Tile with Yellow Mastic

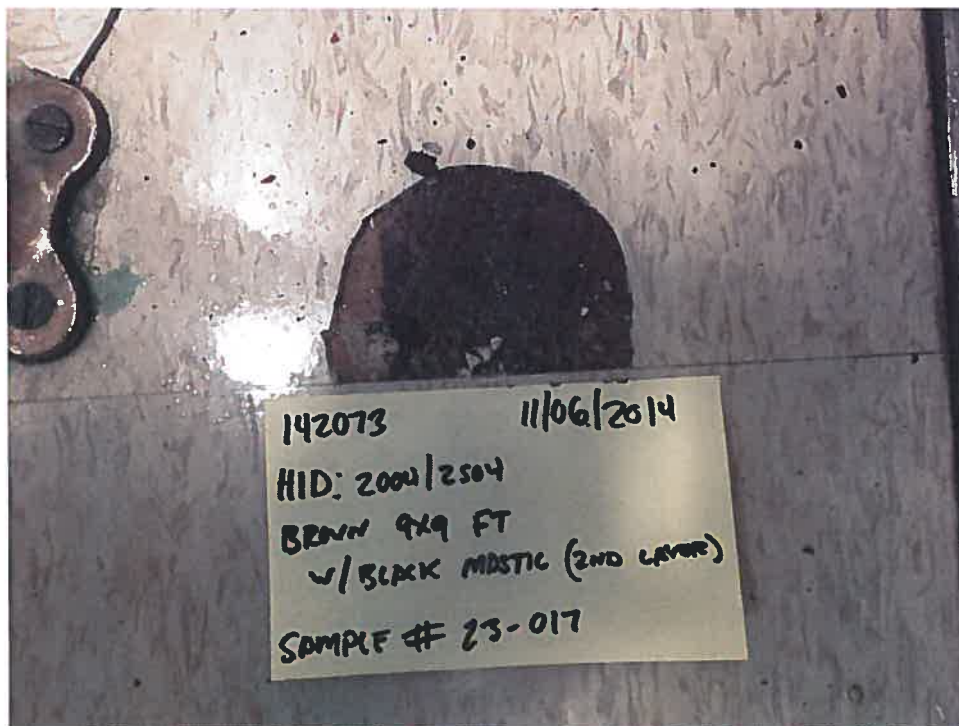
Figure 8: HID#2004/2504 – Brown 9"x9" Floor Tile with Black Mastic

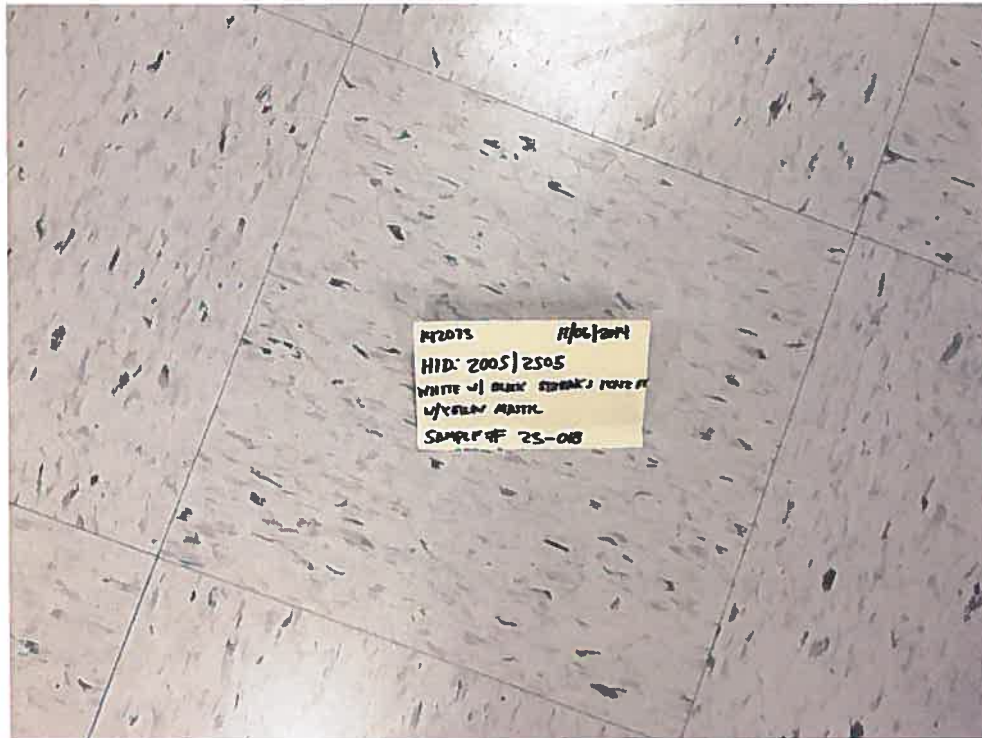
Figure 9: HID#2005/2505 – White with Black Streaks 12"x12" Floor Tile with Yellow Mastic

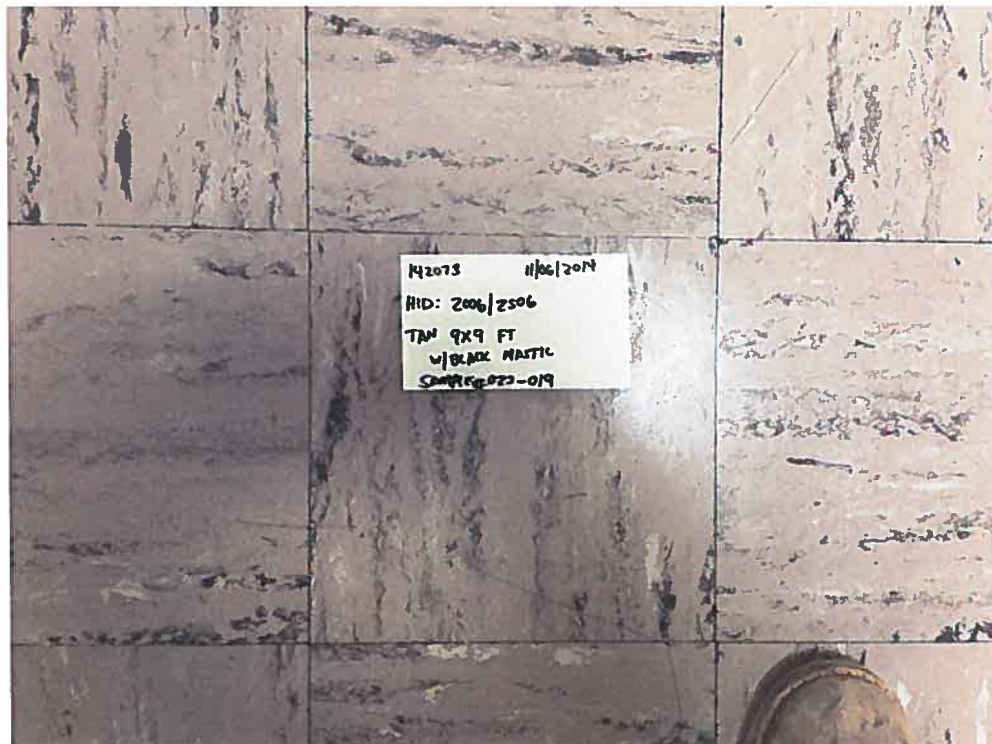
Figure 10: HID#2006/2506 – Tan 9"x9" Floor Tile with Black Mastic

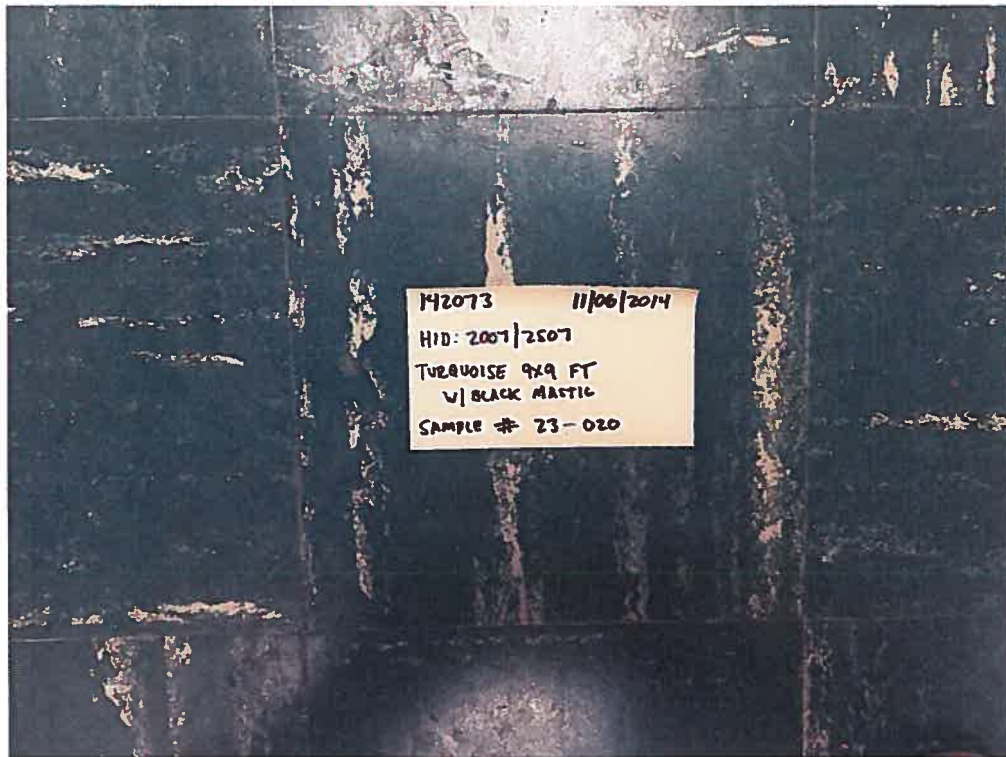
142073-23-020 Turquoise 9" x 9" Floor Tile Building 23 - 1st Floor - Room 115	1	---	98	Chrysotile	2

**Figure 11: HID#2007/2507 – Turquoise 9"x9" Floor Tile with Black Mastic**

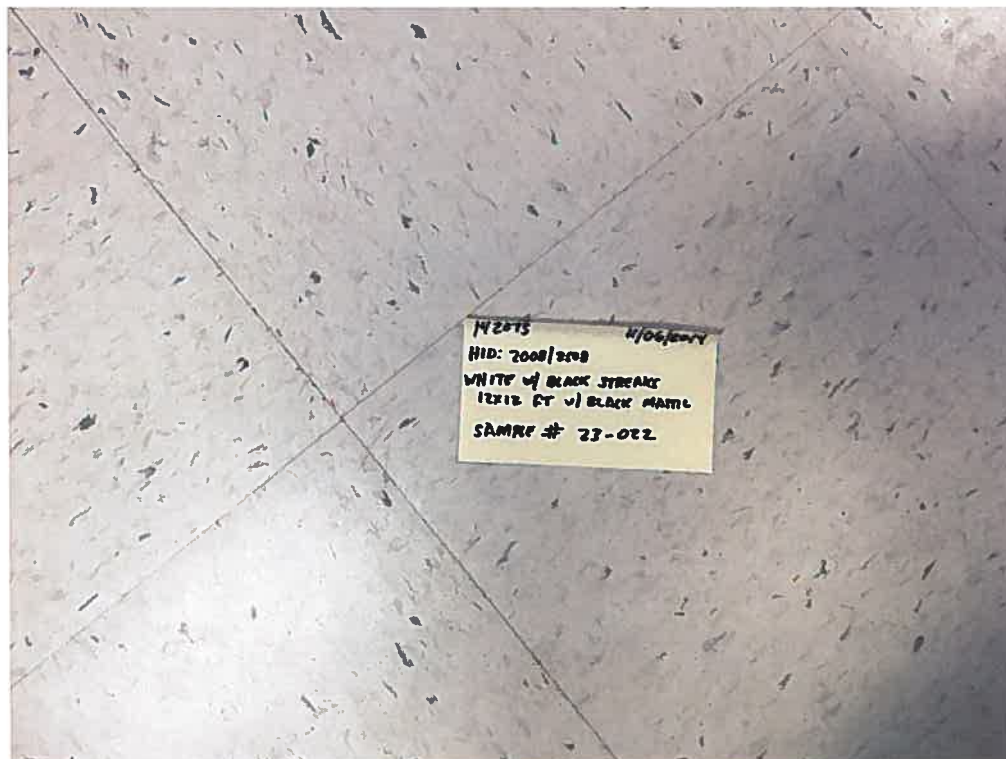
**Figure 12: HID#2008/2508 – White with Black Streaks 12"x12" Floor Tile with Black Mastic**

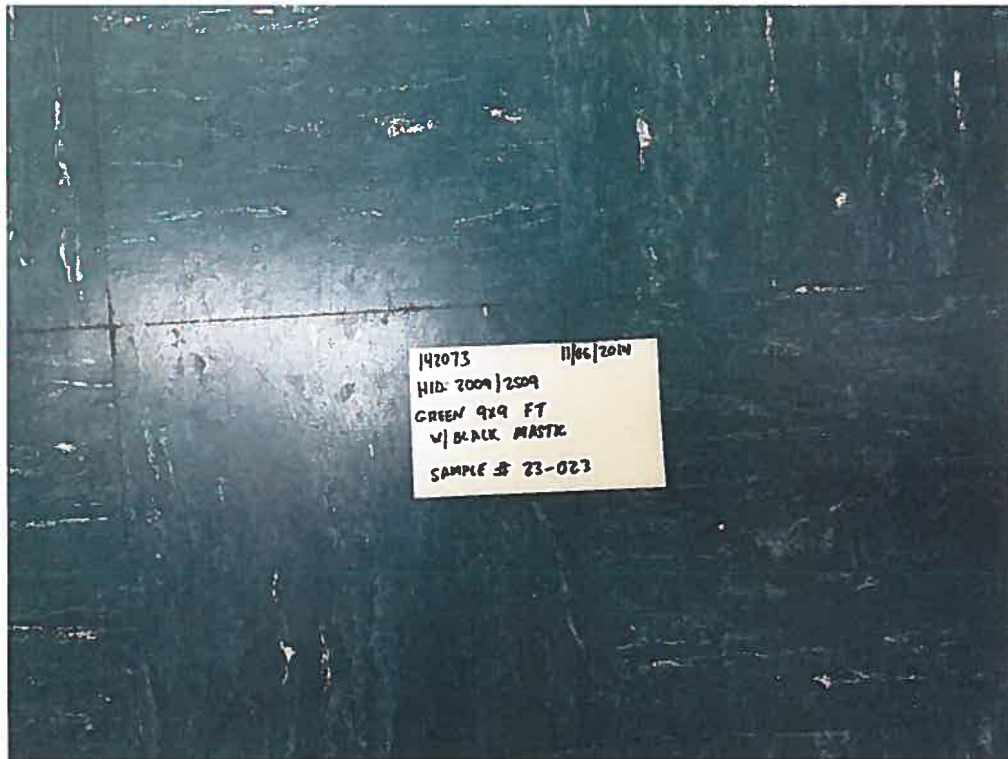
142073-23-024 Green 9" x 9" Floor Tile Building 23 - 1st Floor - Room 114	1	---	98	Chrysotile	2

Figure 13: HID#2009/2509 – Green 9”x9” Floor Tile with Black Mastic

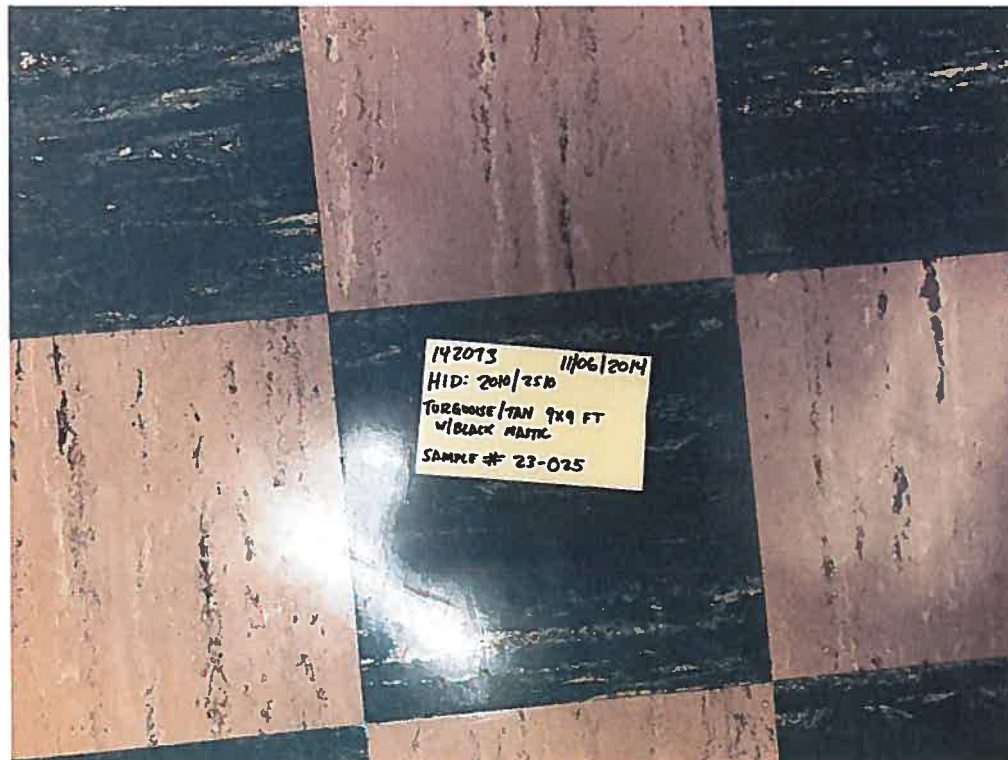
142073-23-028 Turquoise/Tan 9" x 9" Floor Tile Building 23 - 1st Floor - Room 106	1	---	98	Chrysotile	2

Figure 14: HID#2010/2510 – Turquoise/Tan 9”x9” Floor Tile with Black Mastic

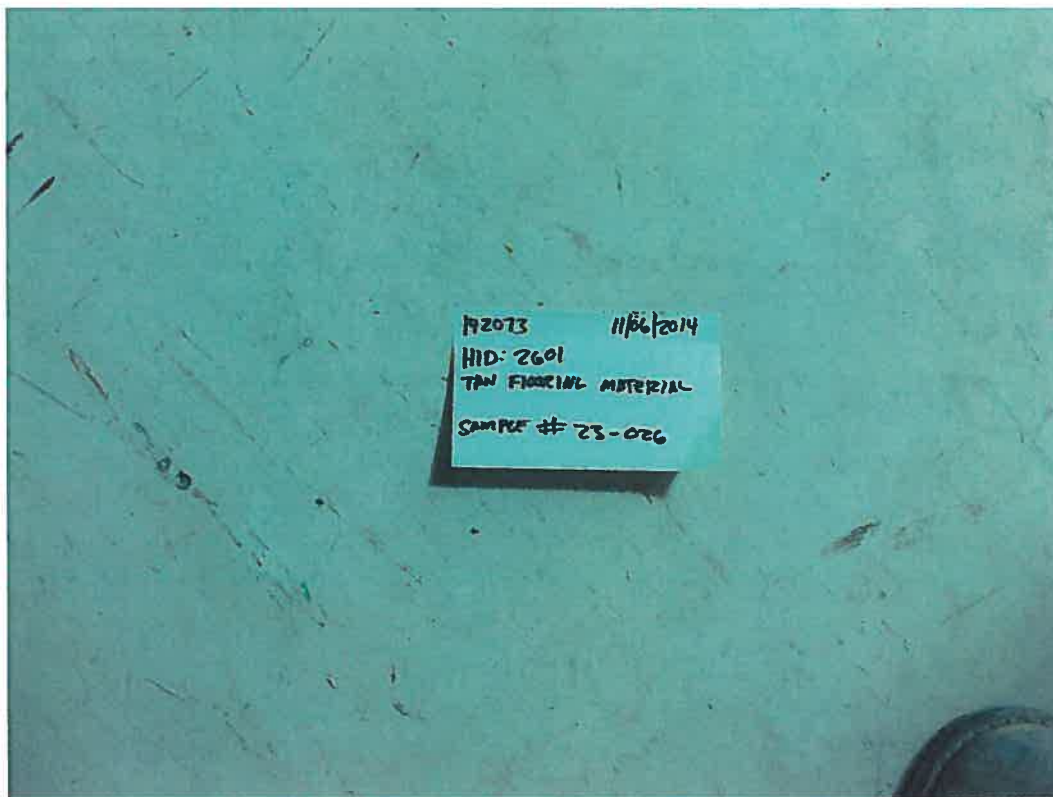
Figure 15: HID#2601 – Tan Flooring Material

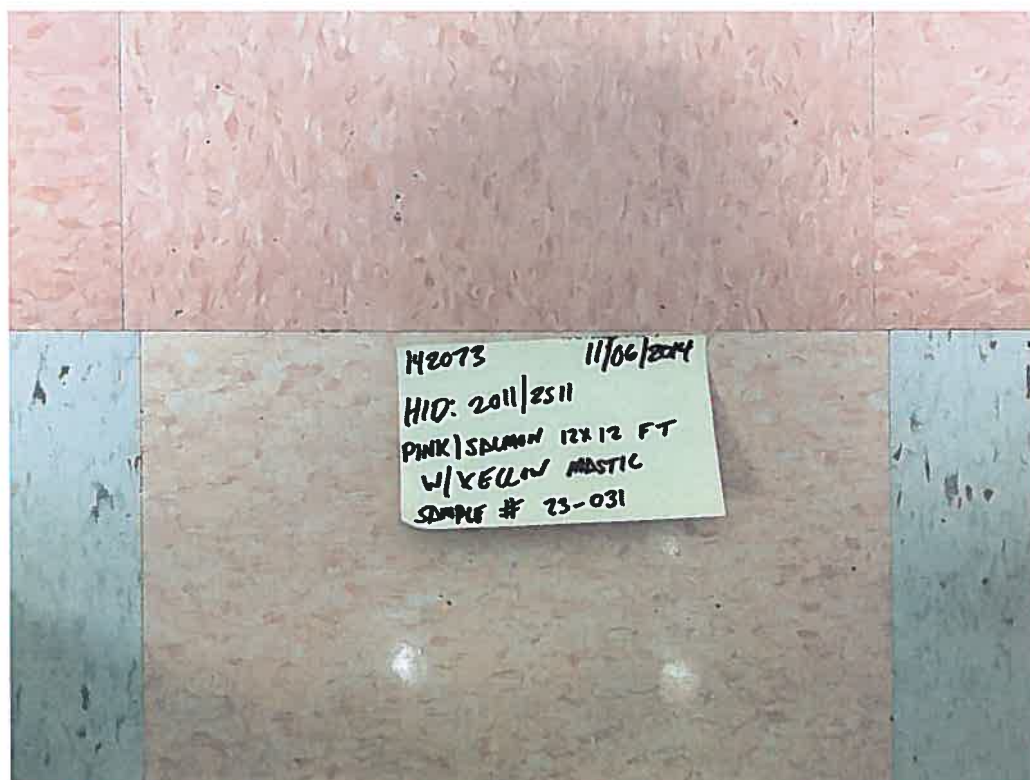
142073-23-031 Pink/Salmon 12" x 12" Floor Tile Building 23 - 1st Floor - Hallway	1	---	100	None Detected	---

Figure 16: HID#2011/2511 – Pink/Salmon 12"x12" Floor Tile with Yellow Mastic

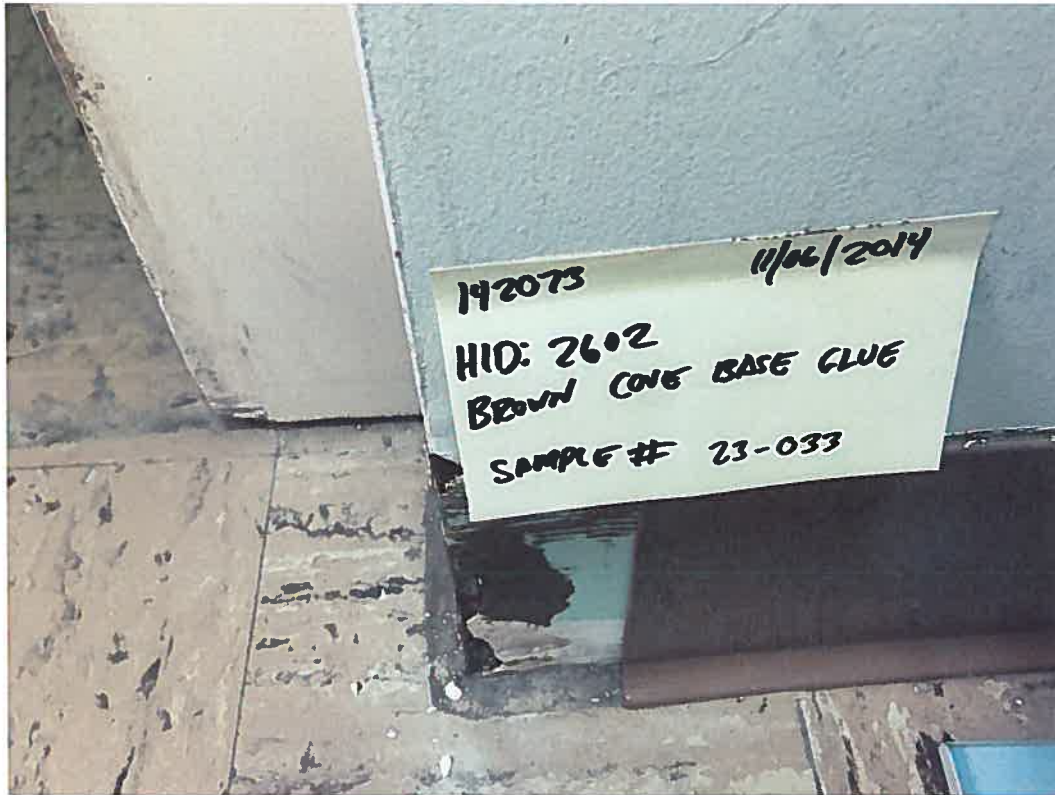
Figure 17: HID#2602 – Brown Cove Base Glue

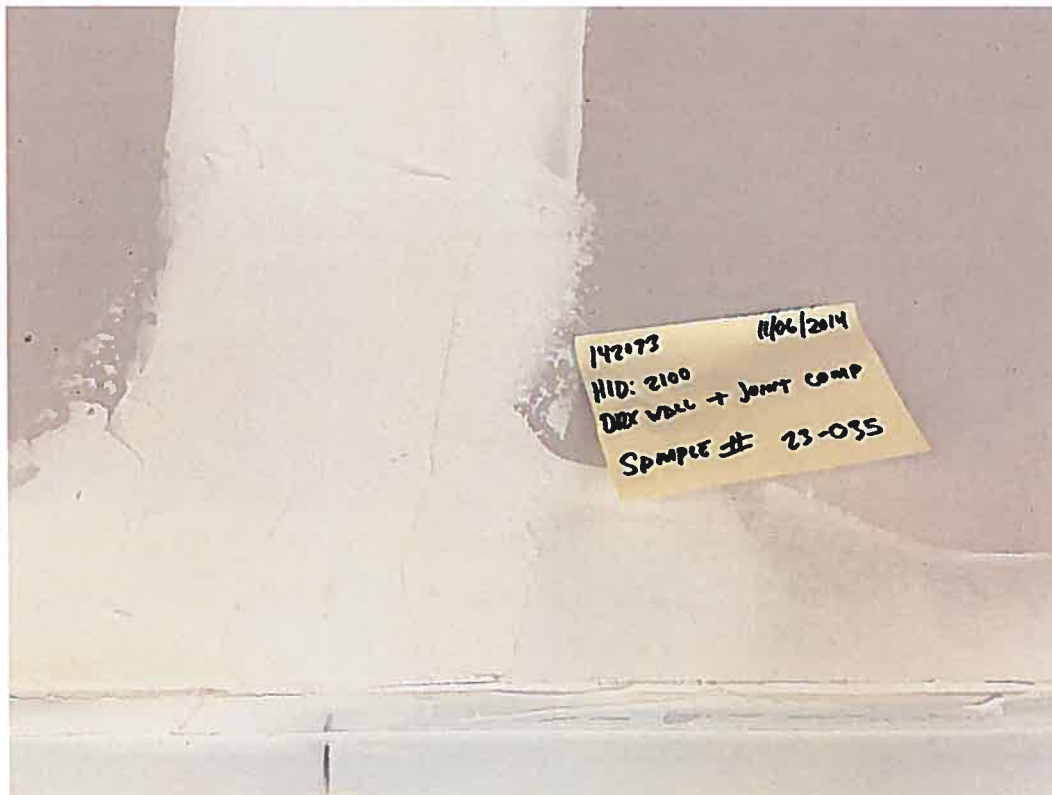
Figure 18: HID#2100 – Drywall Material with Joint Compound

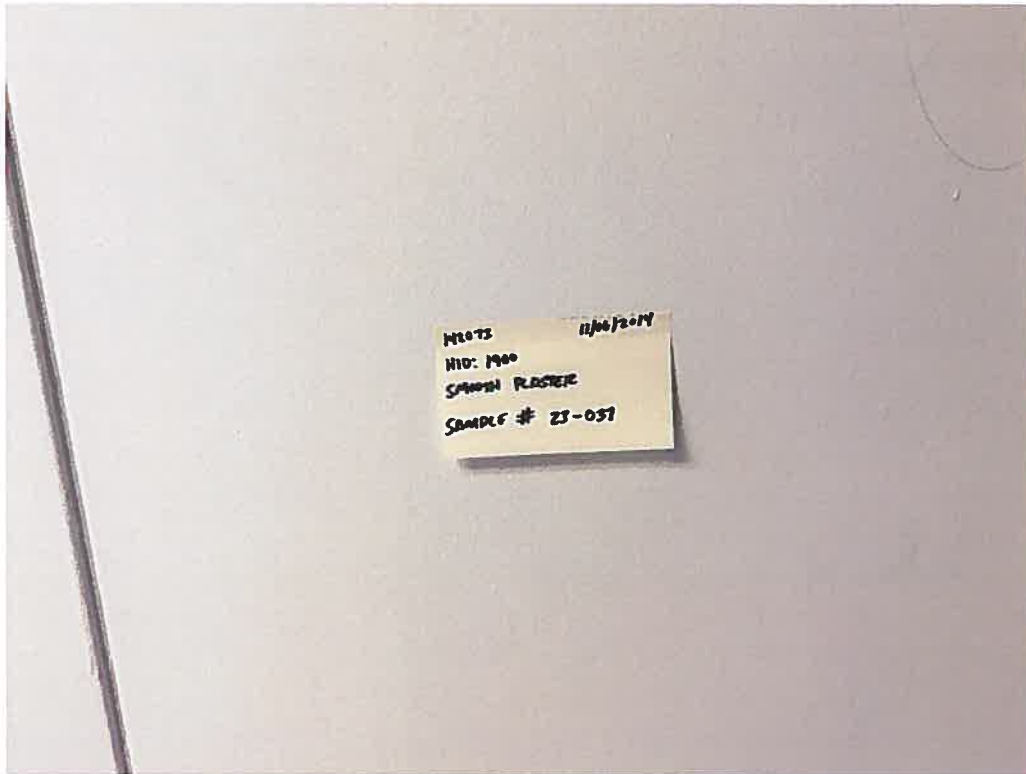
Figure 19: HID#1900 – Smooth Plaster

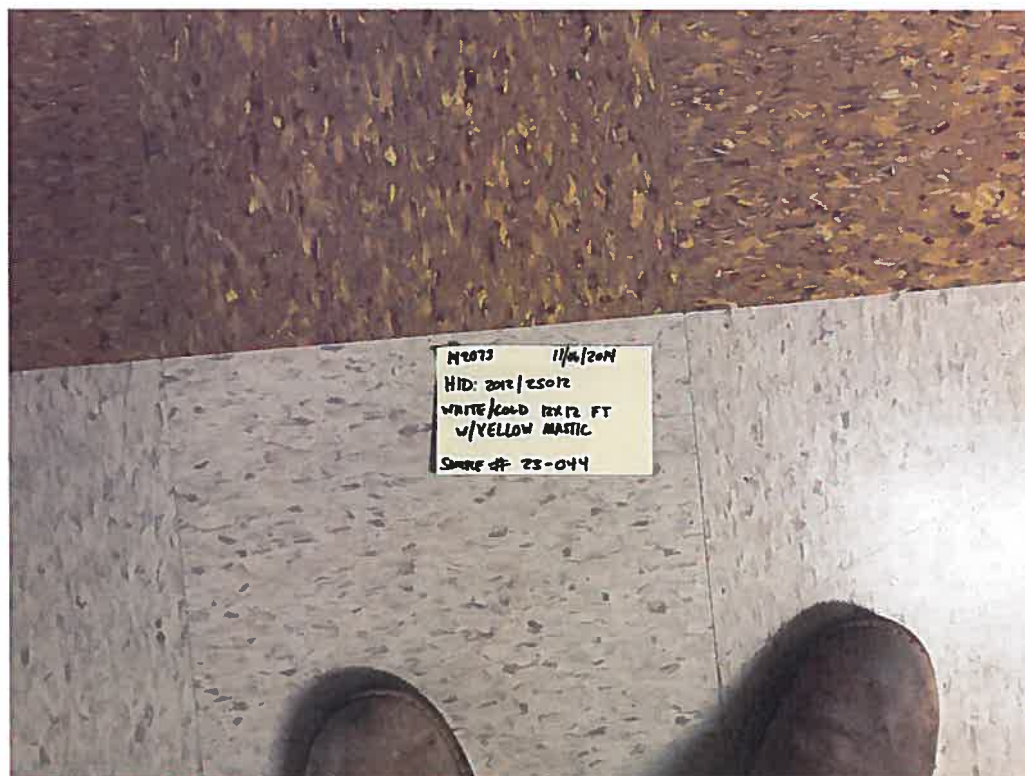
Figure 20: HID#2012/2512 – Whit/Gold 12"x12" Floor Tile with Yellow Mastic
