# *ASBESTOS- CONTAINING MATERIALS SURVEY*

**Lebanon VA Medical Center – Building 7  
1700 South Lincoln Avenue  
Lebanon, PA 17042-7529**

**Report Date: January 15, 2015  
Project Number: 142073  
Date of Project: October 28, 2014  
Solicitation #: VA244-14-Q-1389**

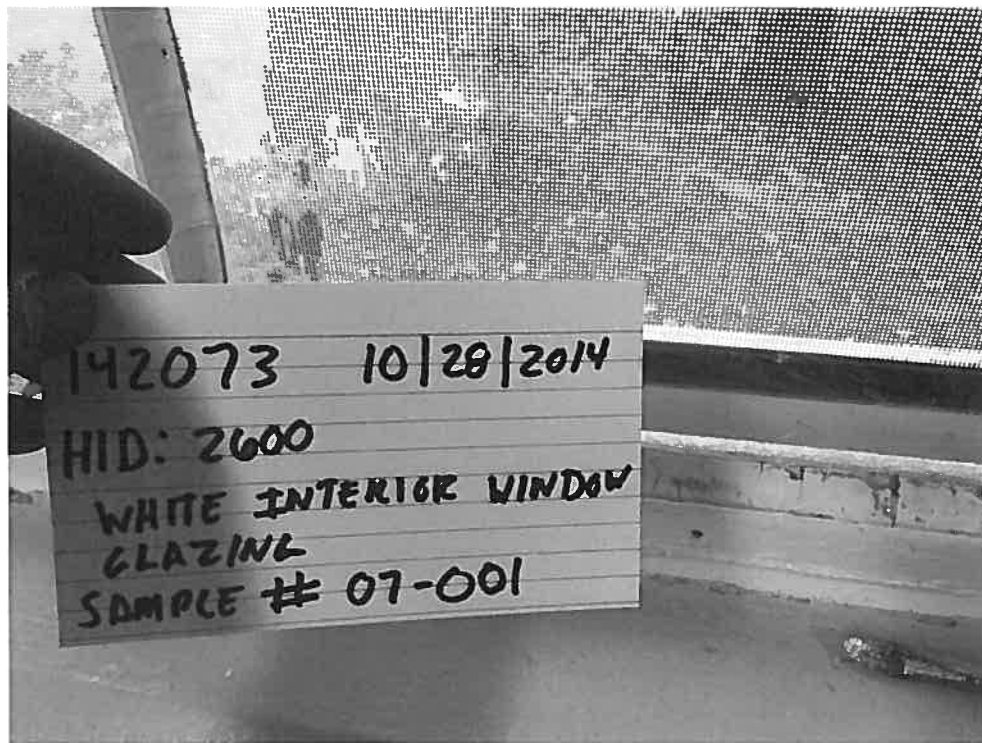
Figure 1: HID#2600 – White Interior Window Glaze

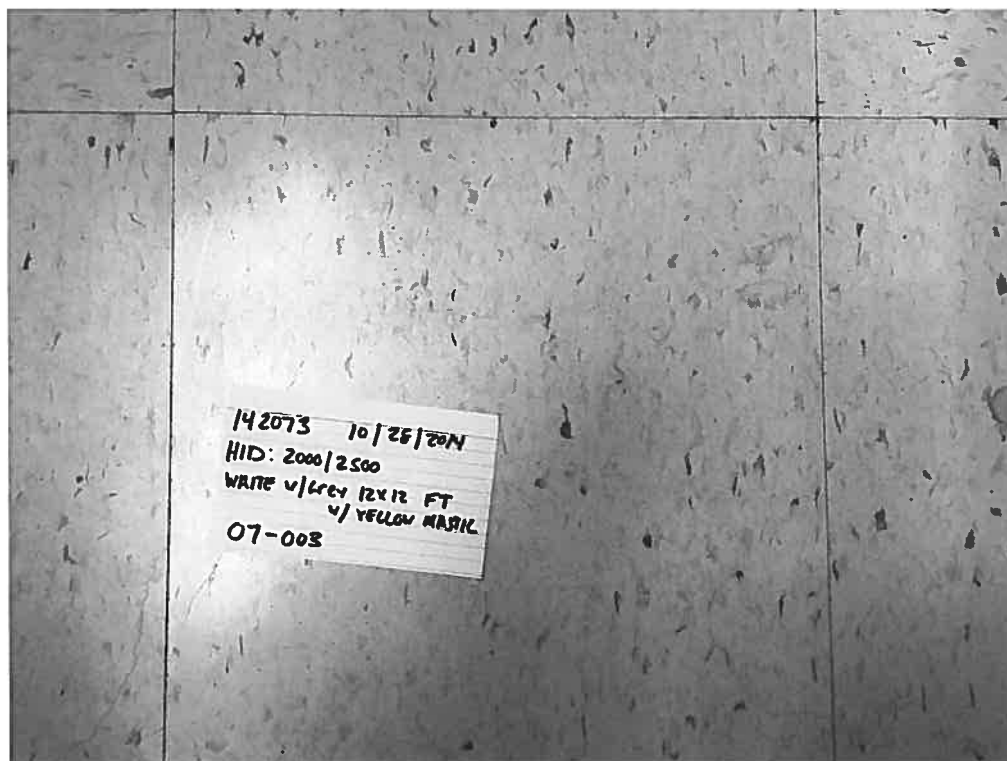
Figure 2: HID#2000/2500 – White with Gray 12"x12" Floor Tile and Yellow Mastic

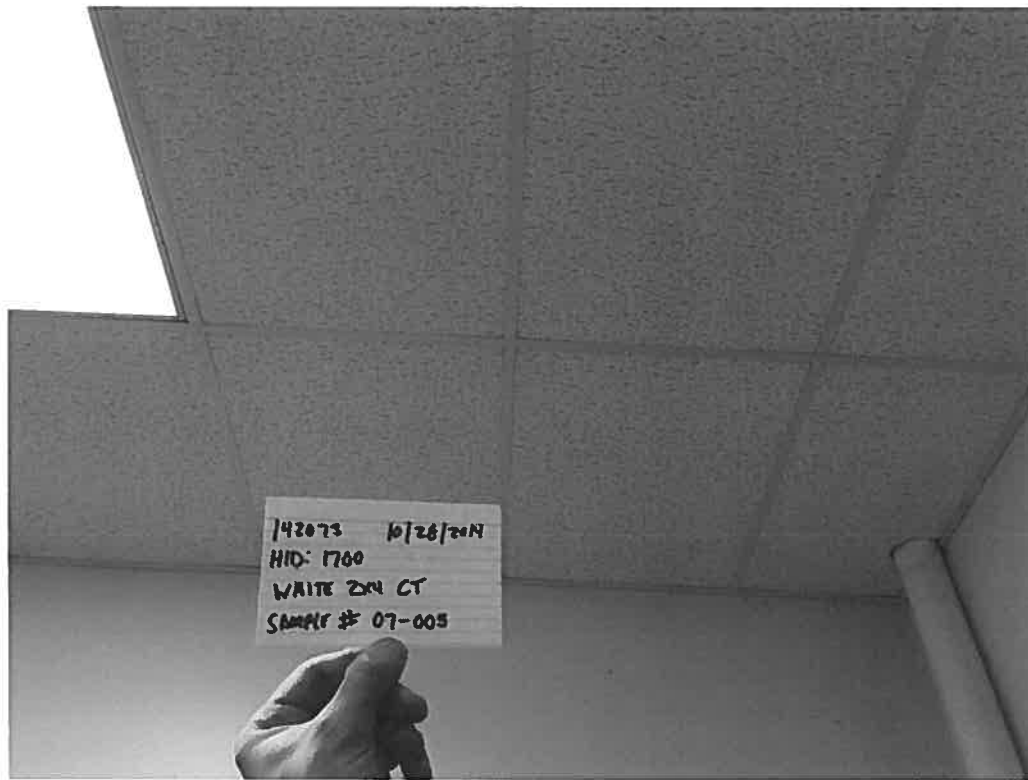
Figure 3: HID#1700 – White 2'x4' Lay-In Ceiling Tile

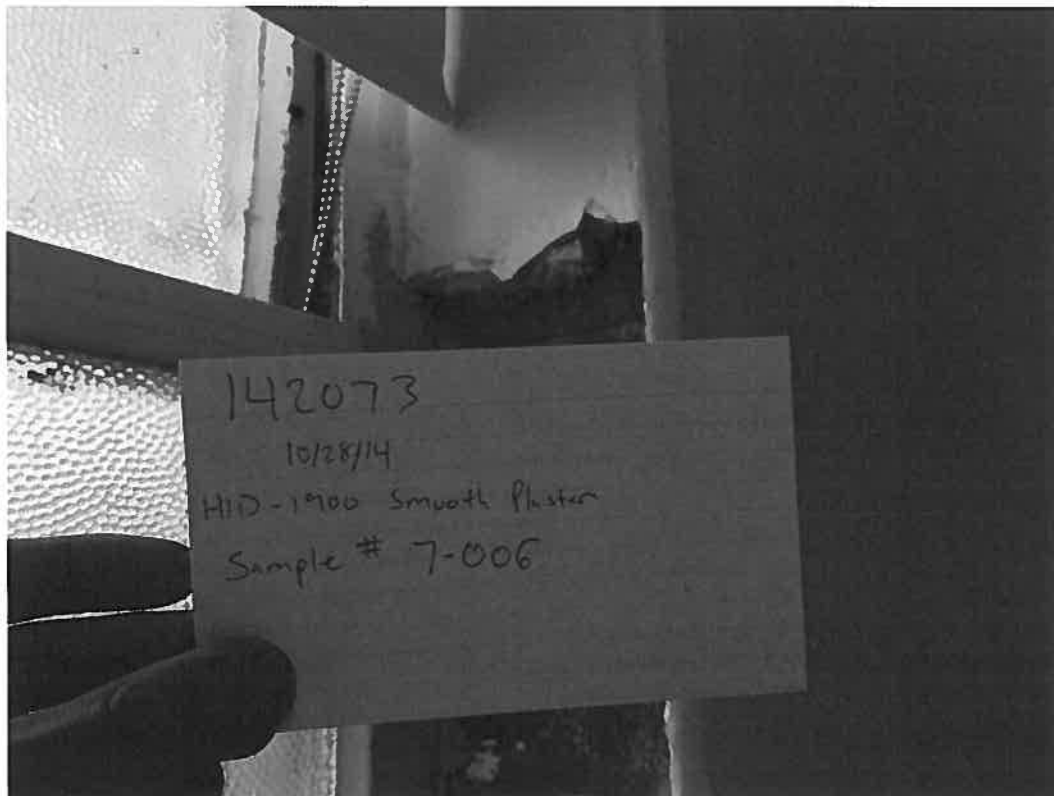
Figure 4: HID#1900 – Smooth Plaster

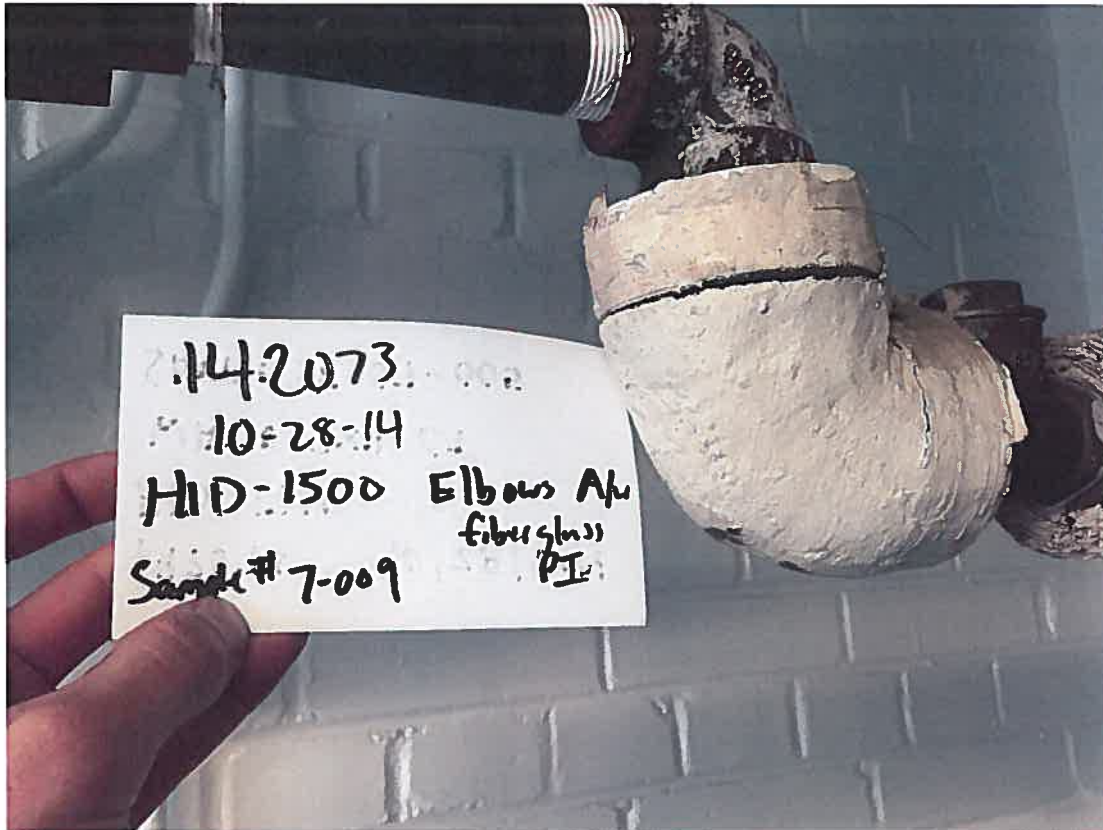
Figure 5: HID#1500 – Elbows Associated with Fiberglass Pipe Insulation
