**Project**  
**Minsi Hall Masonry Repair**  
**ESU 30-2107**  
**East Stroudsburg University**

Drawing Title  
**Exterior Elevations**

Details

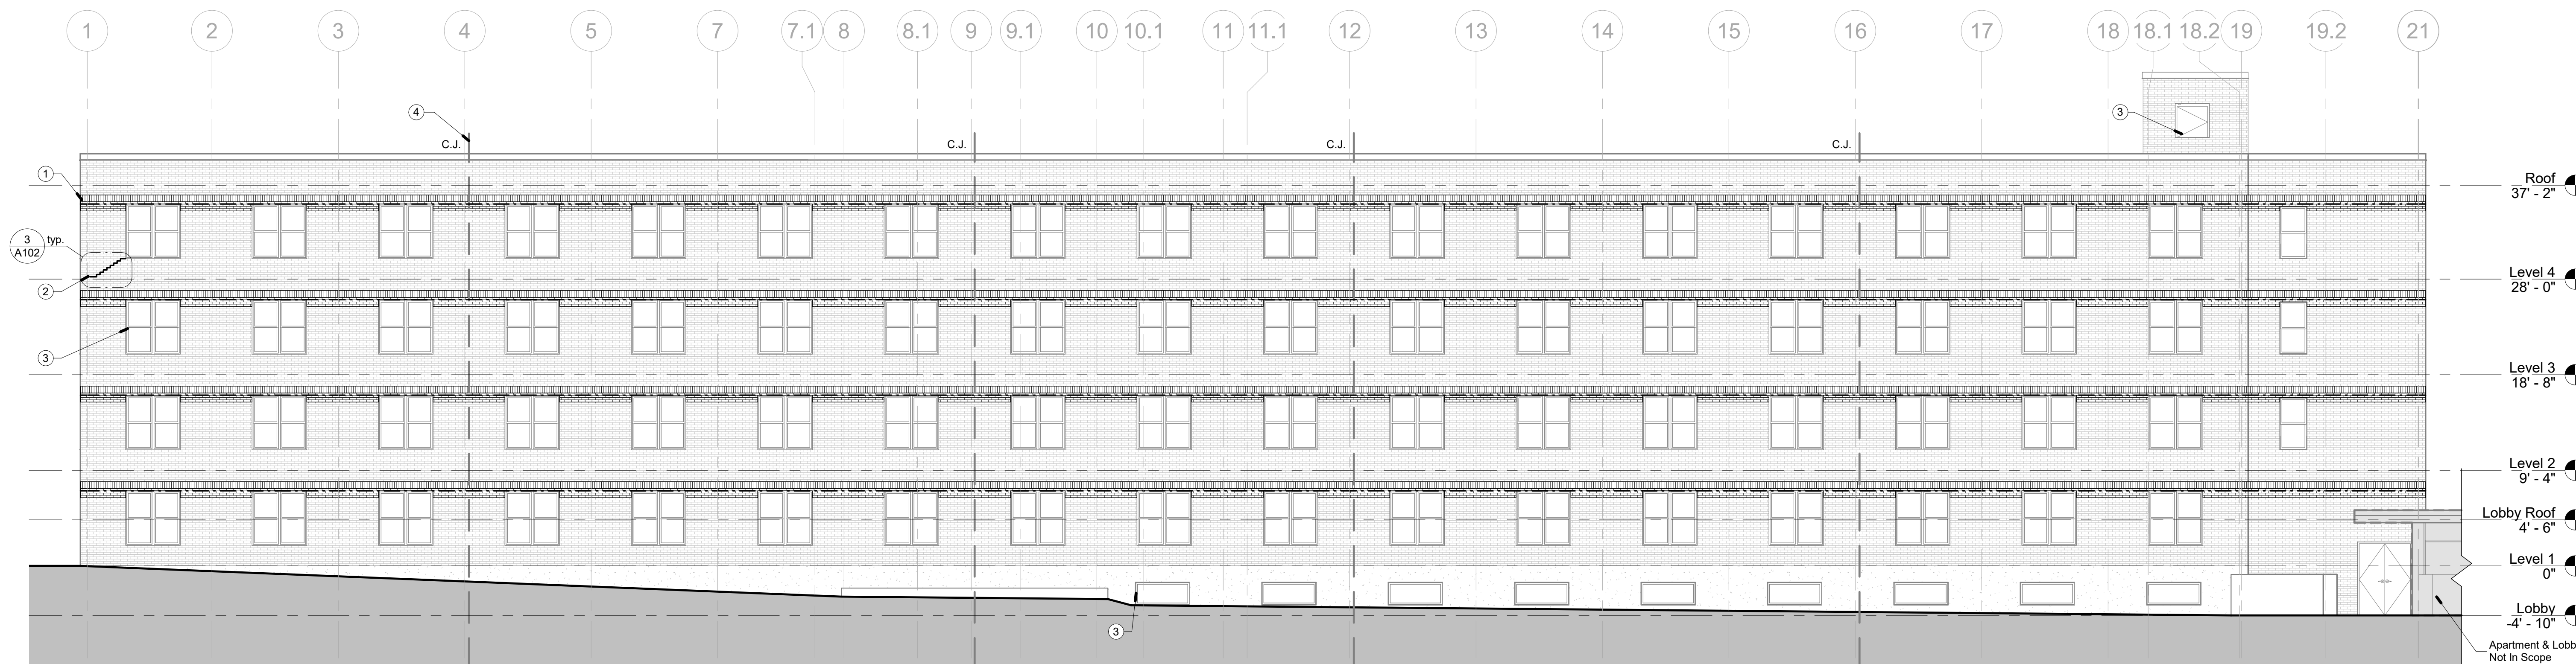
**1 North Elevation - Overall**  
1/8" = 1'-0"

- New brick relief angle and masonry infill. Typical of the perimeter of the entire four story Residence Tower at all four floors. See details A102 for more information.

- Repair existing step/brick crack via stitch anchor and repoint. See detail on A102 for more information.
- Remove existing exterior perimeter sealant and backer rod from existing opening/penetration. Install new backer rod and sealant. Typical of ALL windows, penetrations, frames, holes, etc. around the perimeter of the four story Residence Tower.

- Remove existing exterior perimeter sealant and backer rod from existing control joint. Install new backer rod and sealant.
- Patch/repair existing spalling in existing concrete foundation wall.

- New loose intel at existing opening, typical of all window heads, within masonry, that do not fall at the perimeter steel. New brick infill to be toothed in. Supply prefabricated end dam in head joint, set in mastic (if not self-adhering). End dam to be placed prior to through-wall flashing. The Contractor shall limit brick removal to only those necessary to complete the existing intel removal and new intel installation. See details A102 for intel schedule and for more information.

- Remove and replace existing damaged brick. New brick infill to be toothed in. Remove existing coping as required for new work. Reinstall existing coping.

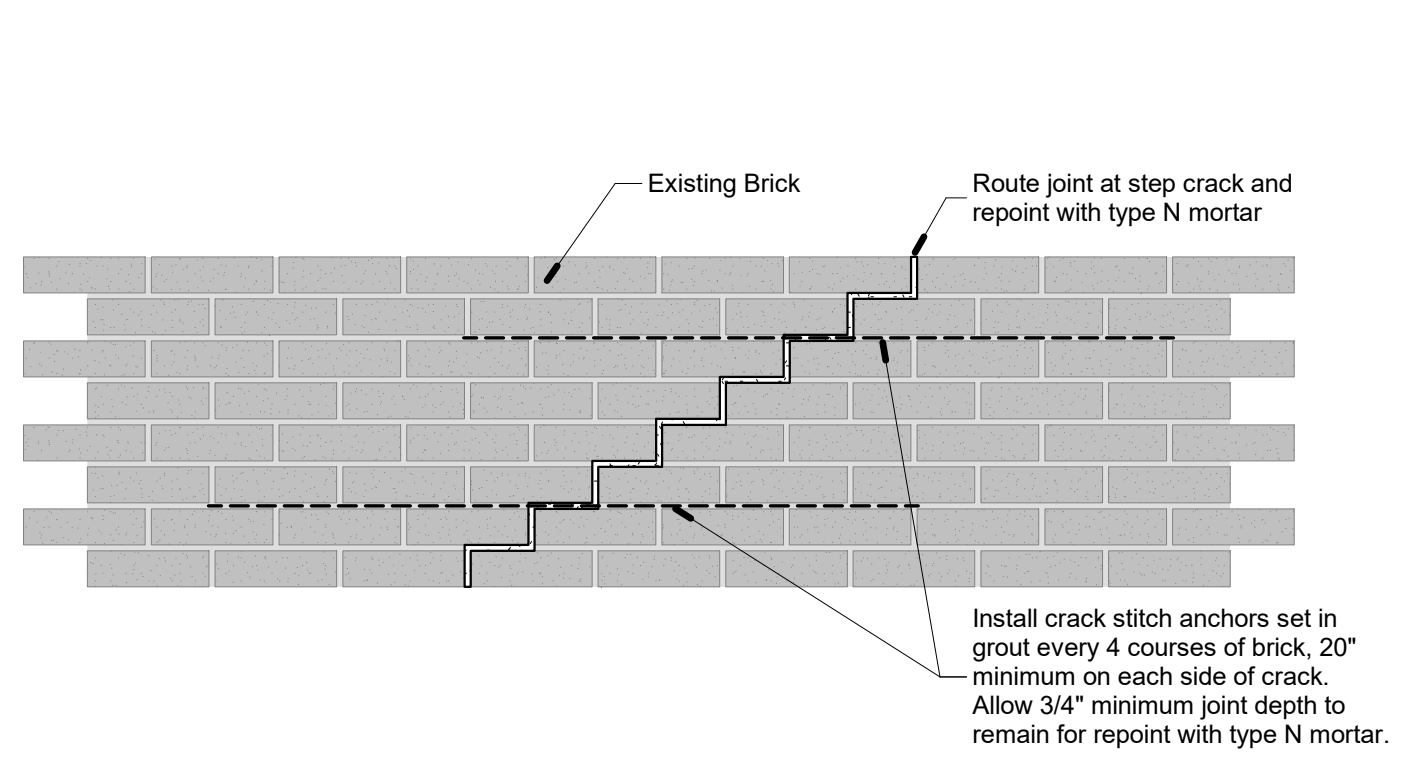
3 Detail - Masonry Crack Repair
1" = 1'-0"

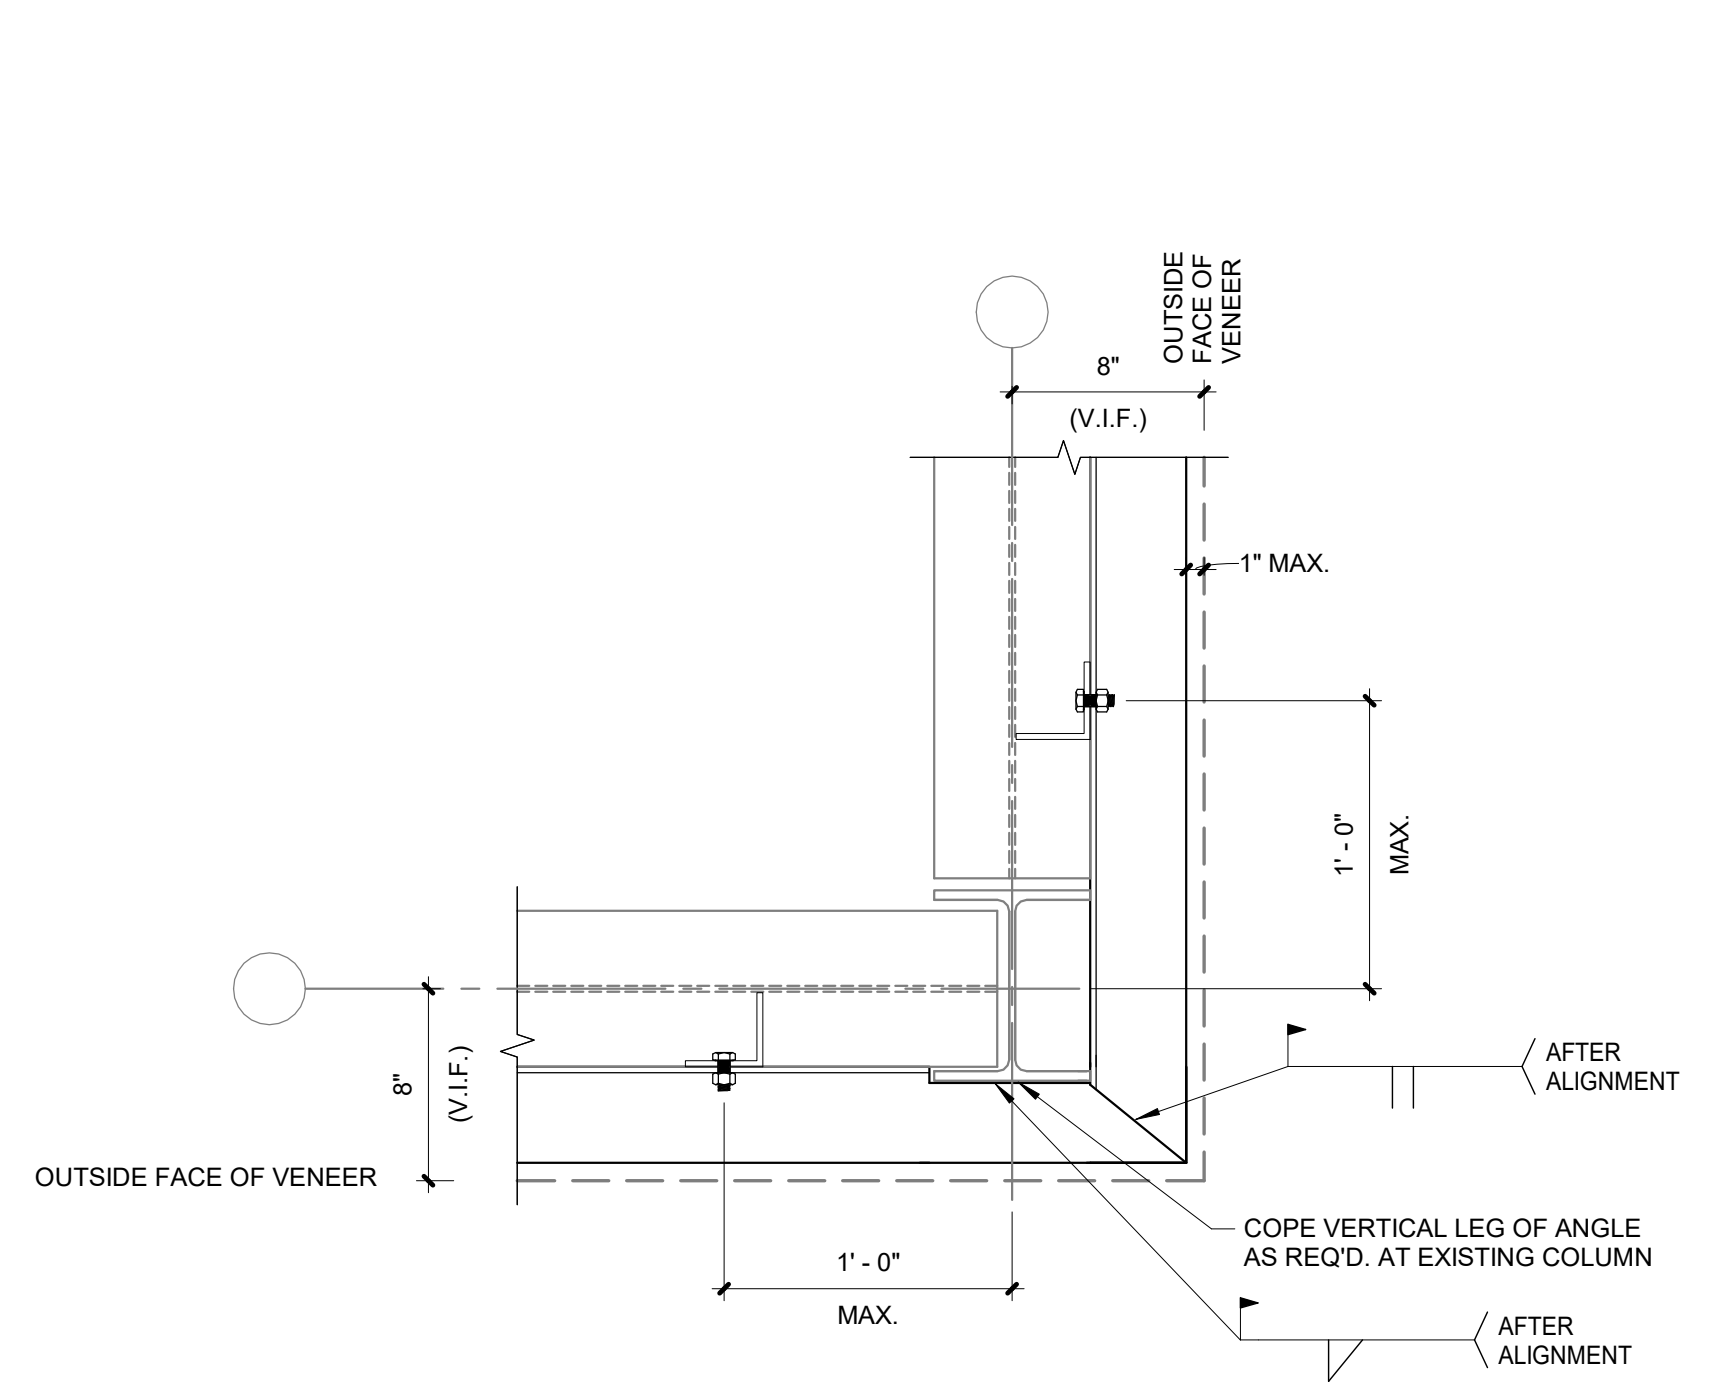
4 Detail - Typical Brick Relief Angle Detail
1 1/2" = 1'-0"

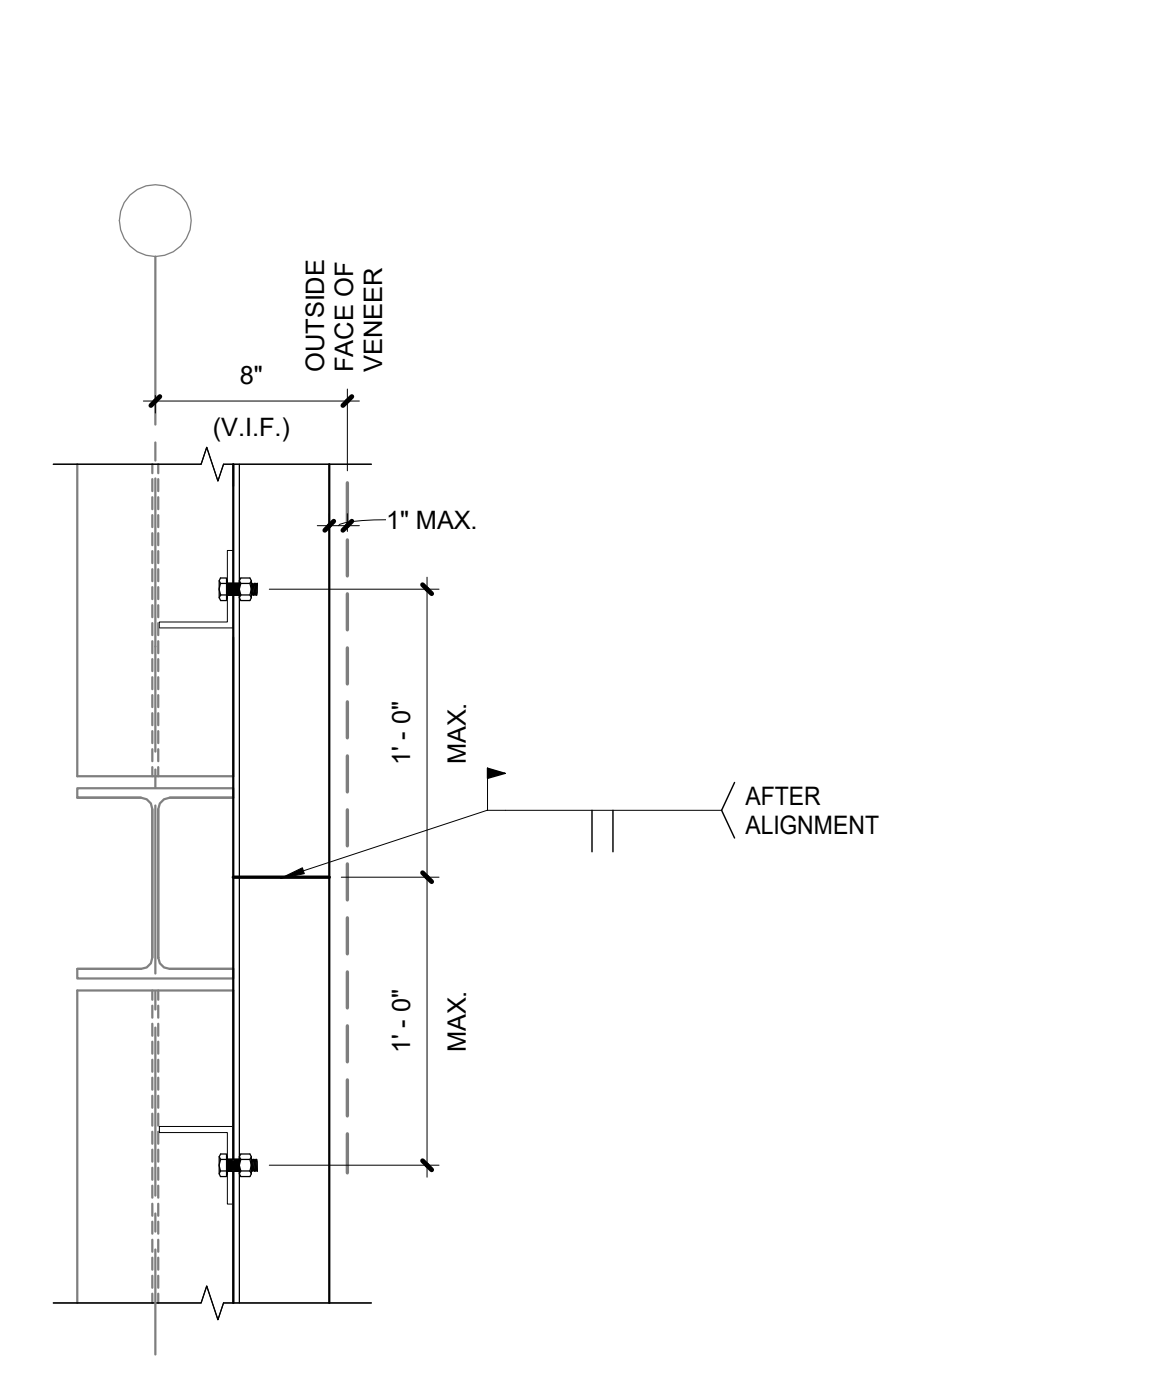
5 Detail - Typical Brick Relief Angle Plan at Splice
1 1/2" = 1'-0"
