# ***ASBESTOS- CONTAINING MATERIALS SURVEY***

**Building 1  
Department of Veterans Affairs  
Michael Crescenz VA Medical Center  
3900 Woodland Avenue  
Philadelphia, PA 19104**

**August 1, 2022**

**212842**

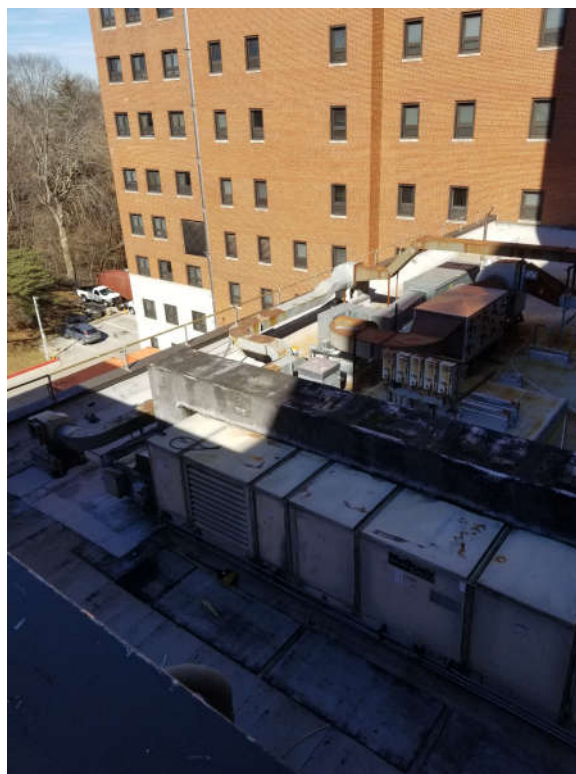
4th floor roof duct mastic 2

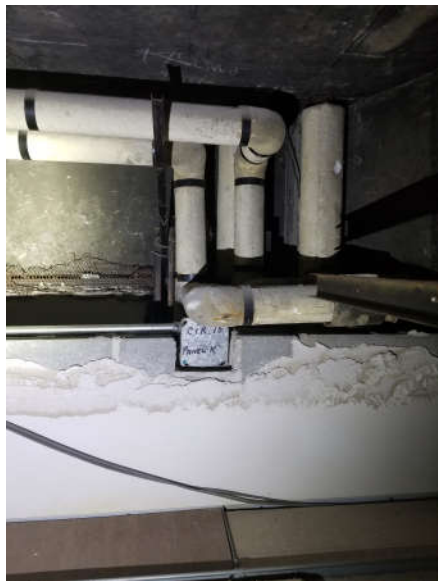
**basement room a25 pipe insulation**

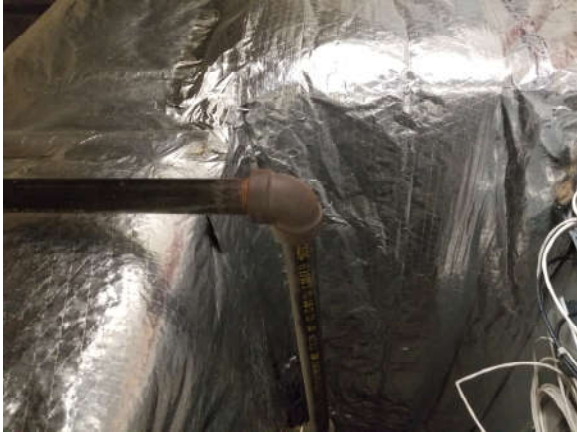
basement sprinkler thread sealant

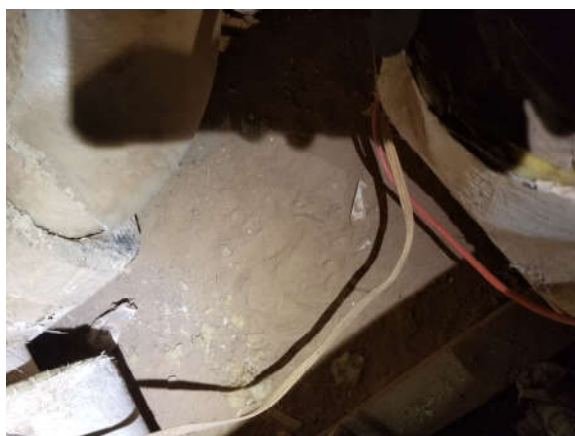
crawl space 3 debris 1

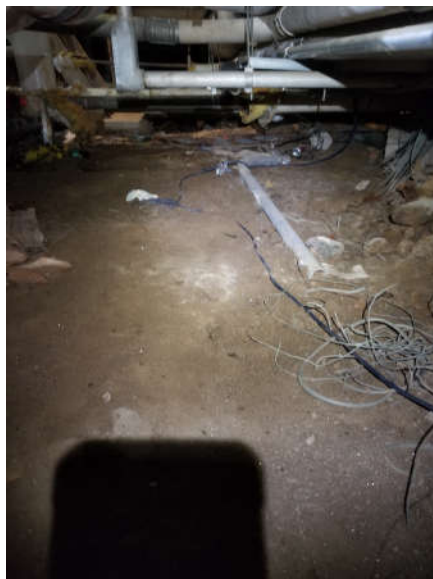
crawl space 3 debris 3

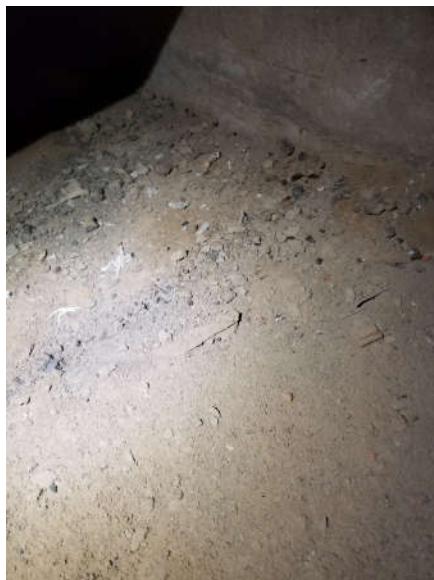
crawl space 3 debris 4

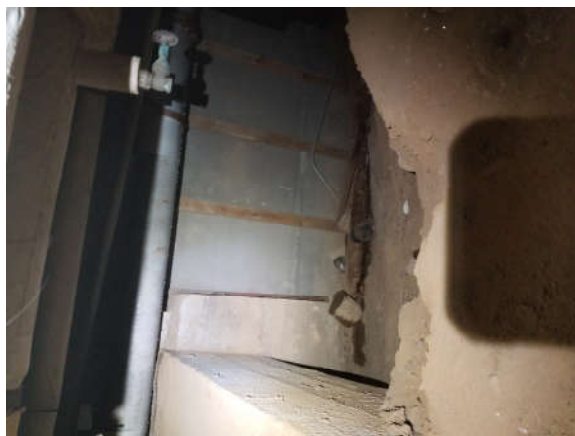
crawl space 3 transite 2

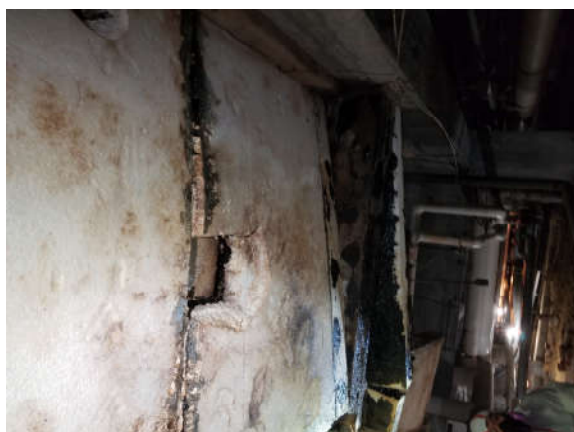
crawl space styrofoam with black mastic 1

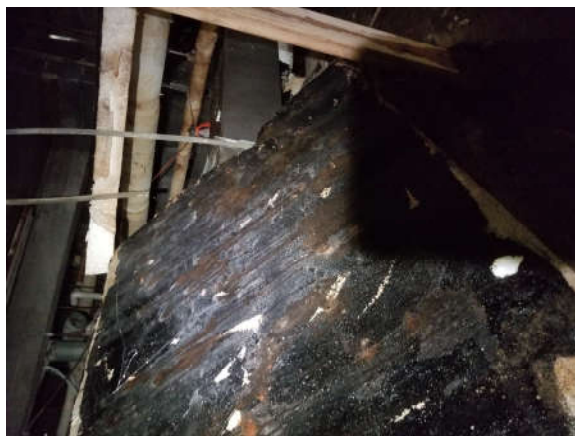
crawl space styrofoam with black mastic 2

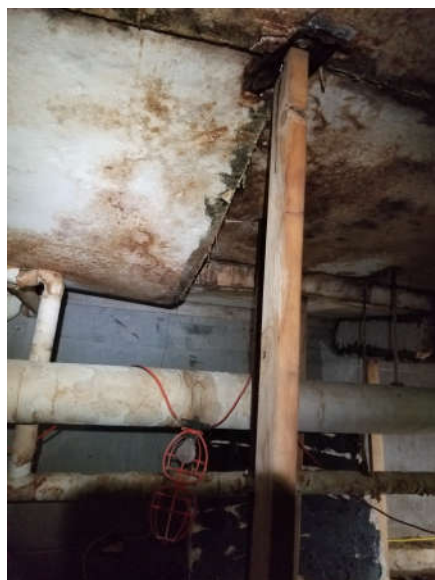
crawl space styrofoam with black mastic 3

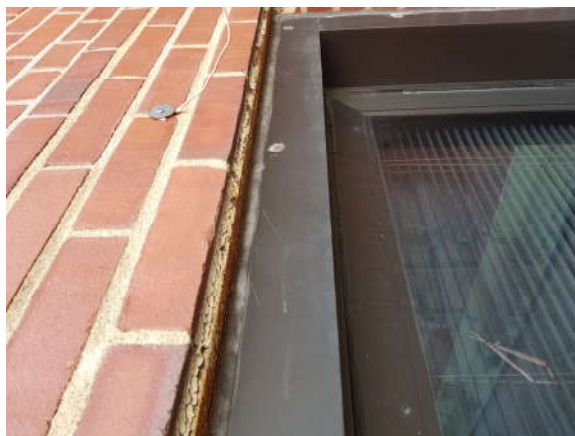
exterior window caulking 2

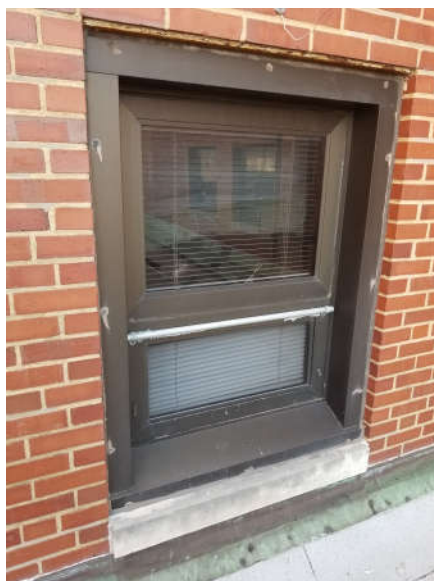
exterior window caulking

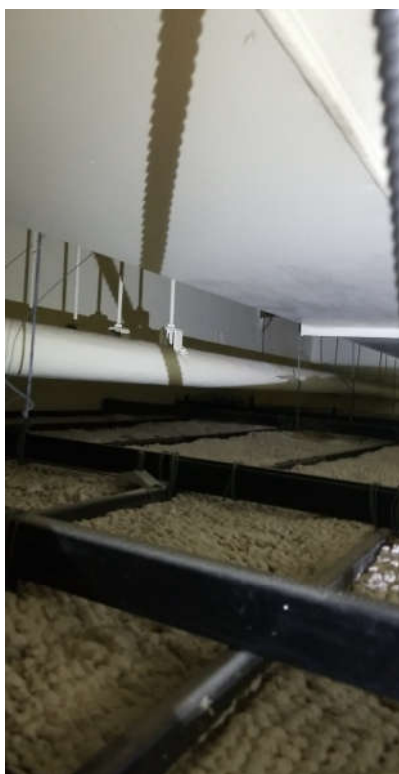
ph stairwell pipe insulaion
