Point of Contact: Daniel Schriever, LS
 Phone Number: (443) 994-7285
 Date Performed: 12/05/2023
 Project Number: MD23-045
 Project Location: Perry Point, MD
 Requested By: AMT Engineering

Project Name: PERRY POINT STEAM
 UPDATE PROJECT

Utility Field Excavation Information

QL-A UTILITY PICTURE REPORT

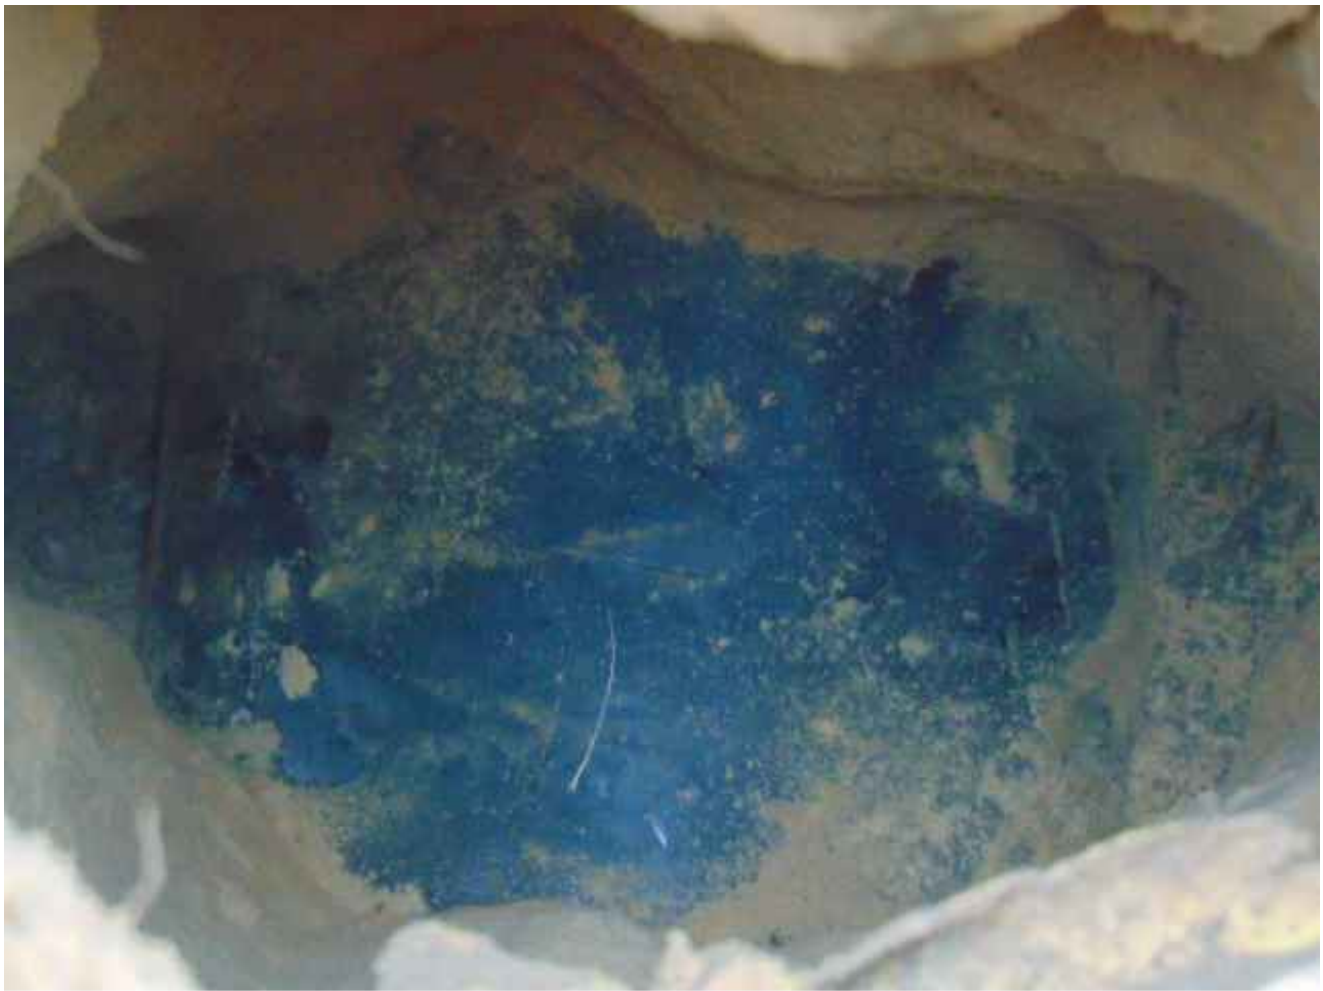
TEST HOLE EXCAVATION OBSERVATION

| Test Hole Number: 1 | Utility Condition: Poor <input type="checkbox"/> Fair <input checked="" type="checkbox"/> Good <input type="checkbox"/> See Notes <input type="checkbox"/> |
| Utility Material: Wrapped Steel | |

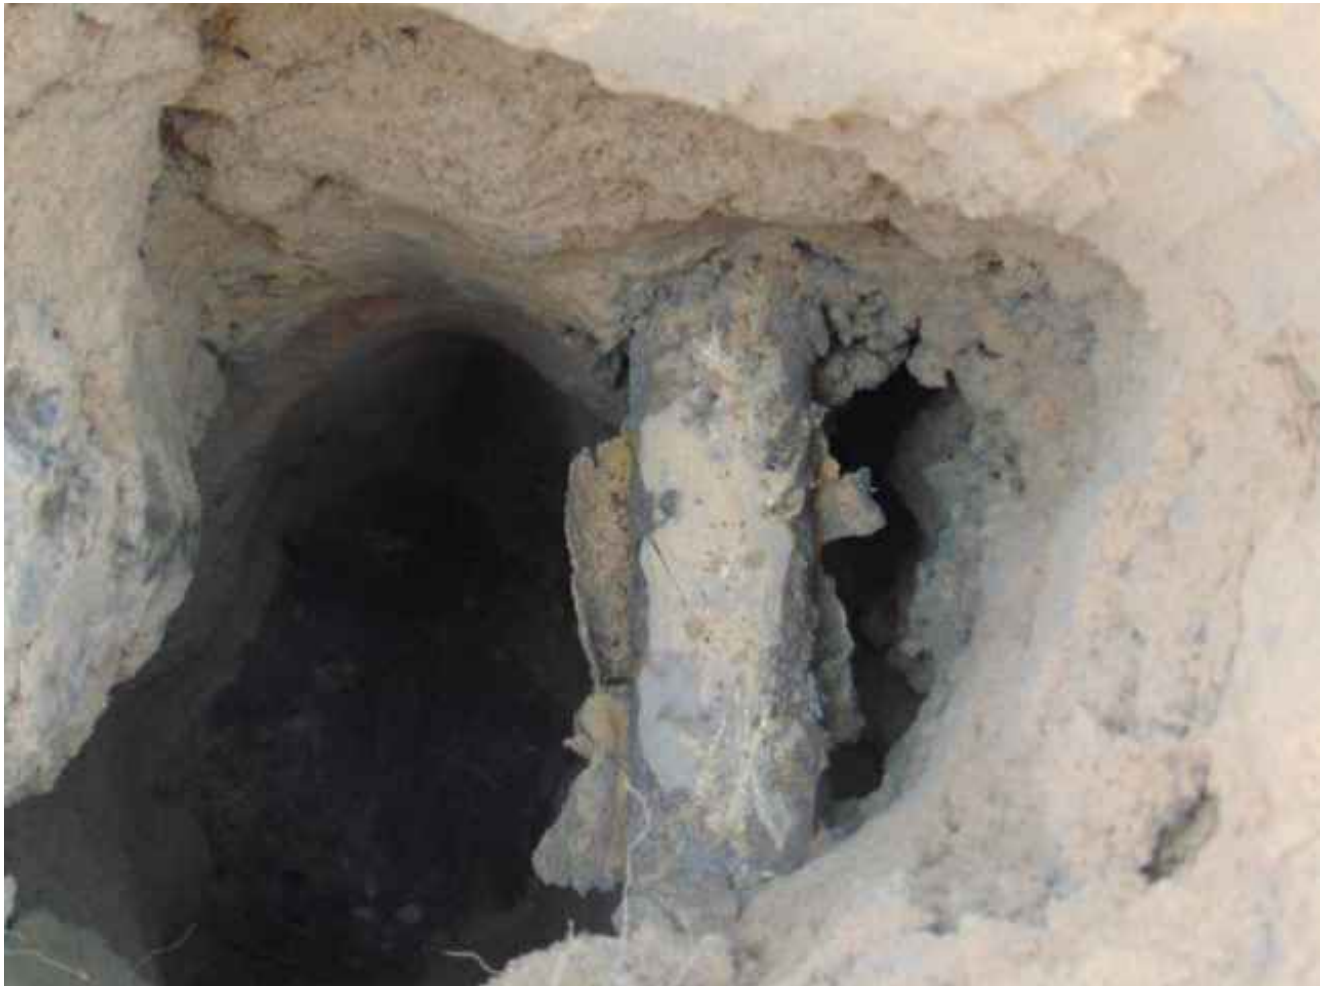
TEST HOLE EXCAVATION OBSERVATION

| Test Hole Number: 1A | Utility Condition: Poor <input type="checkbox"/> Fair <input checked="" type="checkbox"/> Good <input type="checkbox"/> See Notes <input type="checkbox"/> |

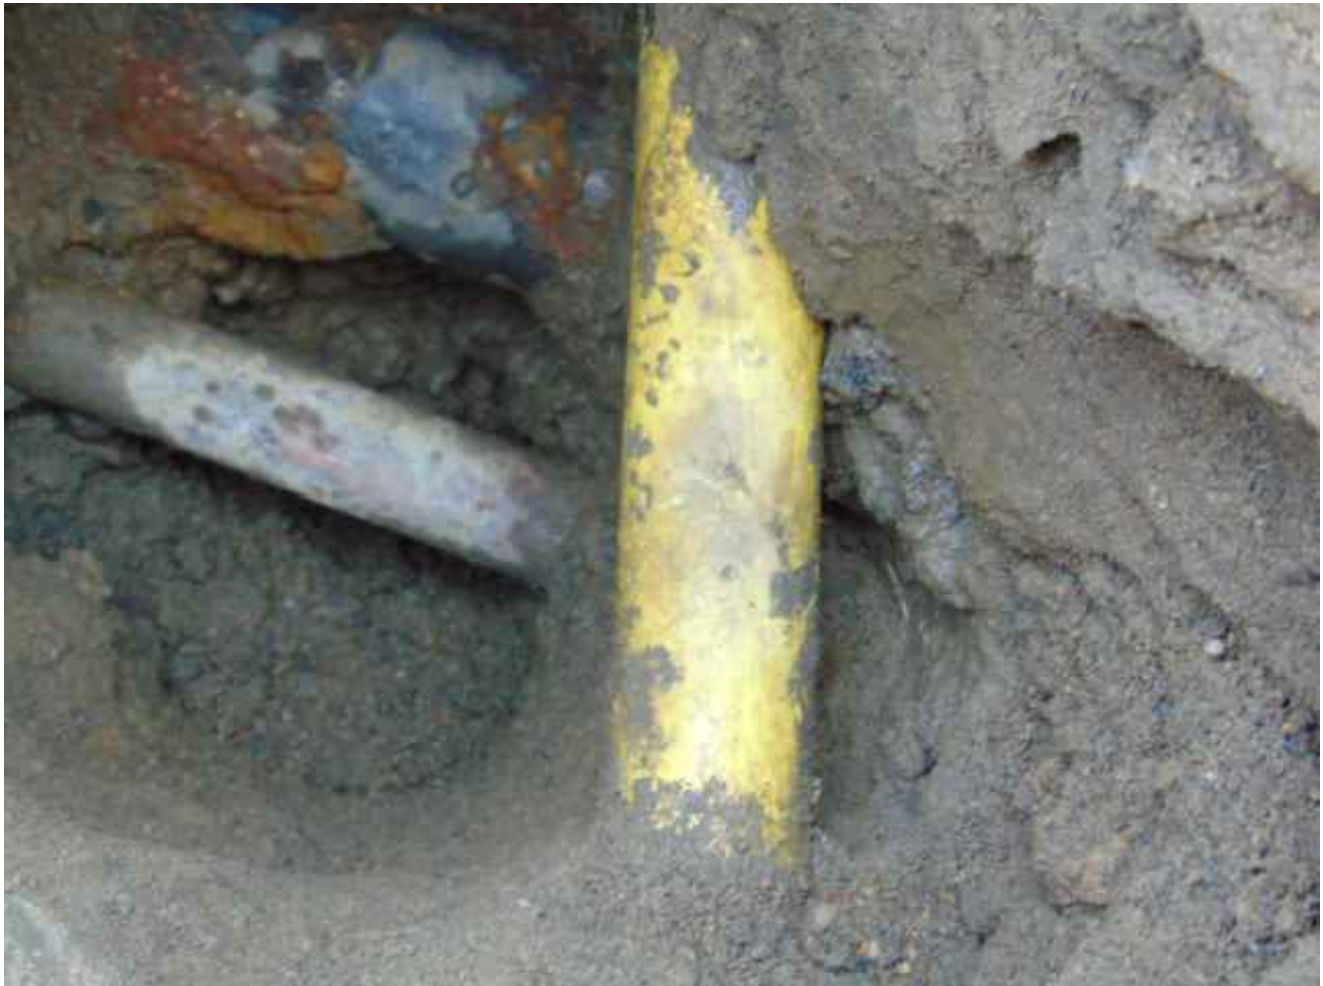
TEST HOLE EXCAVATION OBSERVATION

| Test Hole Number: 2 | Utility Condition: Poor <input type="checkbox"/> Fair <input checked="" type="checkbox"/> Good <input type="checkbox"/> See Notes <input type="checkbox"/> |

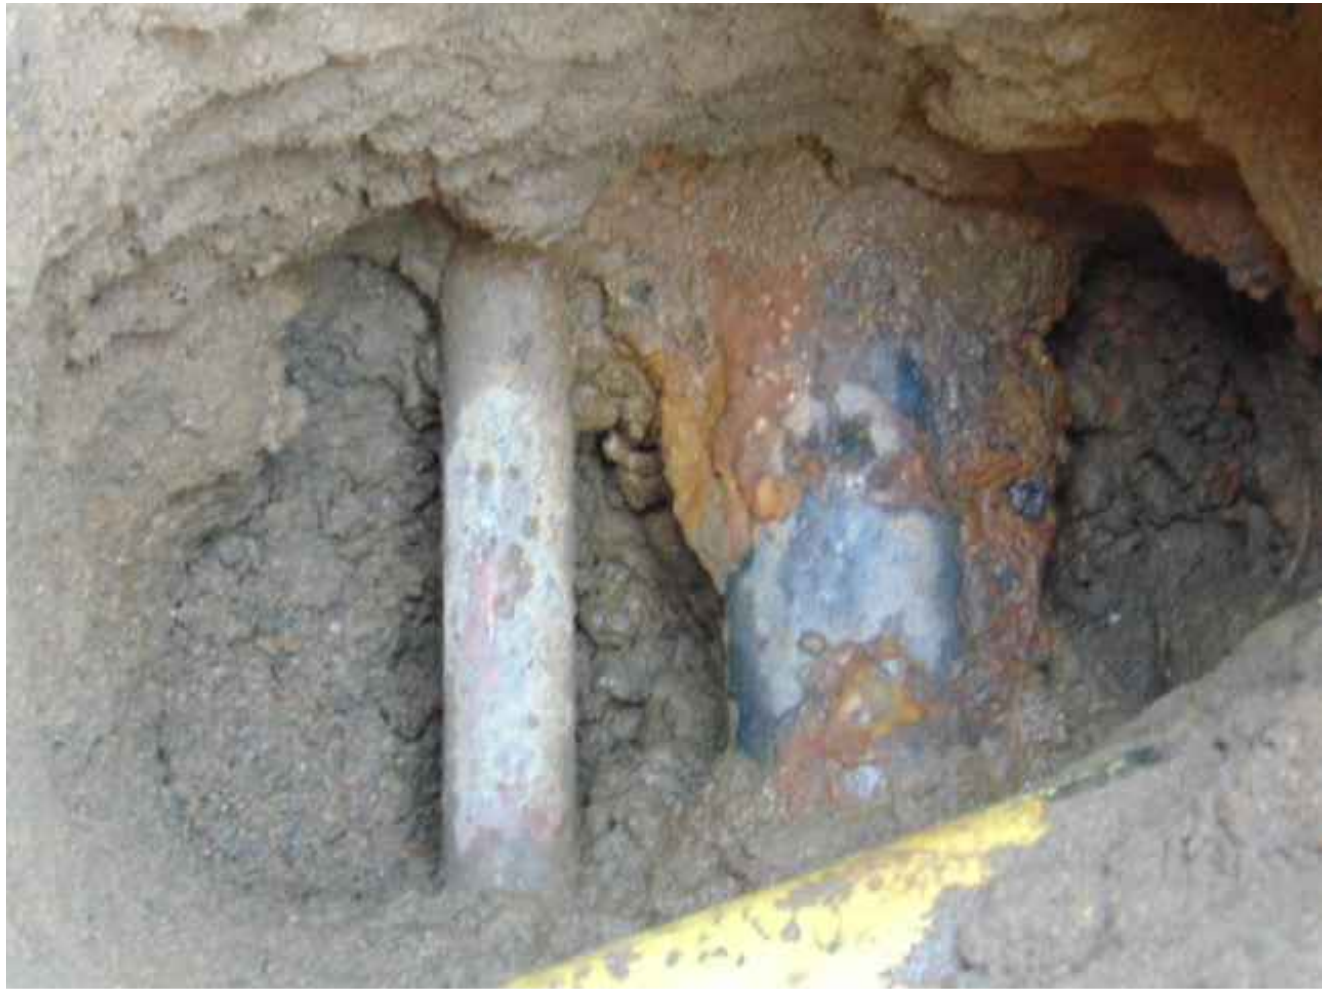
TEST HOLE EXCAVATION OBSERVATION

| Test Hole Number: 2A | Utility Condition: Poor <input type="checkbox"/> Fair <input checked="" type="checkbox"/> Good <input type="checkbox"/> See Notes <input type="checkbox"/> |
| Utility Found: Water | |

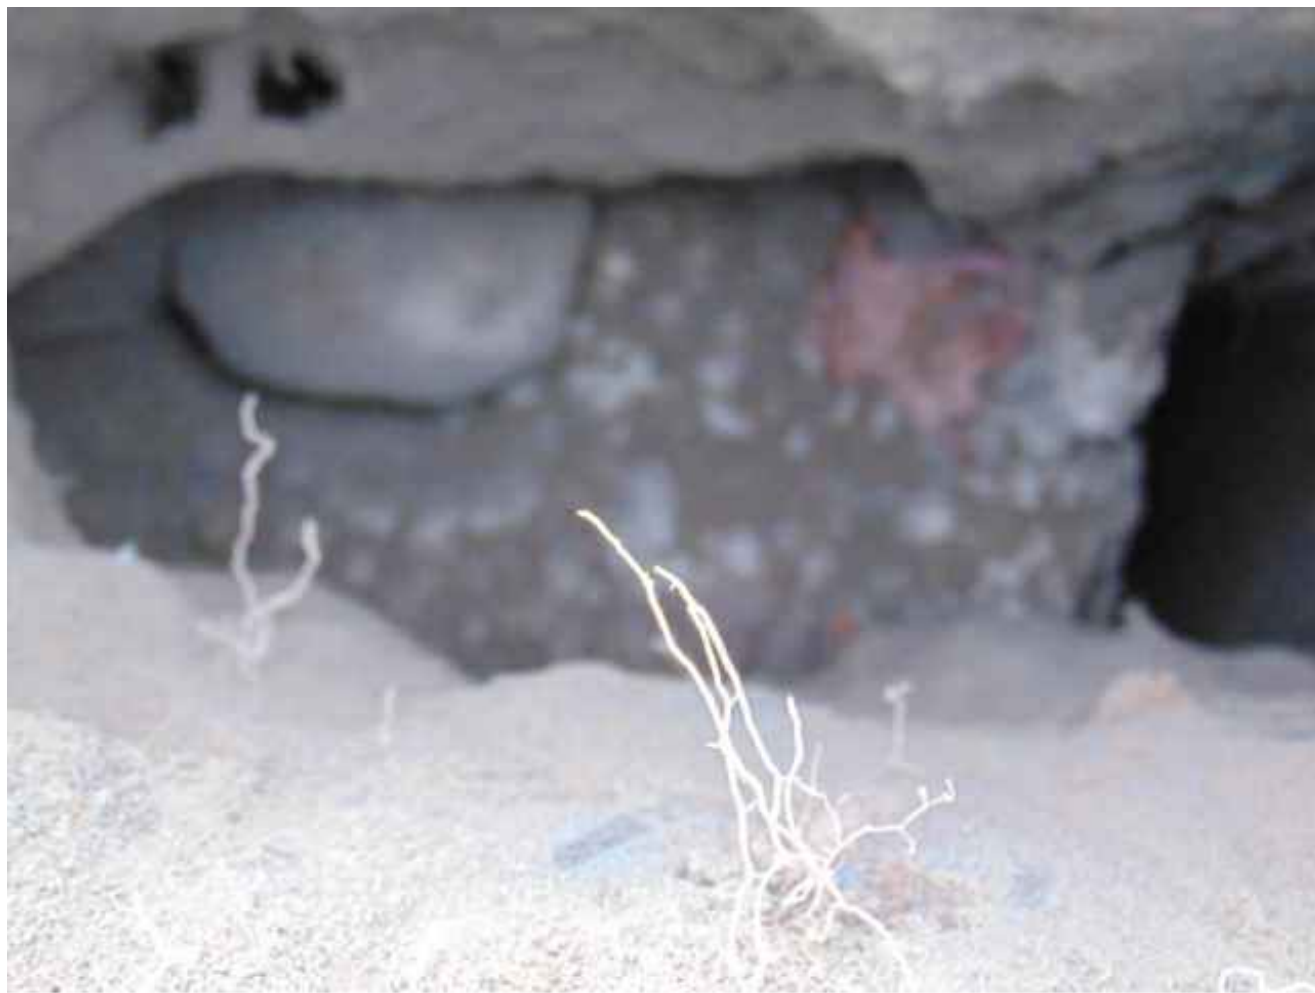
TEST HOLE EXCAVATION OBSERVATION

| Test Hole Number: 3 | Utility Condition: Poor <input type="checkbox"/> Fair <input checked="" type="checkbox"/> |

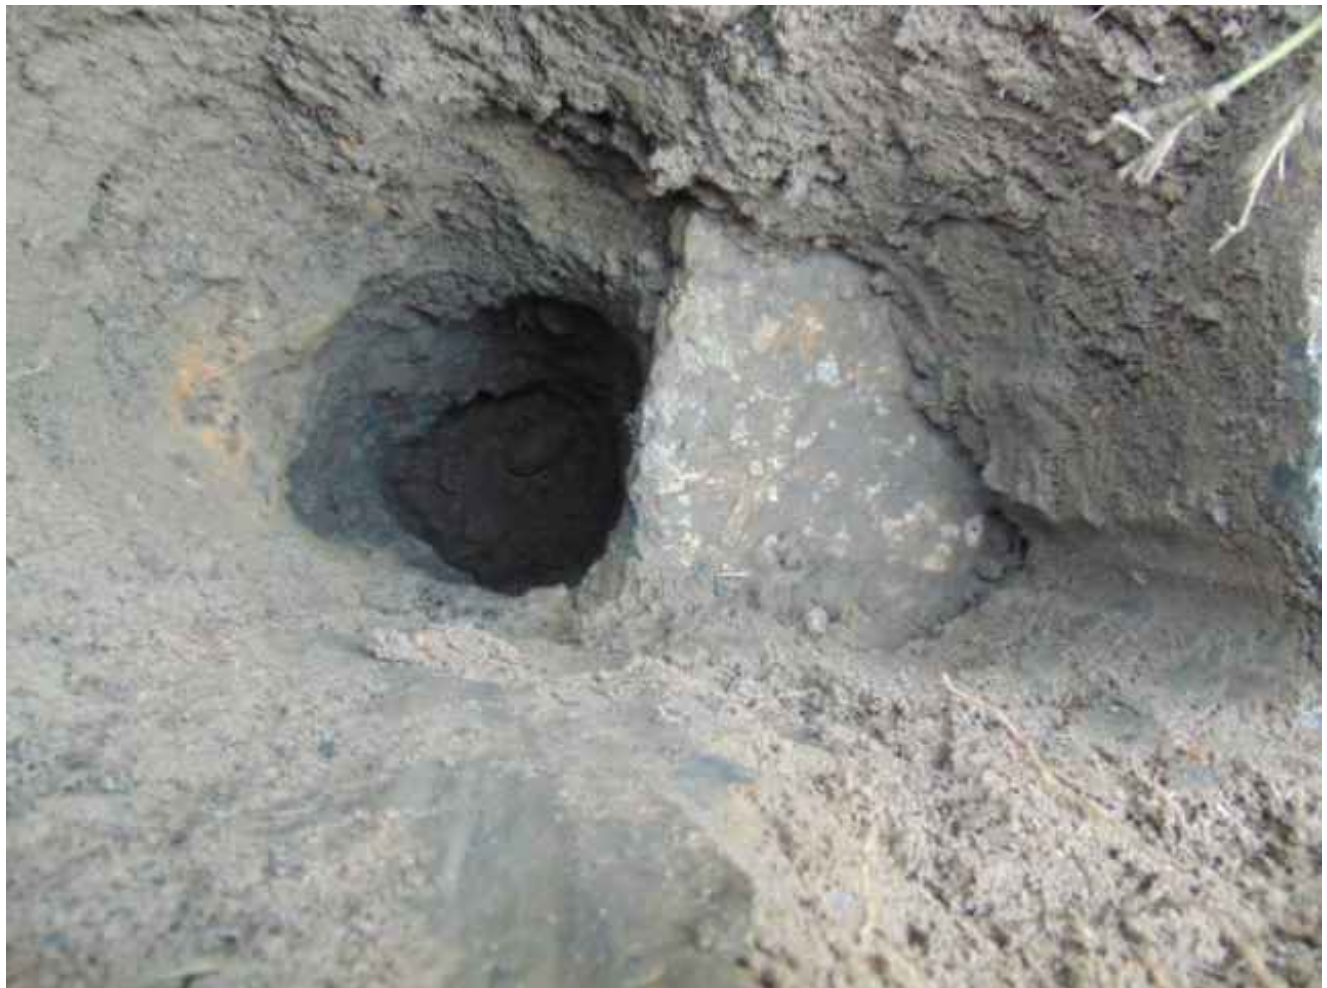
TEST HOLE EXCAVATION OBSERVATION

| Test Hole Number: 4 | Utility Condition: Poor <input type="checkbox"/> Fair <input checked="" type="checkbox"/> |

| Hub and tack set over northern edge of Communication duct. | | |

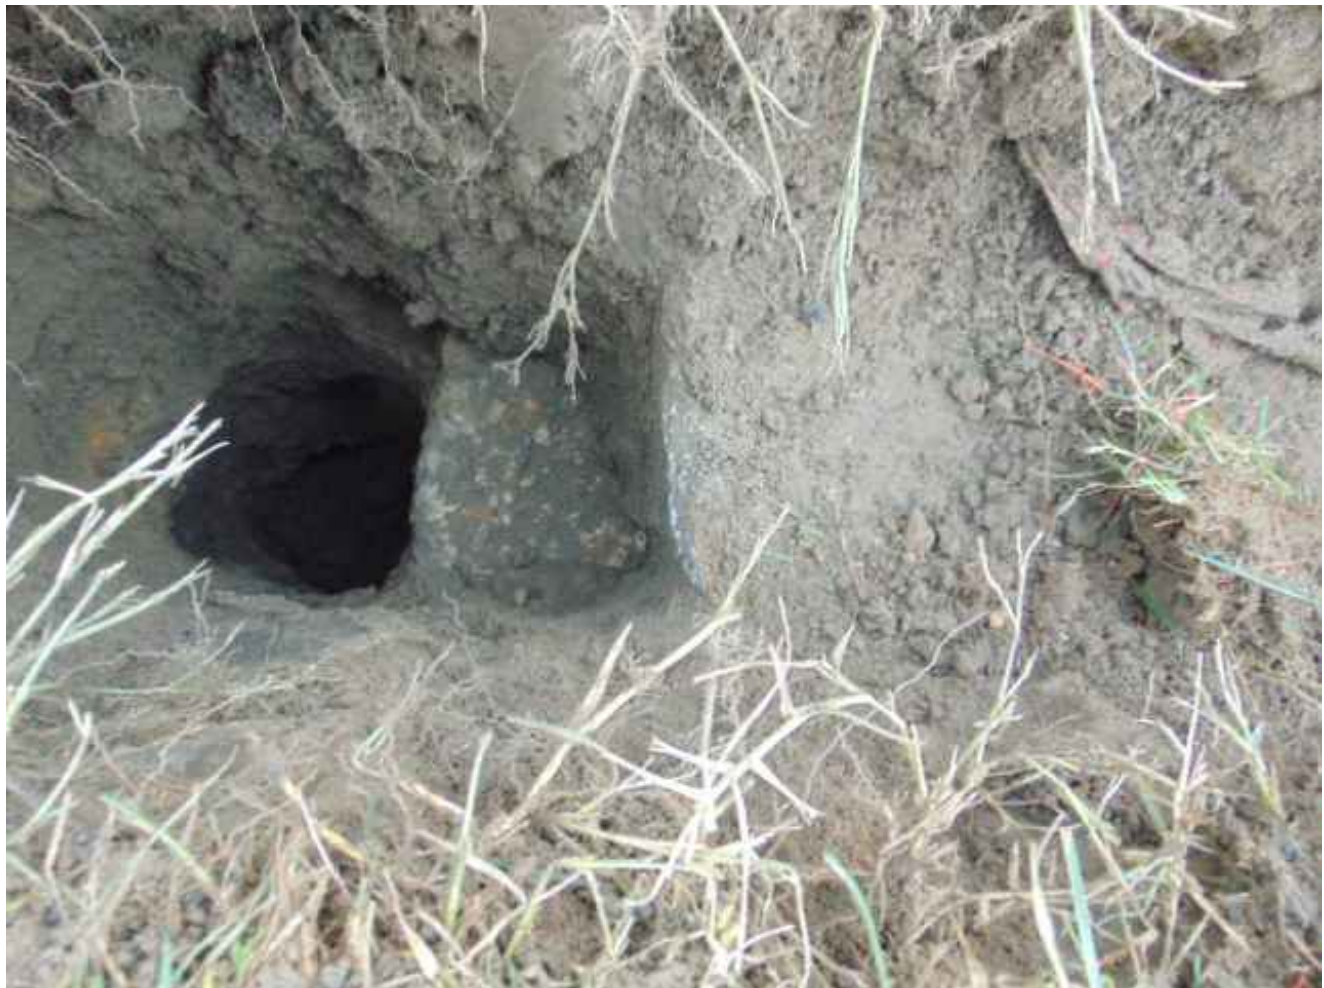
TEST HOLE EXCAVATION OBSERVATION

| Test Hole Number: 4A | Utility Condition: Poor <input type="checkbox"/> Fair <input checked="" type="checkbox"/> |

| Test Hole Survey Information: | | |
|---|---|---|
| <u>Hub and tack set over north edge of unknown duct. Believed to existing steam duct.</u> | | |

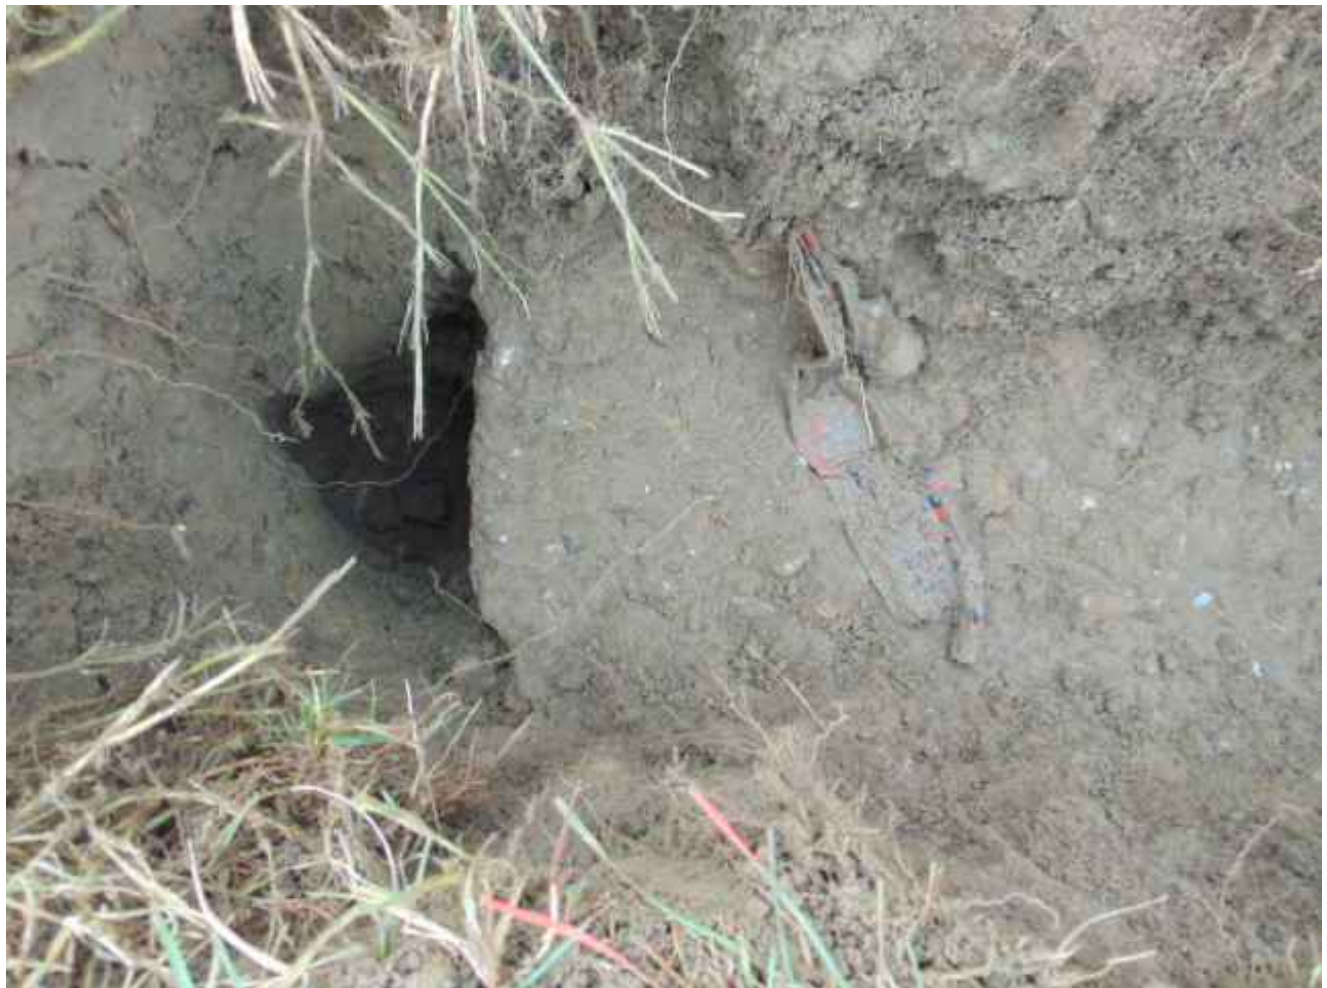
TEST HOLE EXCAVATION OBSERVATION

| Test Hole Number: 5 | Utility Condition: Poor <input type="checkbox"/> Fair <input checked="" type="checkbox"/> |

| Marker: 38.91' | Utility Top: 37.91' | Utility Bottom: 37.18' |

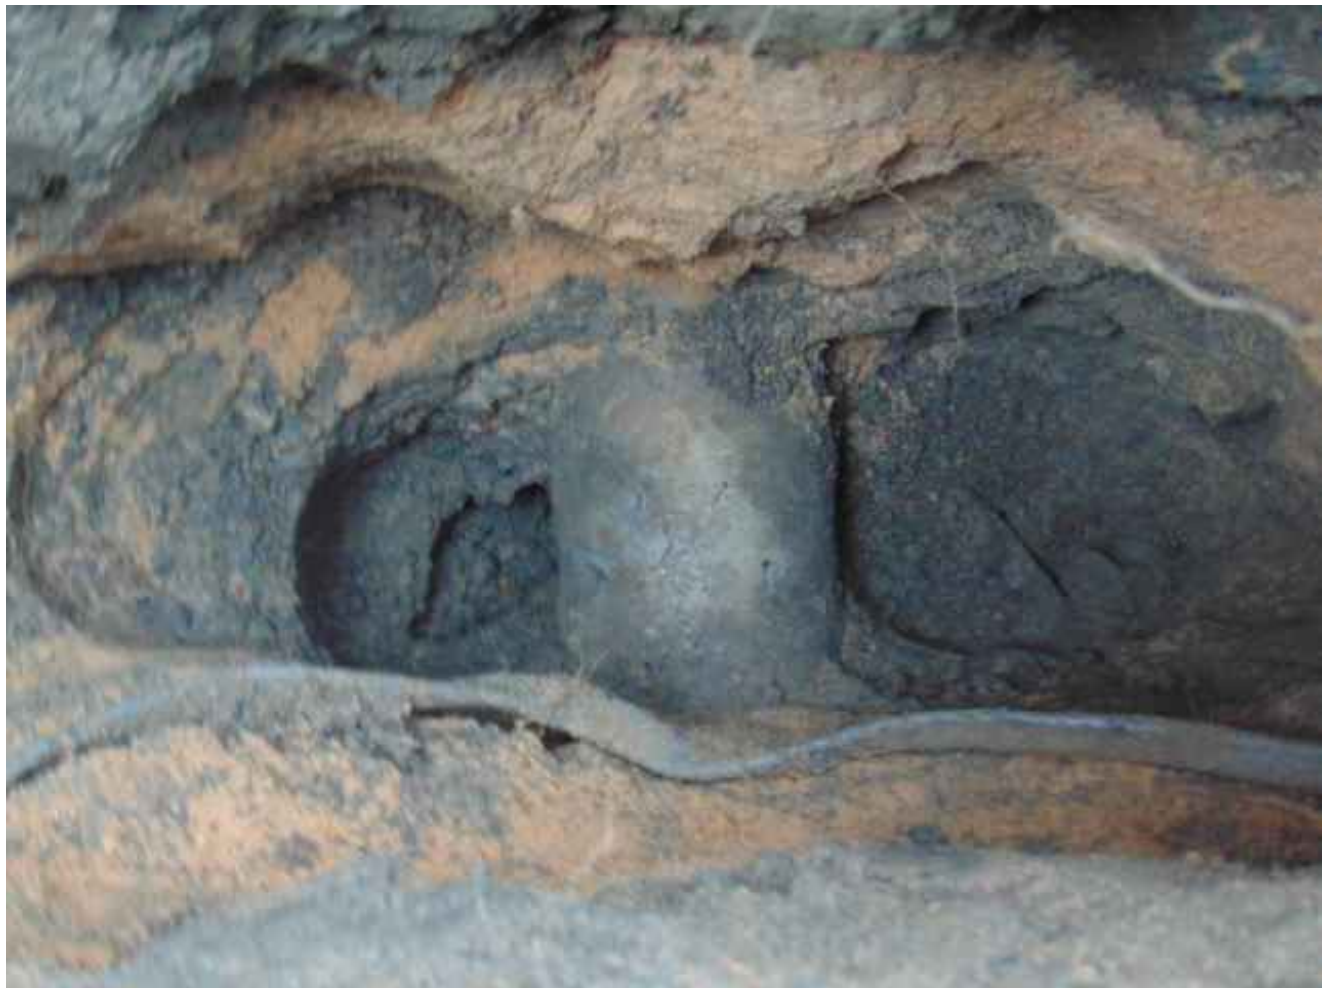
TEST HOLE EXCAVATION OBSERVATION

| Test Hole Number: 5A | Utility Condition: Poor <input type="checkbox"/> Fair <input checked="" type="checkbox"/> |

| Marker: 39.03' | Utility Top: 34.95' | Utility Bottom: N/A |

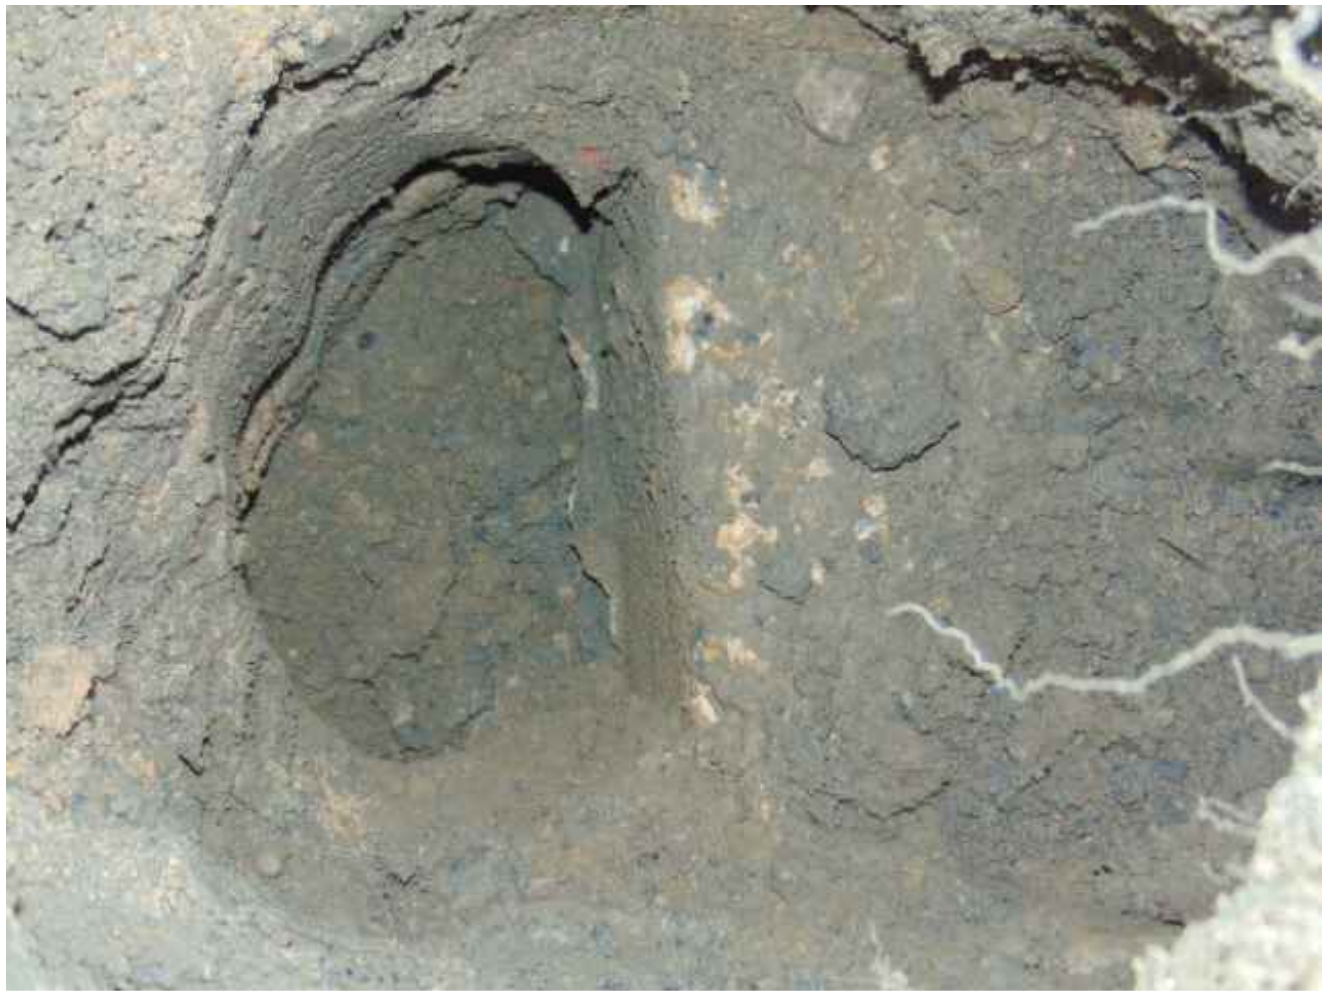
TEST HOLE EXCAVATION OBSERVATION

| Hub and tack set over eastern edge of communication duct. | | |

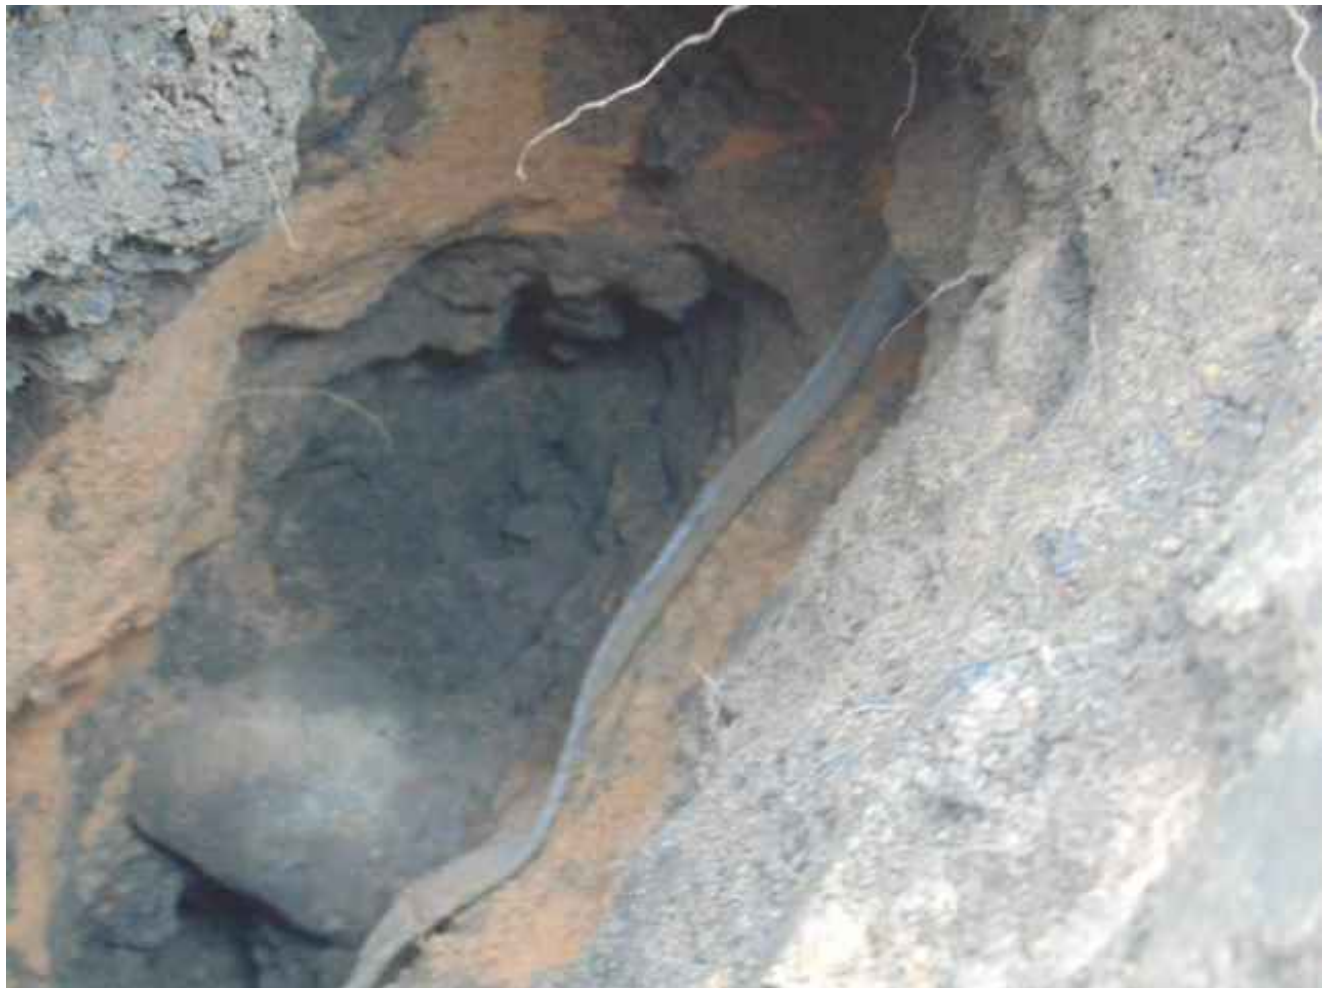
TEST HOLE EXCAVATION OBSERVATION

| Hub and tack set over center of utility. | | |

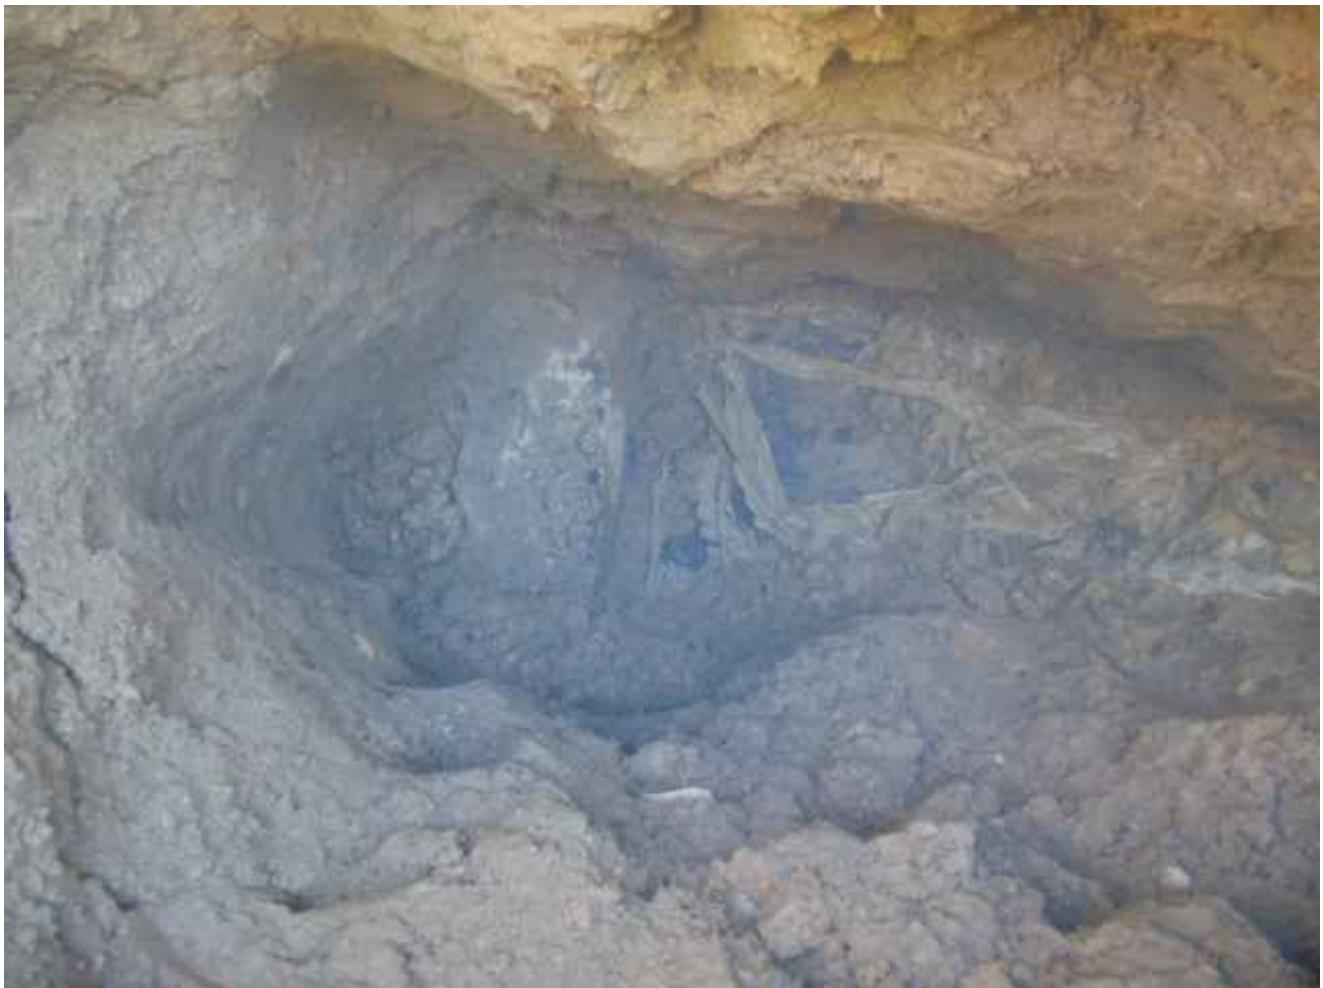
TEST HOLE EXCAVATION OBSERVATION

| concrete. Bottom measurement to top of | | |
| footer 4.77'. Unable to obtain bottom. | | |

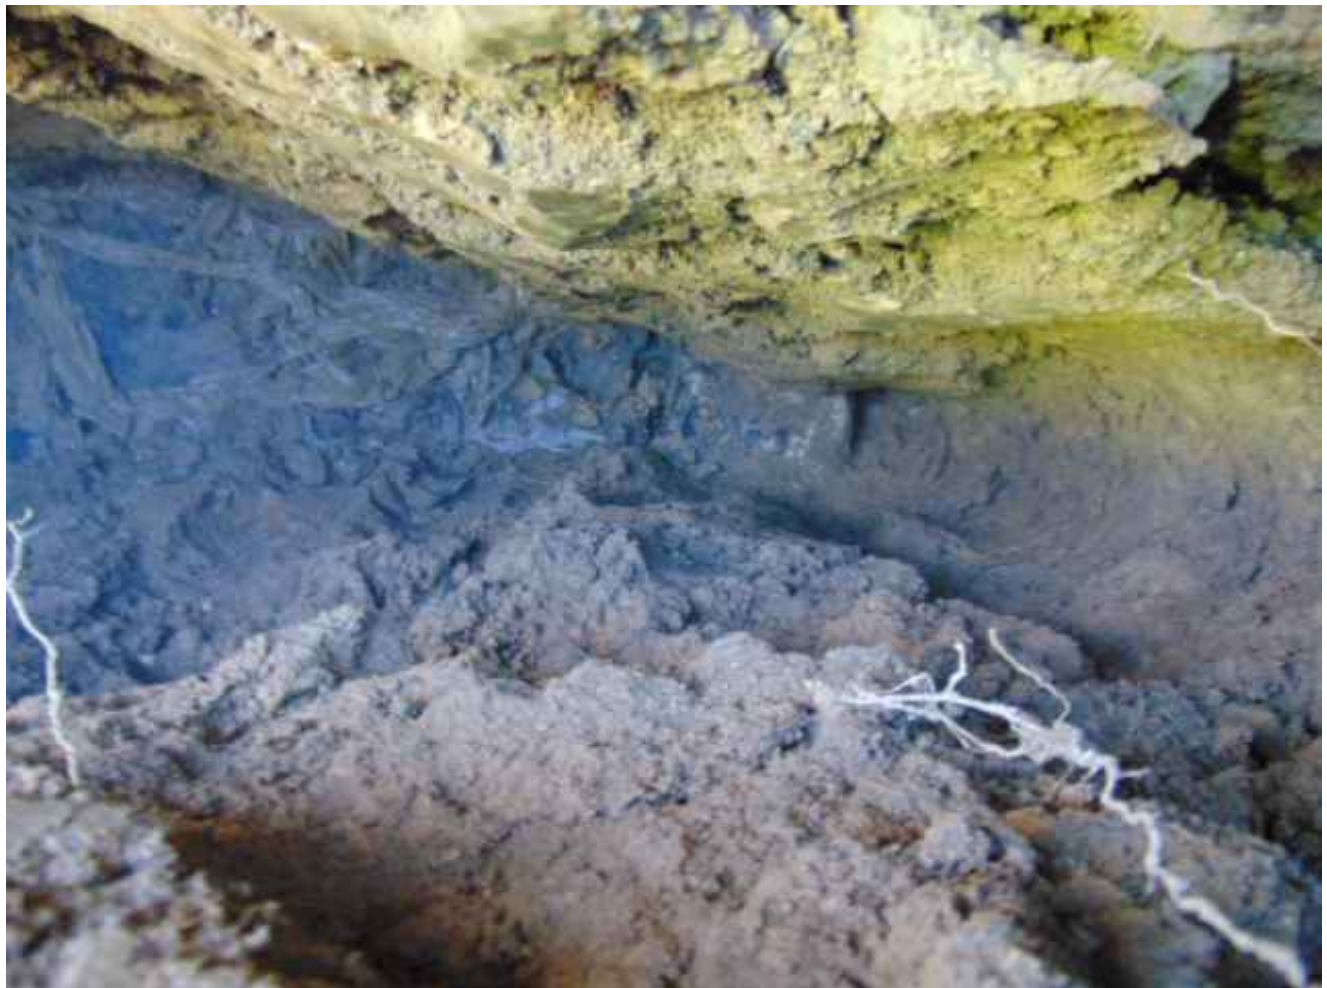
TEST HOLE EXCAVATION OBSERVATION

| concrete. Bottom measurement to top of | | |
| footer 4.77'. Unable to obtain bottom. | | |

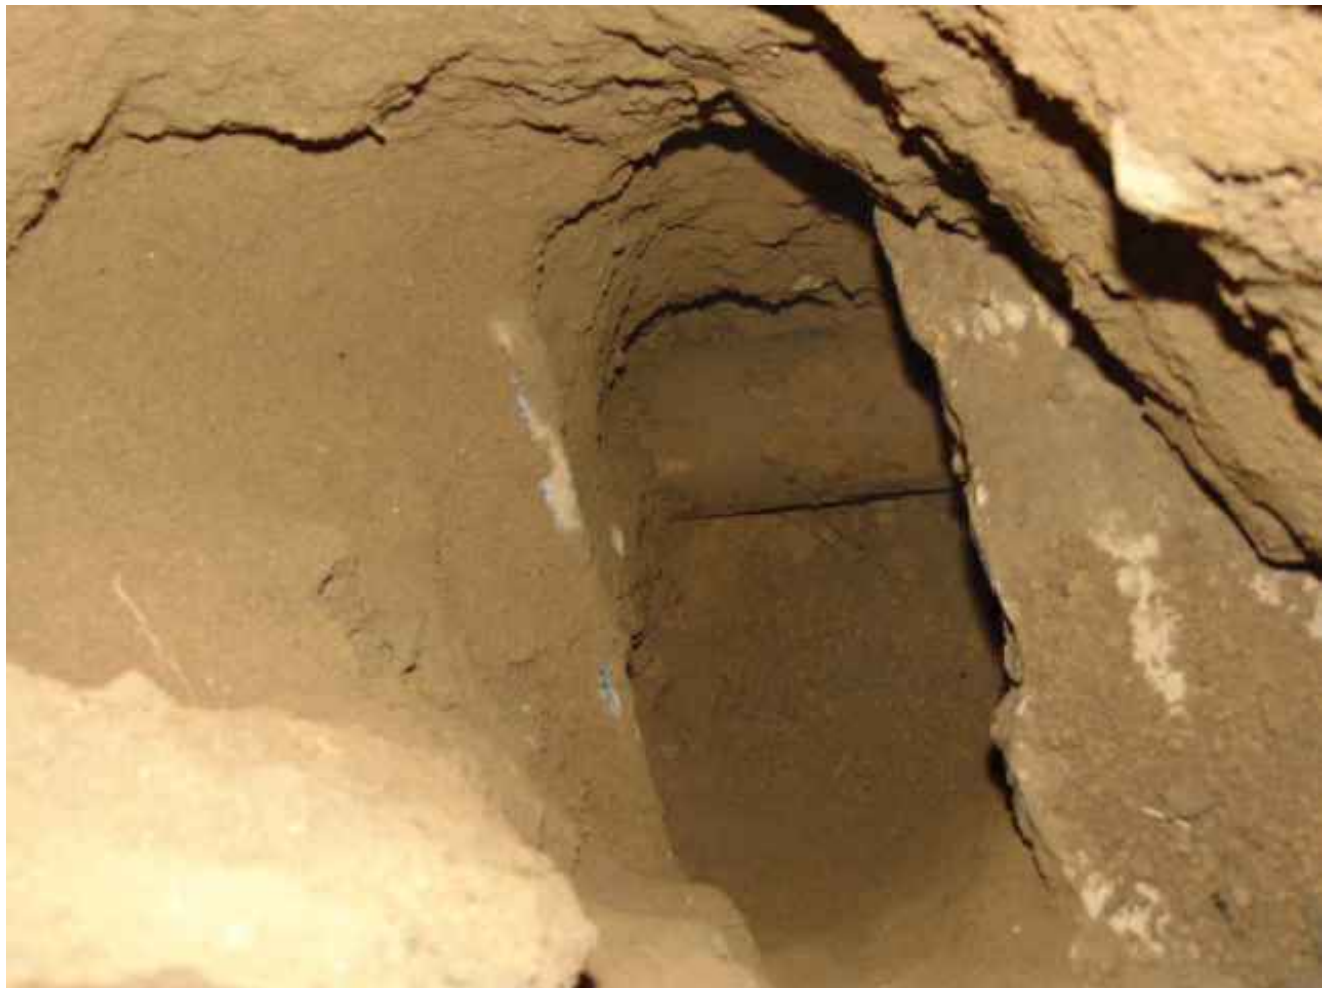
TEST HOLE EXCAVATION OBSERVATION

| Hub and tack set over crown of utility, believed to be possible roof drain. | | |

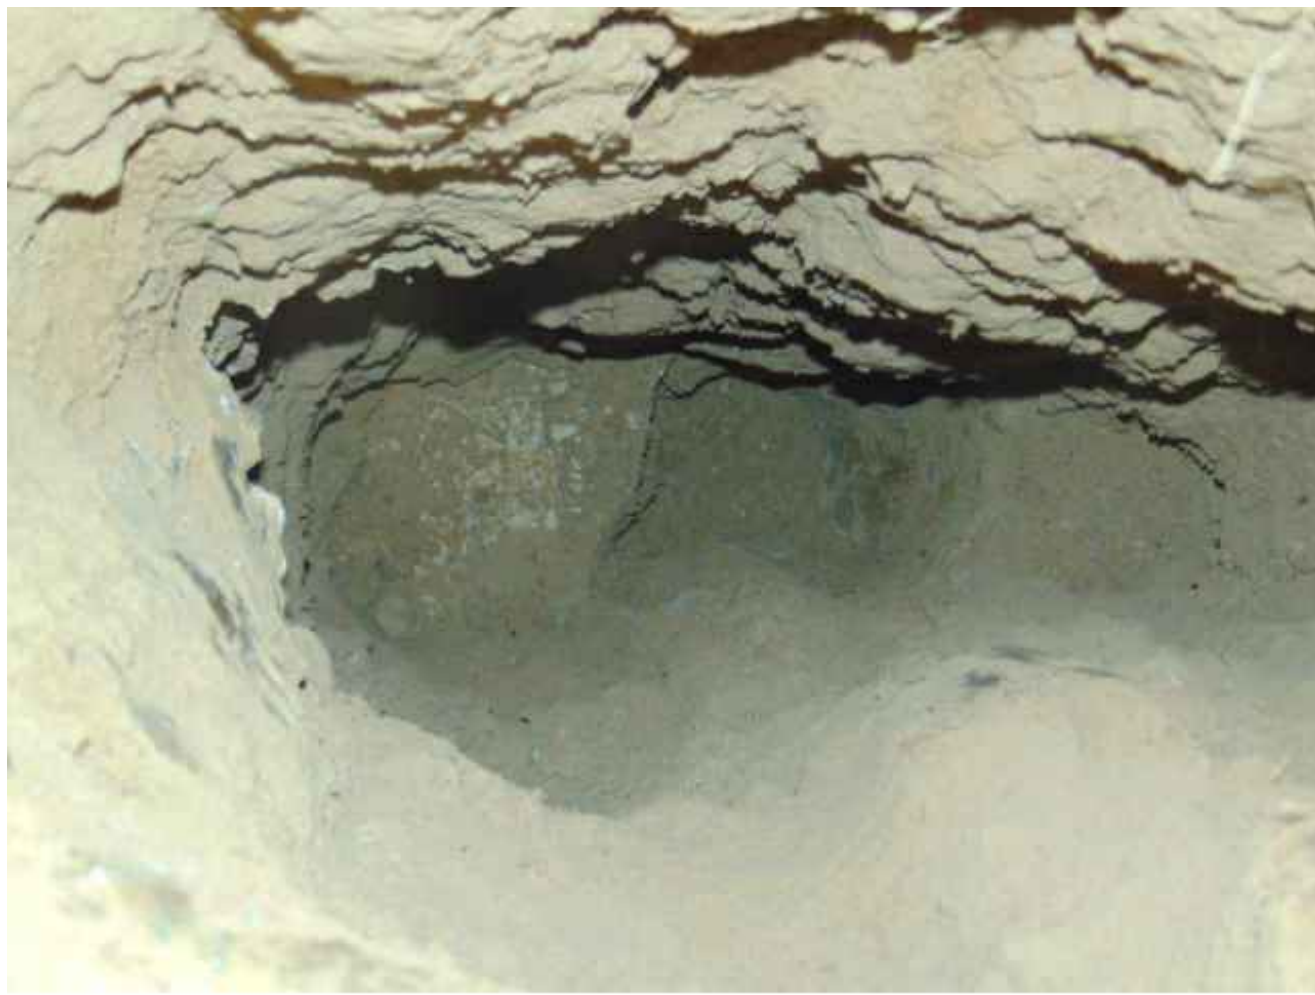
TEST HOLE EXCAVATION OBSERVATION

| Test Hole Survey Information: | | |
|--|---|---|
| Hub and tack set over east edge of unknown duct. Believed to be communication. | | |

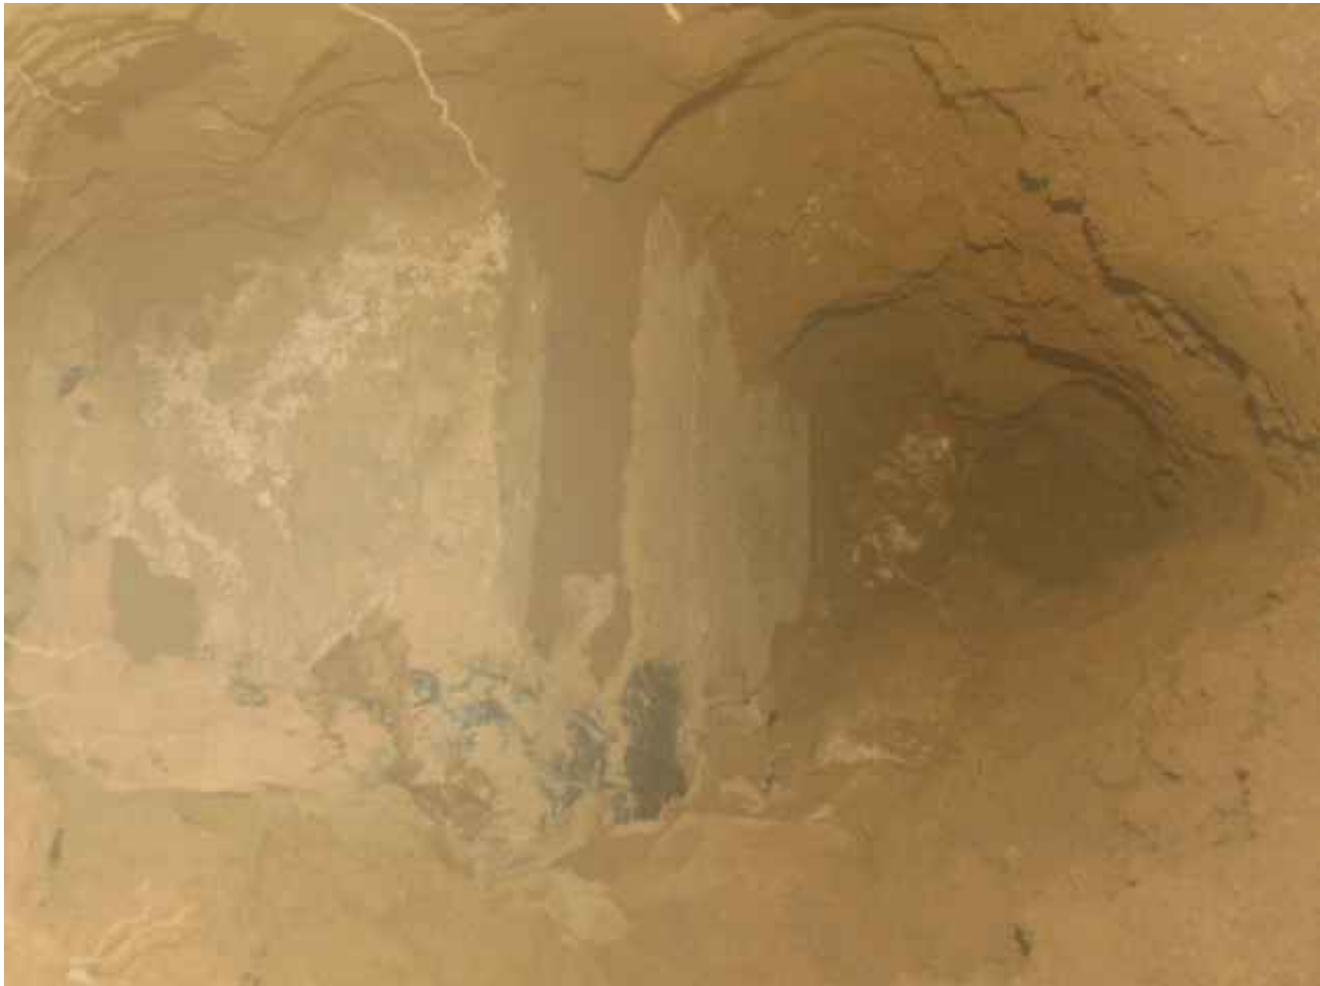
TEST HOLE EXCAVATION OBSERVATION

| Hub and tack set over south edge of steam duct footer. | | |

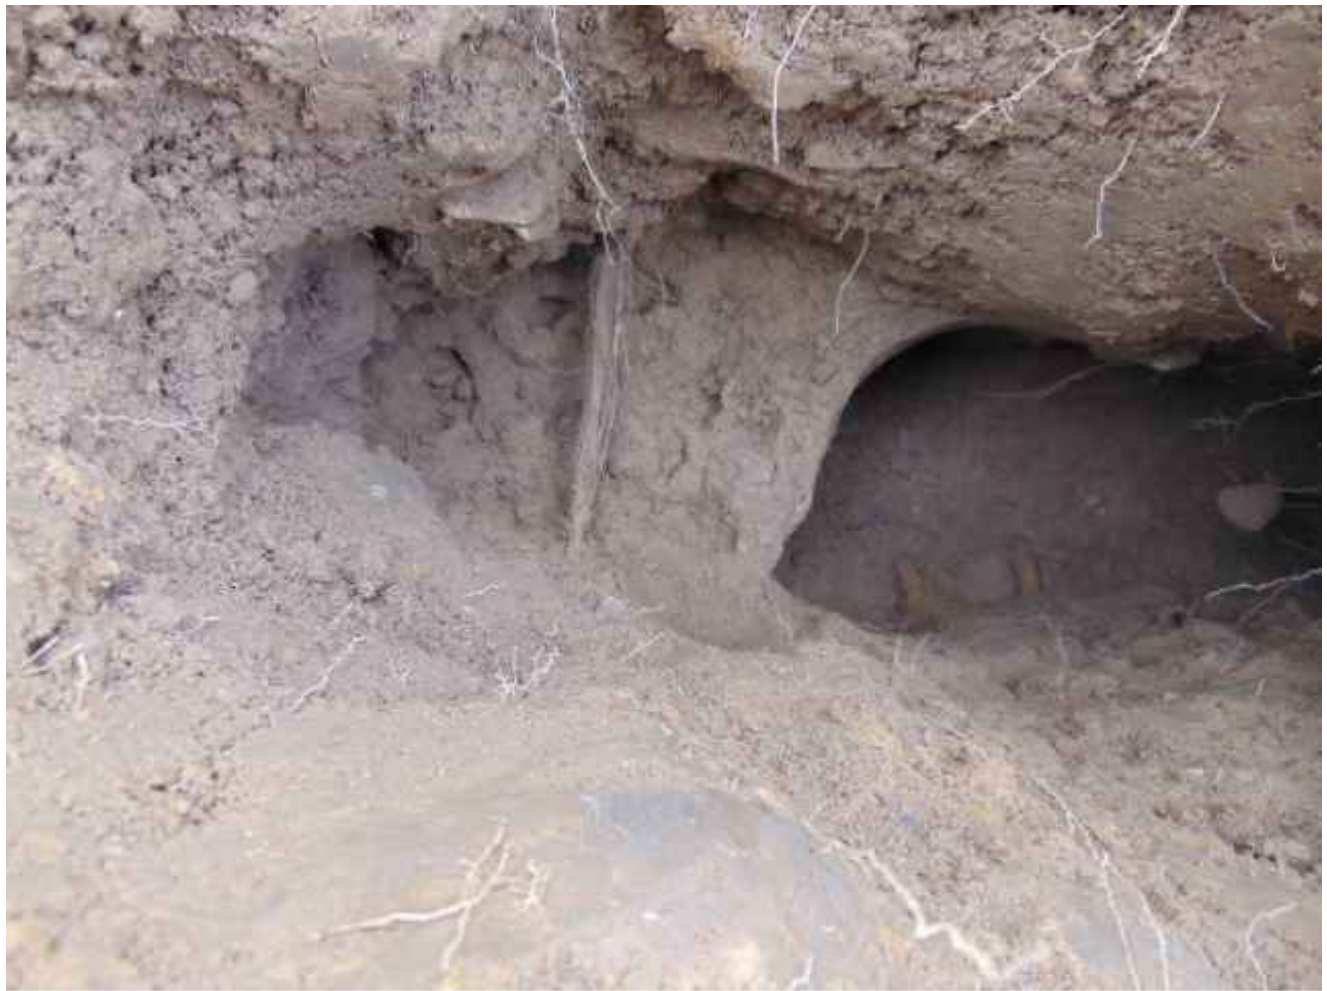
TEST HOLE EXCAVATION OBSERVATION

| electric duct. Test hole also found unknown | | |
| concrete under electric. See form 26A for | | |
| details | | |
