Point of Contact: Daniel Schriever, LS
 Phone Number: (443) 994-7285
 Date Performed: 12/05/2023
 Project Number: MD23-045
 Project Location: Perry Point, MD
 Requested By: AMT Engineering

Project Name: PERRY POINT STEAM
 UPDATE PROJECT

Utility Field Excavation Information

QL-A UTILITY PICTURE REPORT

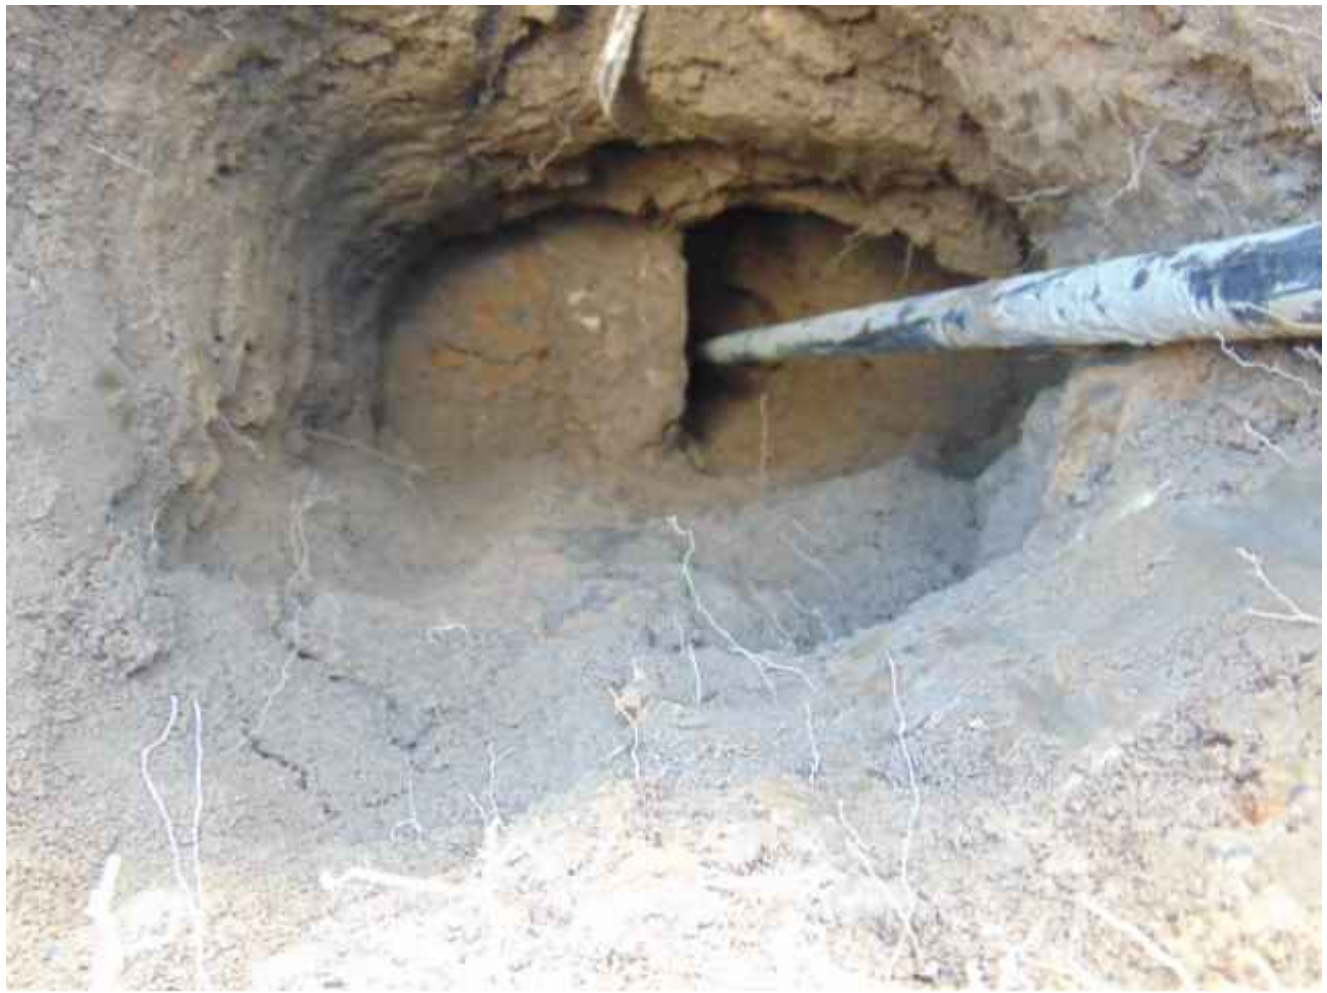
TEST HOLE EXCAVATION OBSERVATION

| Hub and tack set over northern edge of unknown duct. | | |

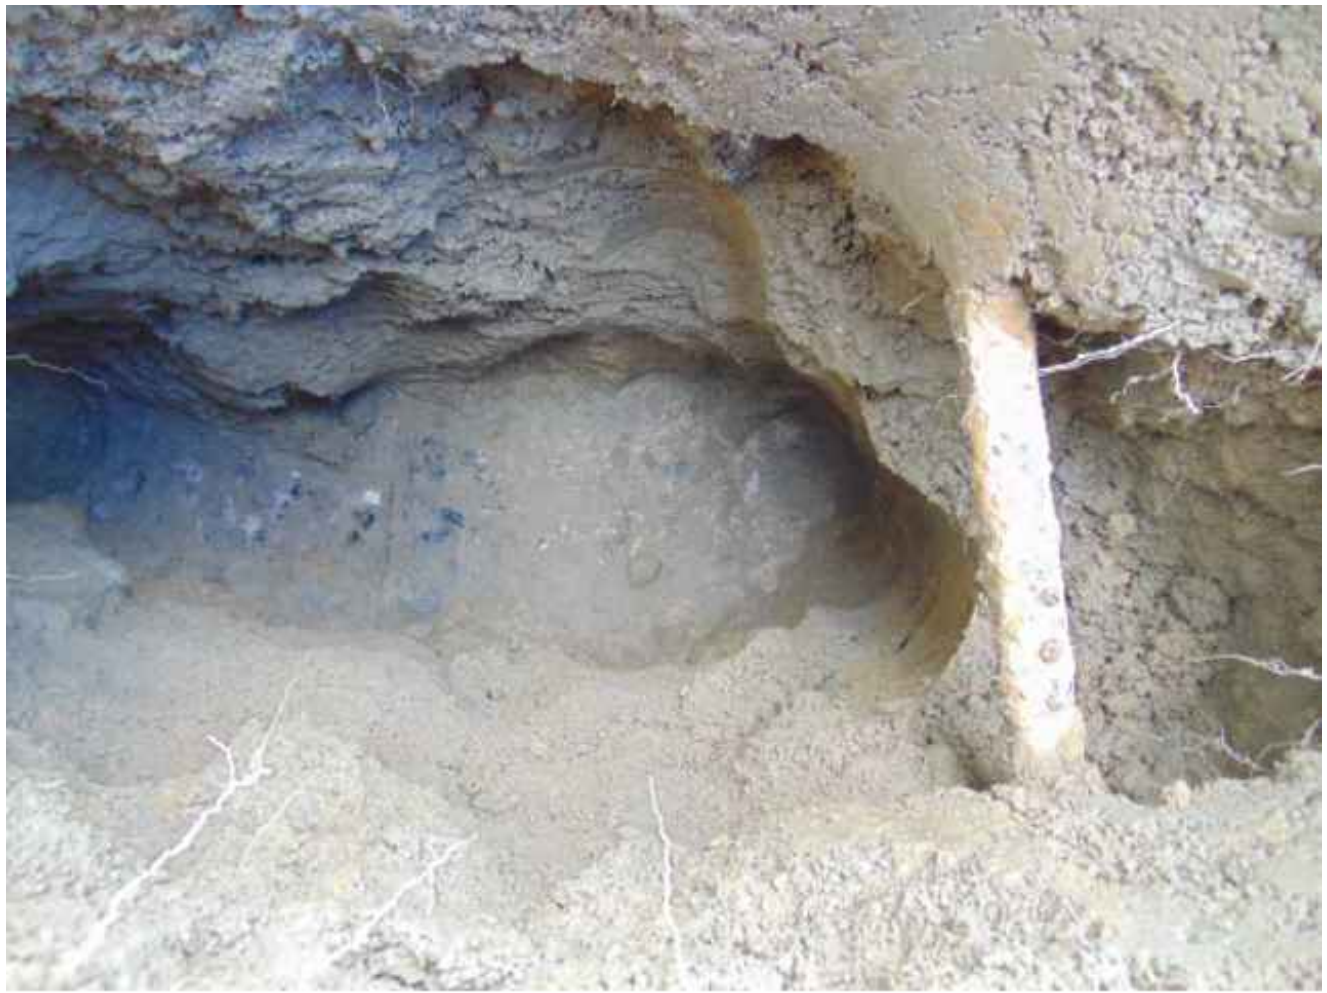
TEST HOLE EXCAVATION OBSERVATION

| Marker Set | Test Hole Notes: Hub and tack set over center of utility. Also found unknown concrete at 3.34'. Unable to obtain edge. |

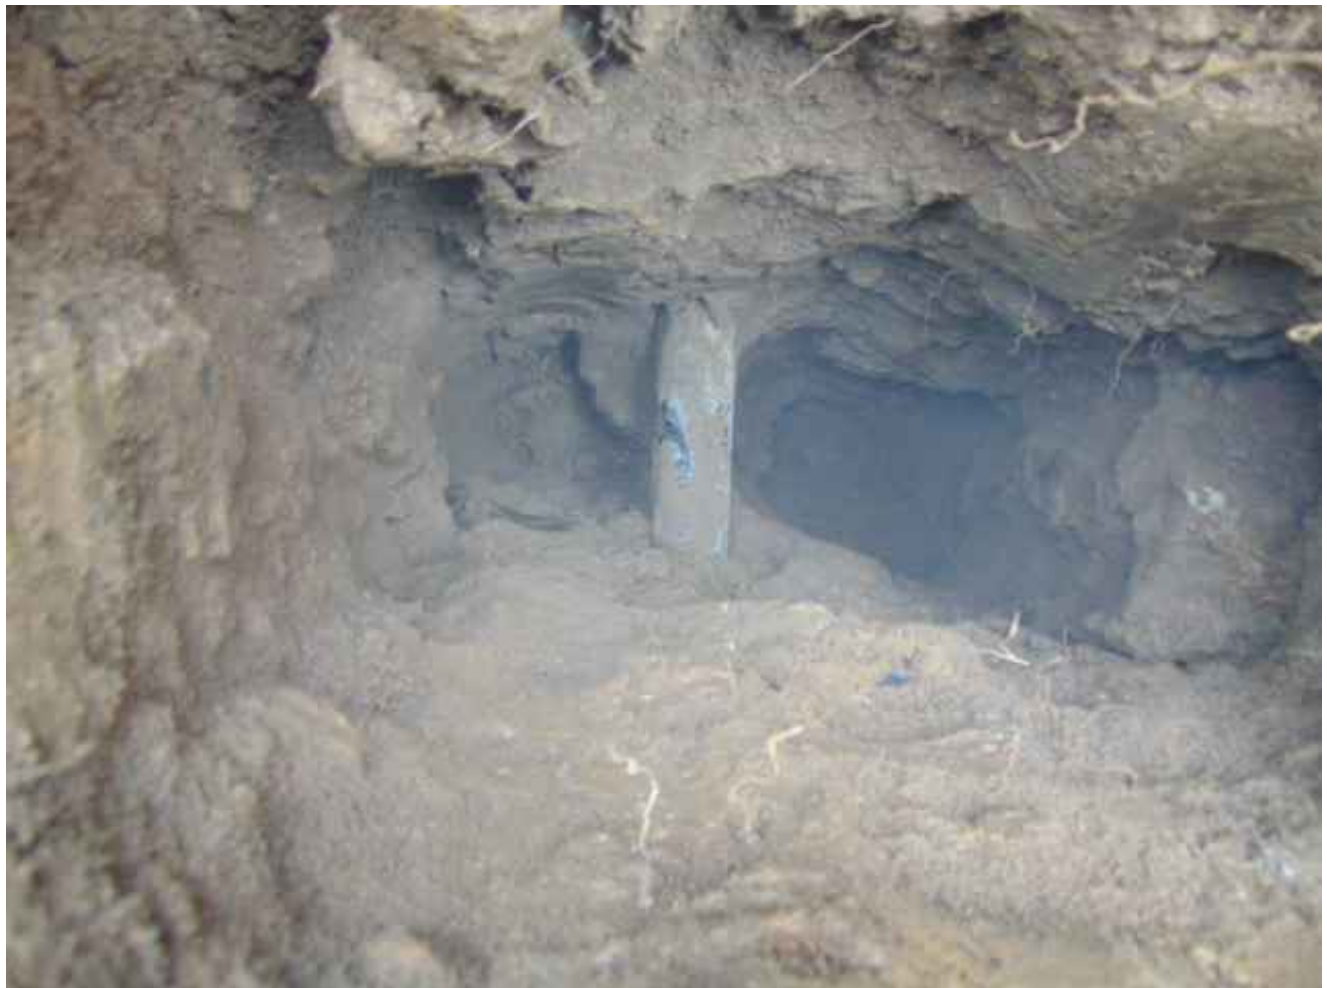
TEST HOLE EXCAVATION OBSERVATION

| crews cleared to 6' no utilities were found. | | |

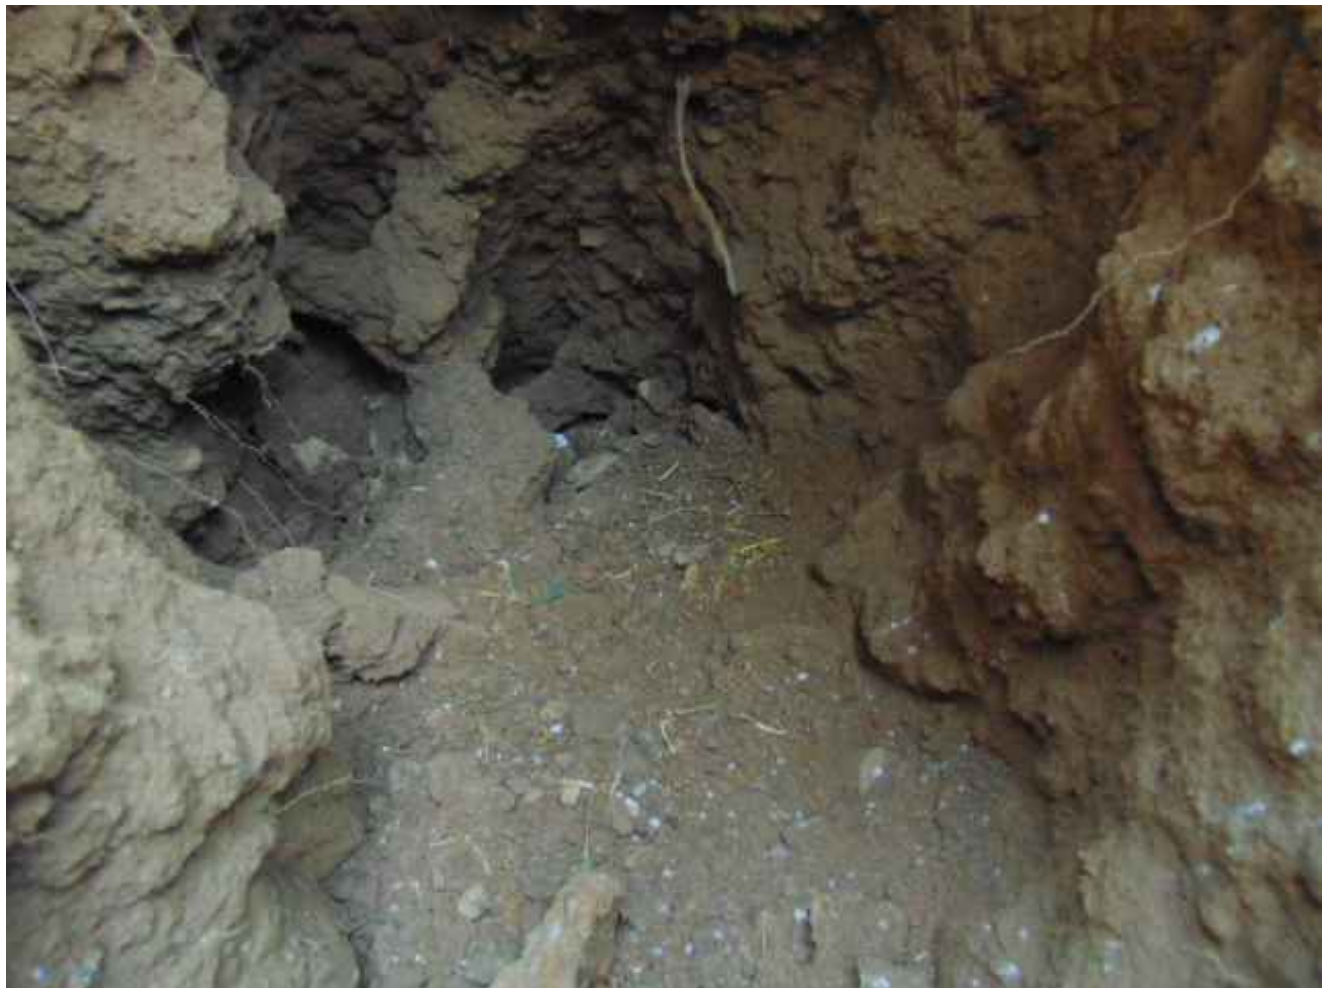
TEST HOLE EXCAVATION OBSERVATION

| PK <input type="checkbox"/> | Test Hole Survey Information: Field Surveyed By: CNC Civil Services Survey Control Established By: AMT Engineering Survey Coordinates: Northing: 687276.39 Easting: 1578055.24 Elevation: 34.21 Elevation Data: Marker: 34.21' Utility Top: 30.24' Utility Bottom: N/A Test Hole Notes: <u>Hub and tack set over south west edge of highest concrete duct. Crew found multiple extra utilities in test hole see profile sketch for depths.</u> |

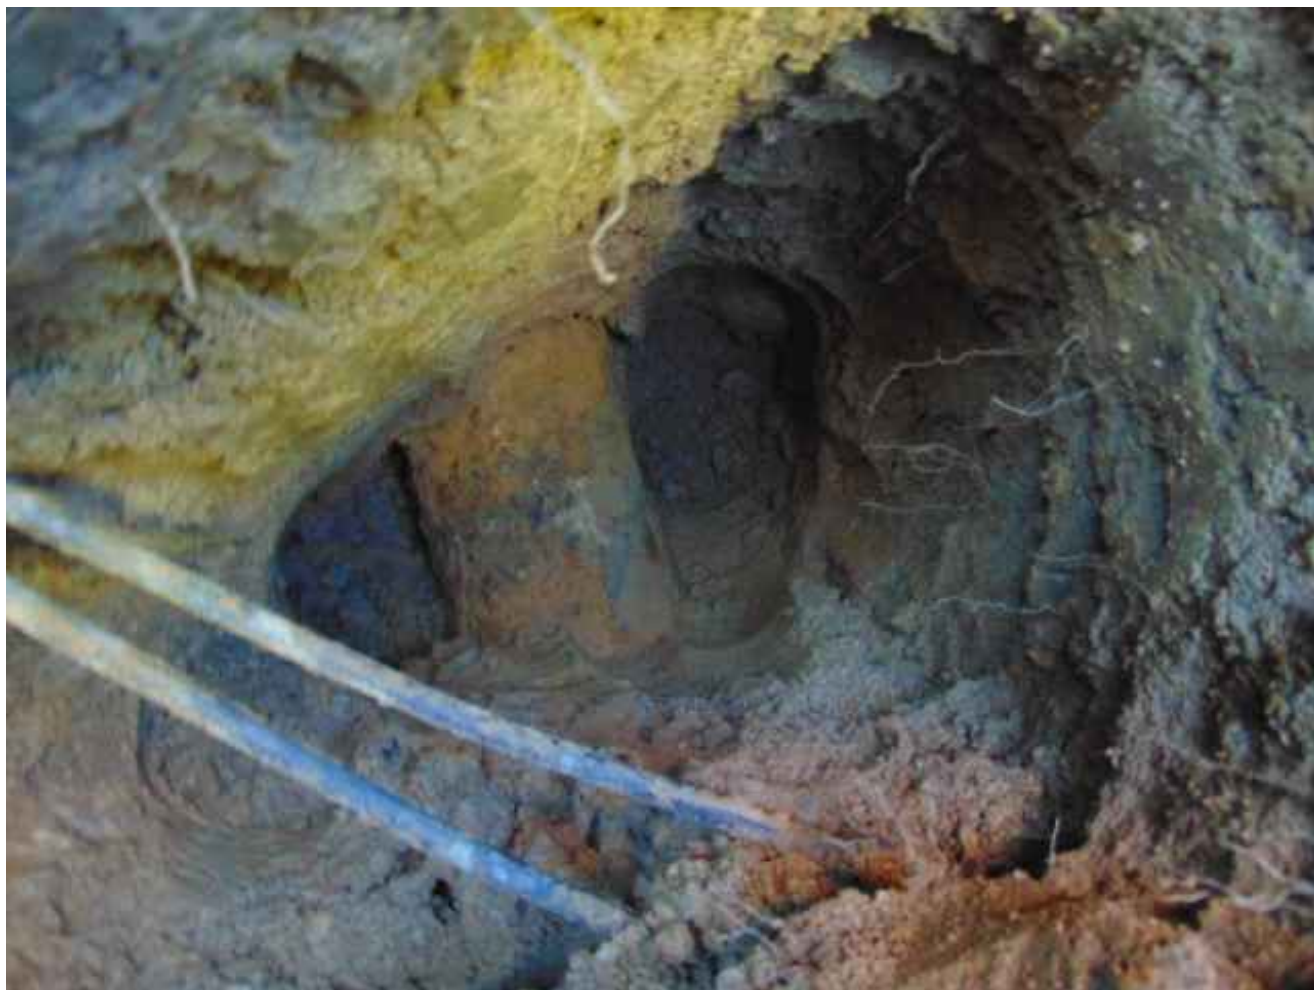
TEST HOLE EXCAVATION OBSERVATION

| Test Hole Number: 47 | | Utility Condition: Poor <input type="checkbox"/> Fair <input checked="" type="checkbox"/> Good <input type="checkbox"/> See Notes <input type="checkbox"/> | |

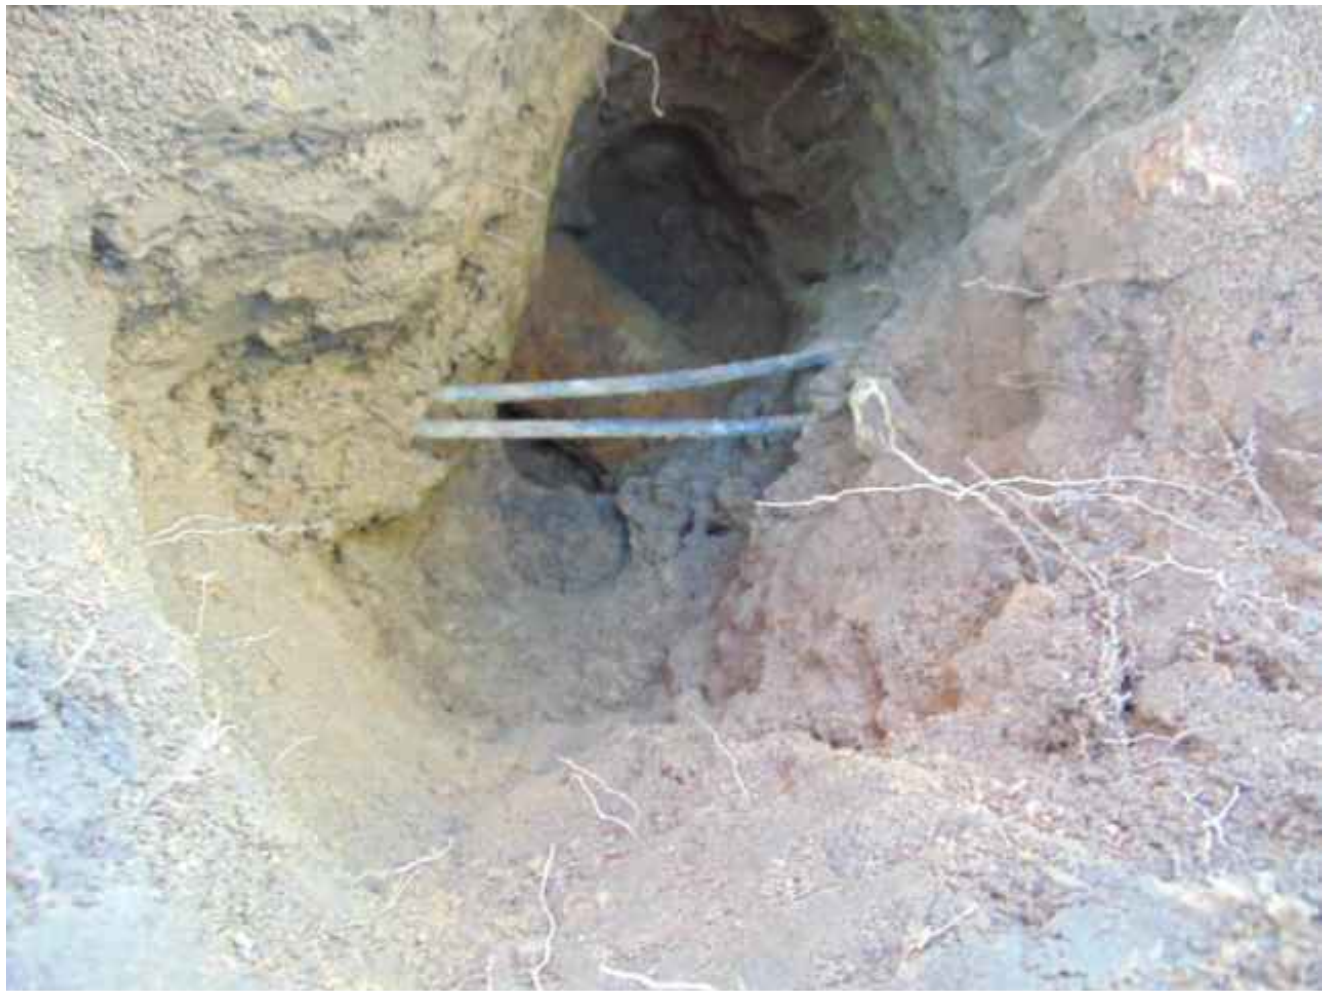
TEST HOLE EXCAVATION OBSERVATION

| Test Hole Number: 47A | Utility Condition: Poor <input type="checkbox"/> Fair <input checked="" type="checkbox"/> |

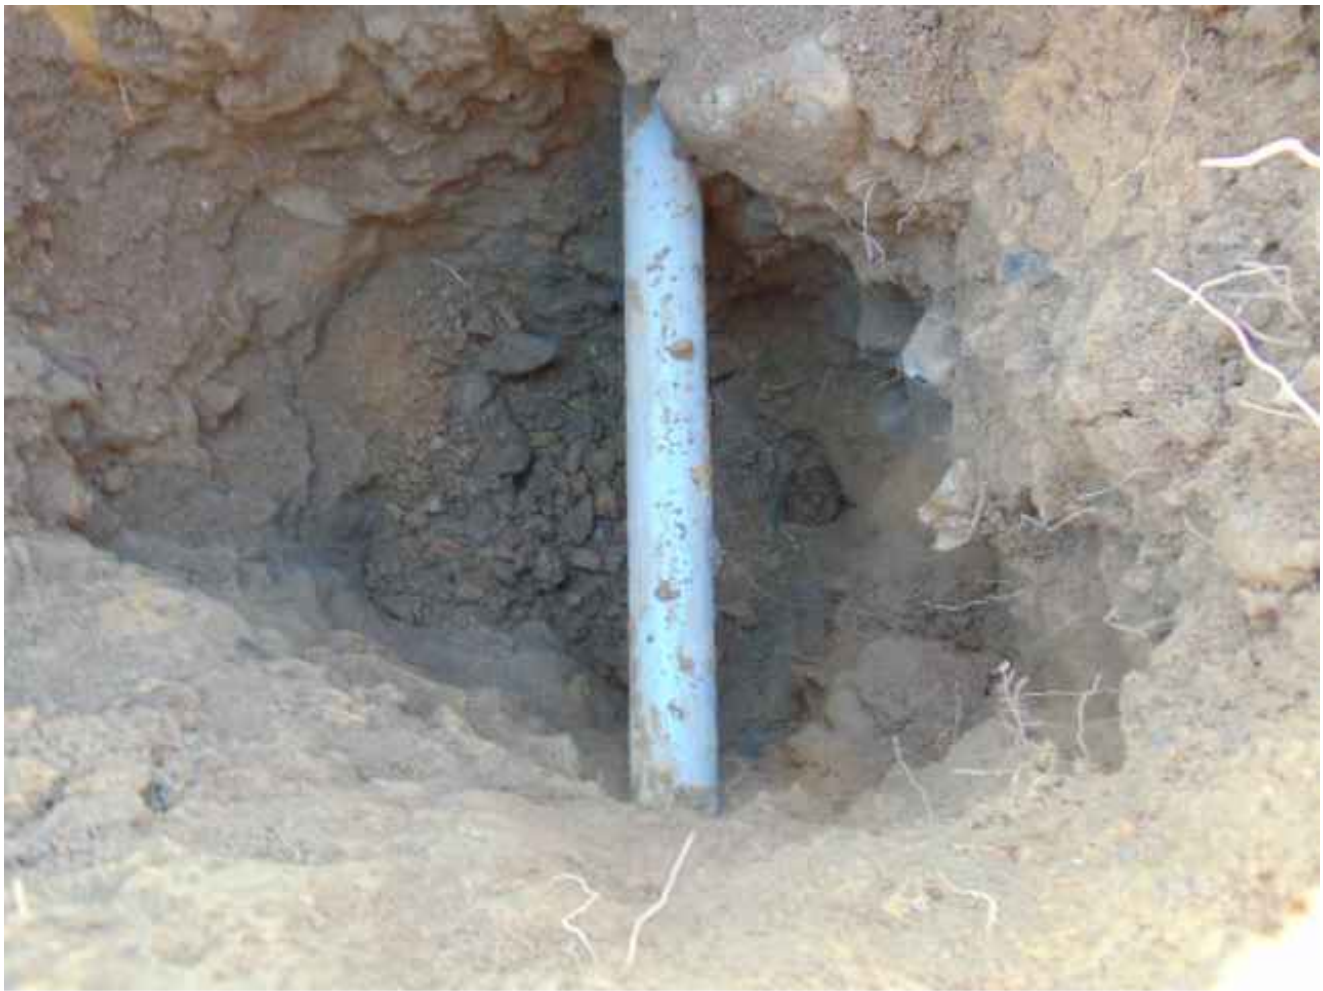
TEST HOLE EXCAVATION OBSERVATION

| Test Hole Number: 48 | Utility Condition: Poor <input type="checkbox"/> Fair <input checked="" type="checkbox"/> |

| Hub and tack set over center of the utility. | | |

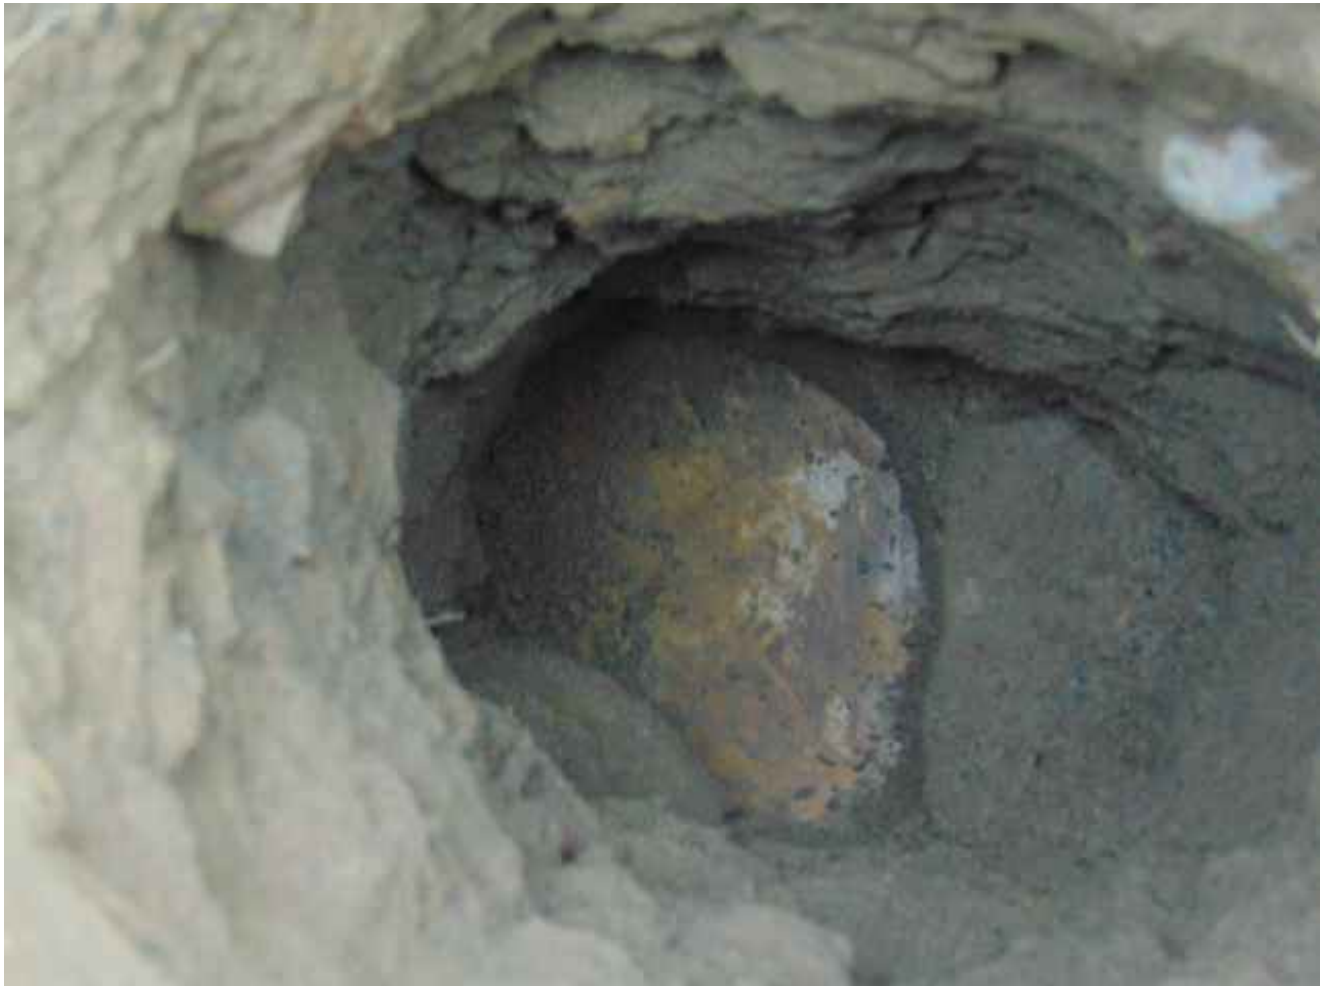
TEST HOLE EXCAVATION OBSERVATION

| Test Hole Number: 49 | Utility Condition: Poor <input type="checkbox"/> Fair <input checked="" type="checkbox"/> |

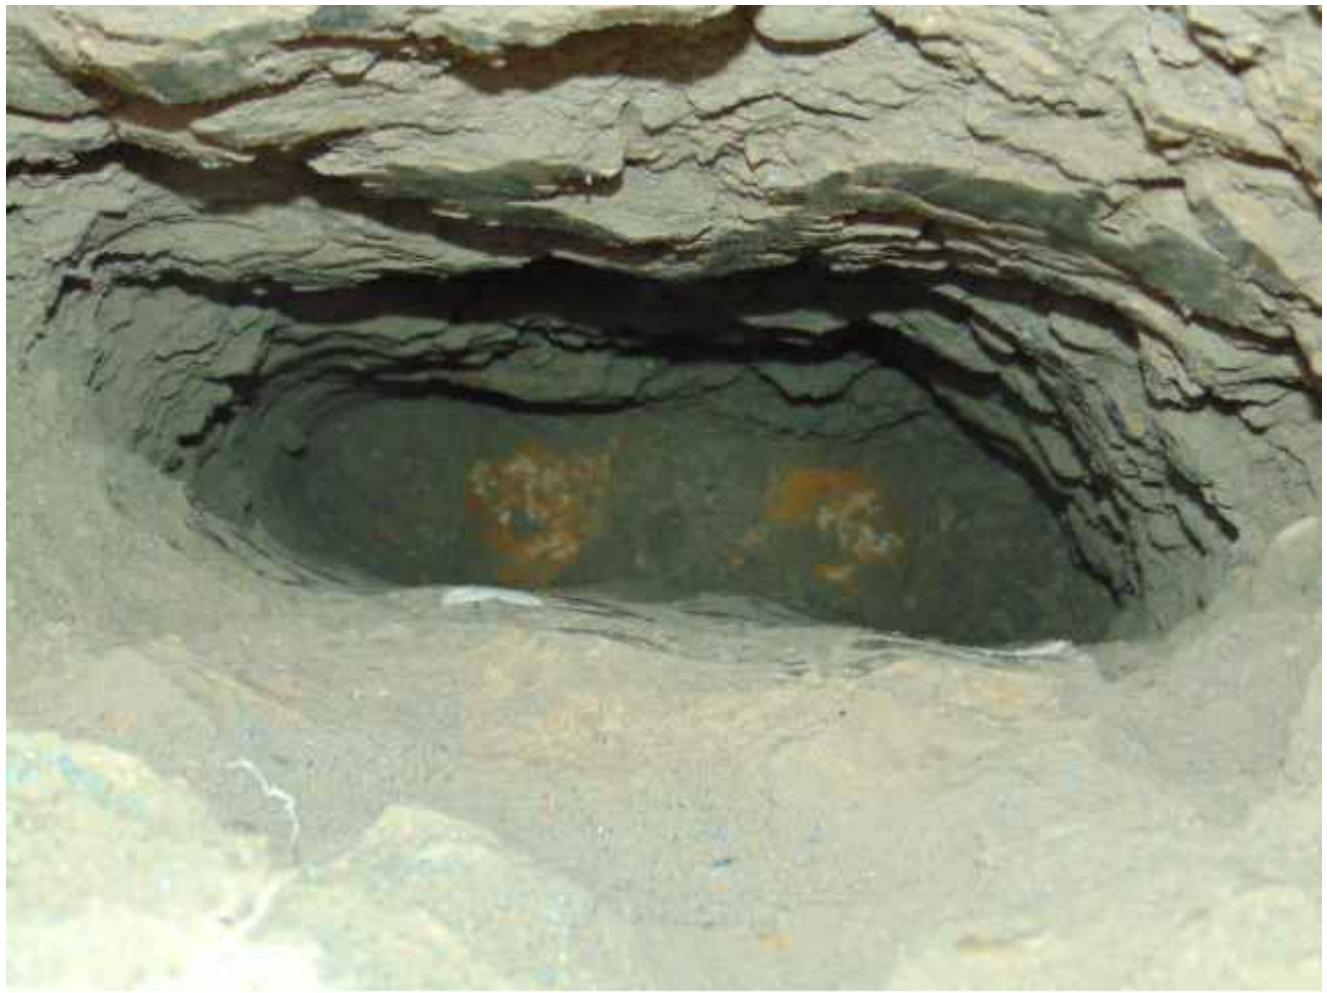
TEST HOLE EXCAVATION OBSERVATION

| Test Hole Number: 49A | Utility Condition: Poor <input type="checkbox"/> Fair <input checked="" type="checkbox"/> |

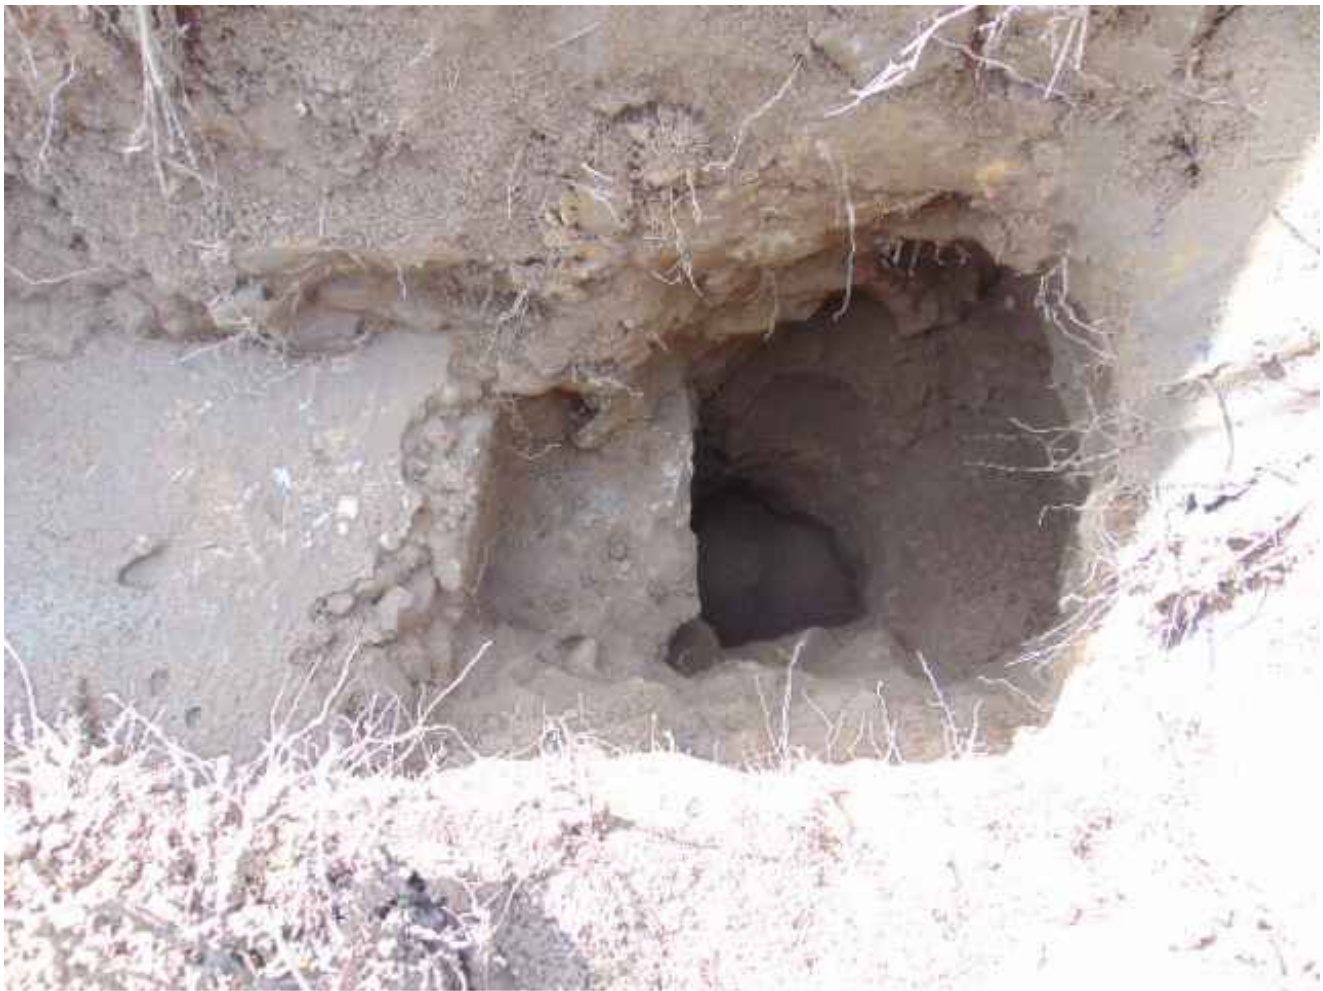
TEST HOLE EXCAVATION OBSERVATION

| Test Hole Number: 51 | Utility Condition: Poor <input type="checkbox"/> Fair <input checked="" type="checkbox"/> |

| Hub and tack set over northern edge of electric duct. | | |

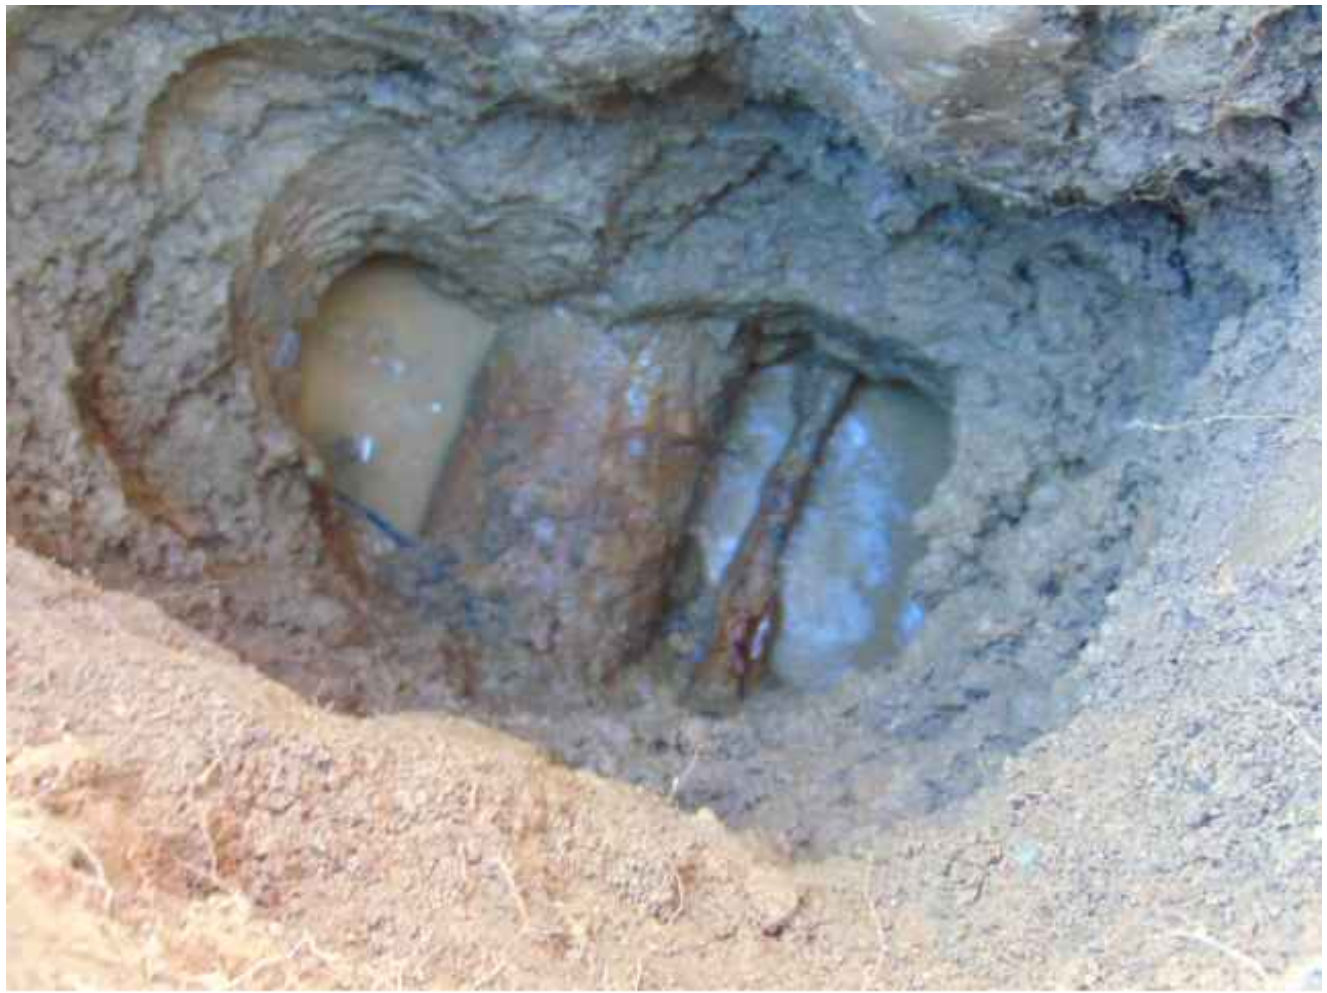
TEST HOLE EXCAVATION OBSERVATION

| Test Hole Number: 53 | Utility Condition: Poor <input type="checkbox"/> Fair <input checked="" type="checkbox"/> Good <input type="checkbox"/> See Notes <input type="checkbox"/> |

| Chis. "X" <input type="checkbox"/> | Hub and tack set over crown of water pipe. | | | |
| | See form #53A for parallel pipe details. | | | |

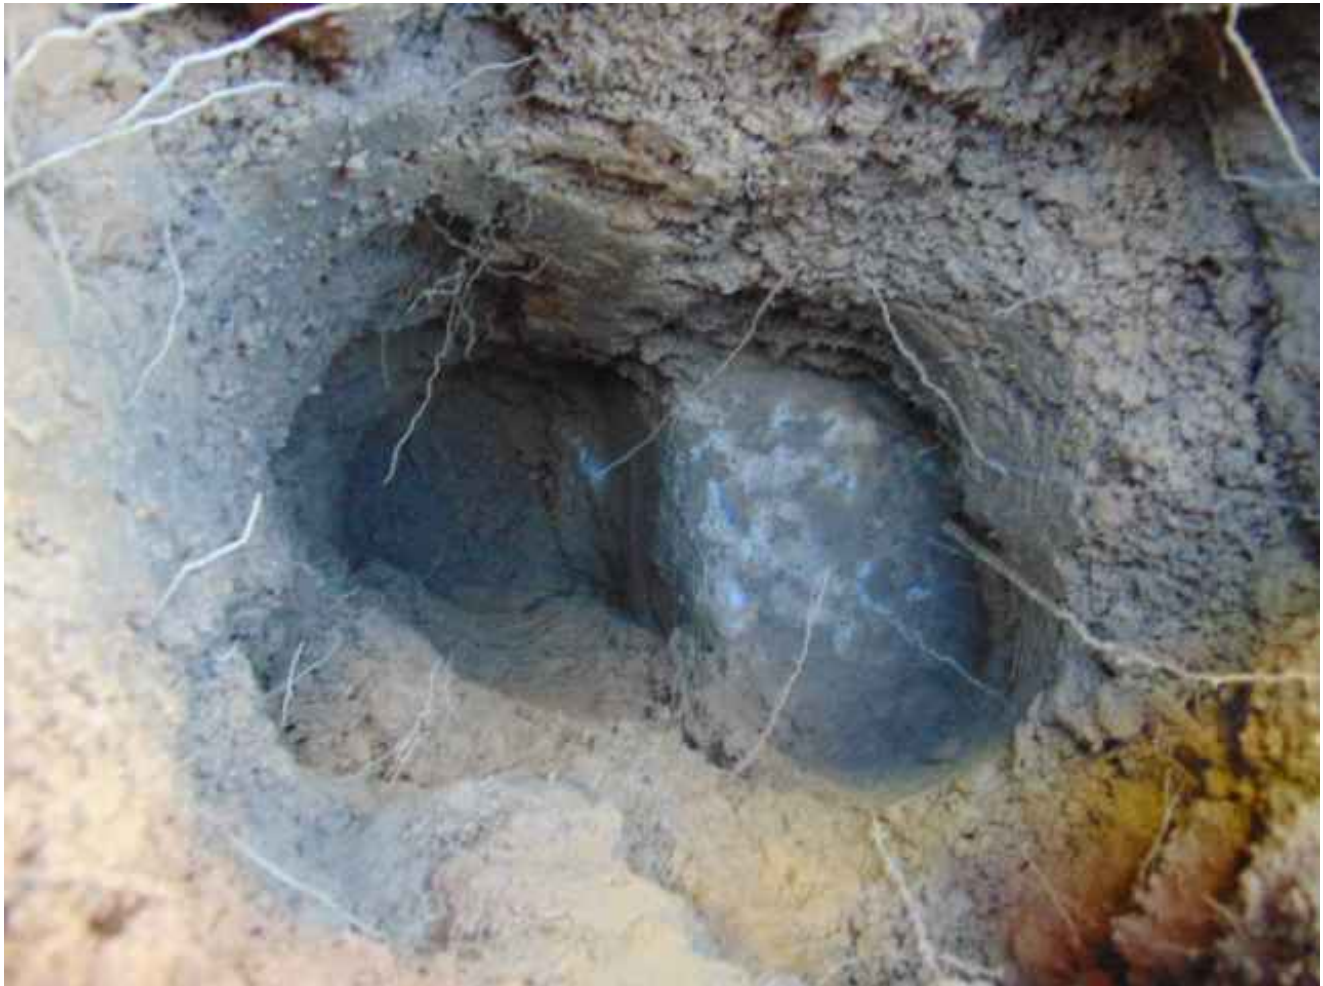
TEST HOLE EXCAVATION OBSERVATION

| Test Hole Number: 54 | Utility Condition: Poor <input type="checkbox"/> Fair <input checked="" type="checkbox"/> |
| Utility Found: Communication | |

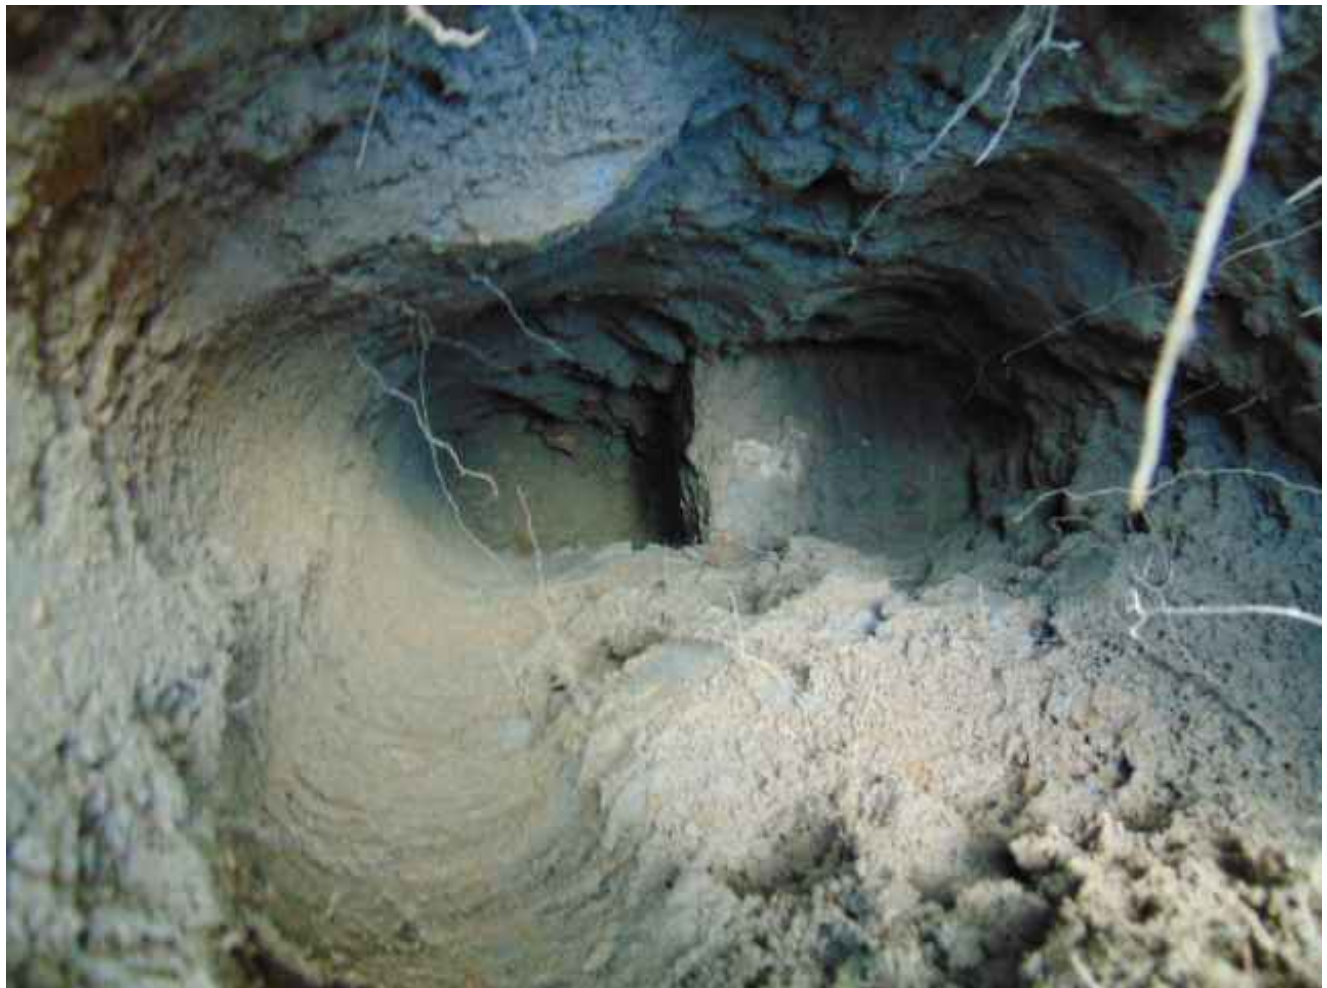
TEST HOLE EXCAVATION OBSERVATION

| Test Hole Number: 55 | Utility Condition: Poor <input type="checkbox"/> Fair <input checked="" type="checkbox"/> |
| Utility Found: Electric | |

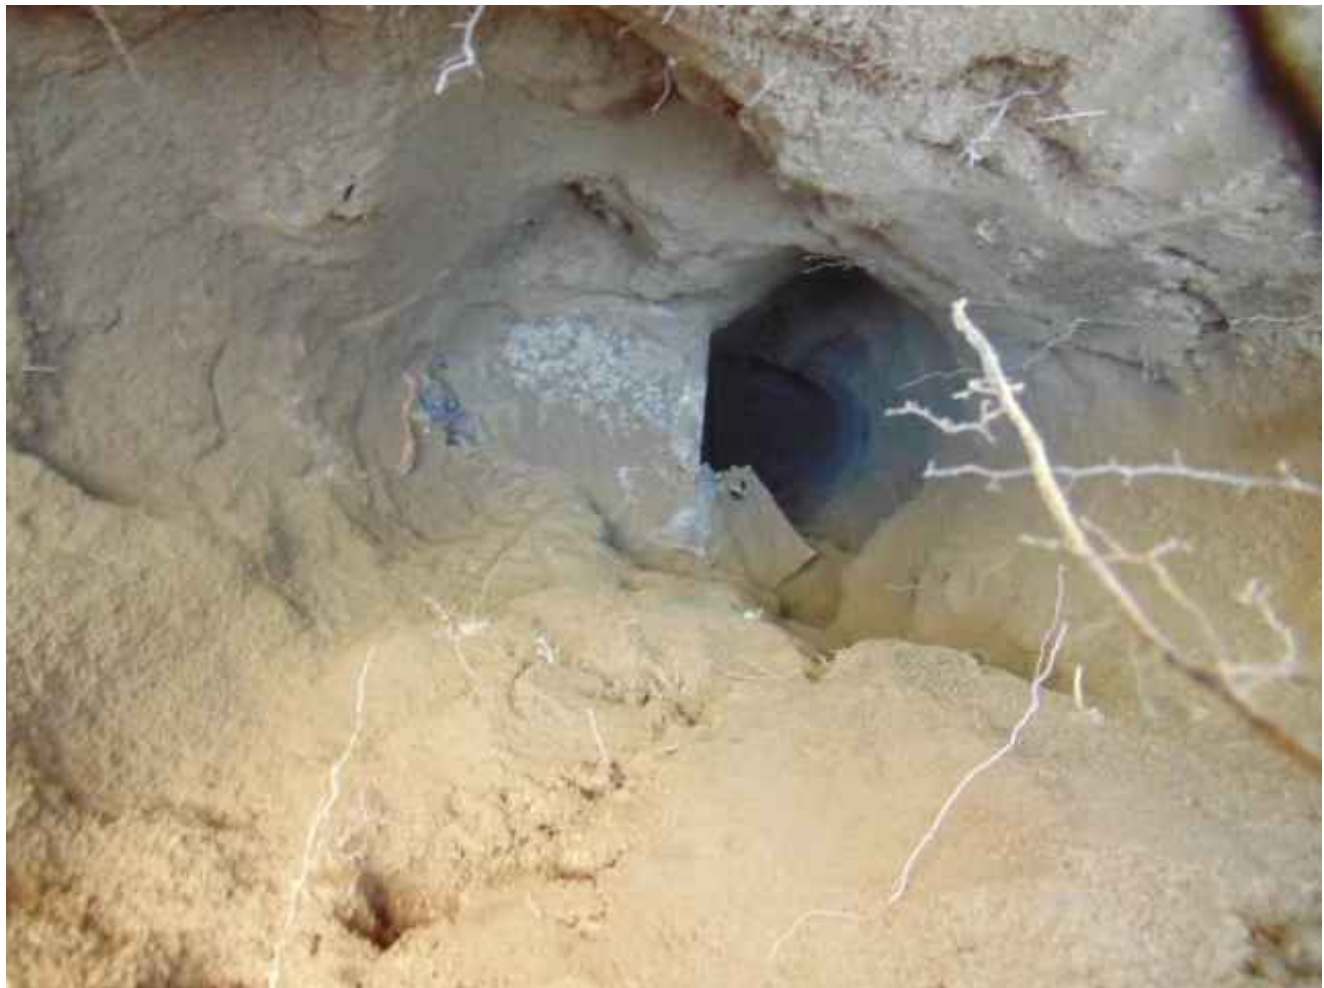
TEST HOLE EXCAVATION OBSERVATION

| Test Hole Number: 59 | Utility Condition: Poor <input type="checkbox"/> Fair <input checked="" type="checkbox"/> |
| Utility Found: Steam | |

| Hub and tack set over eastern edge of steam duct. | | |

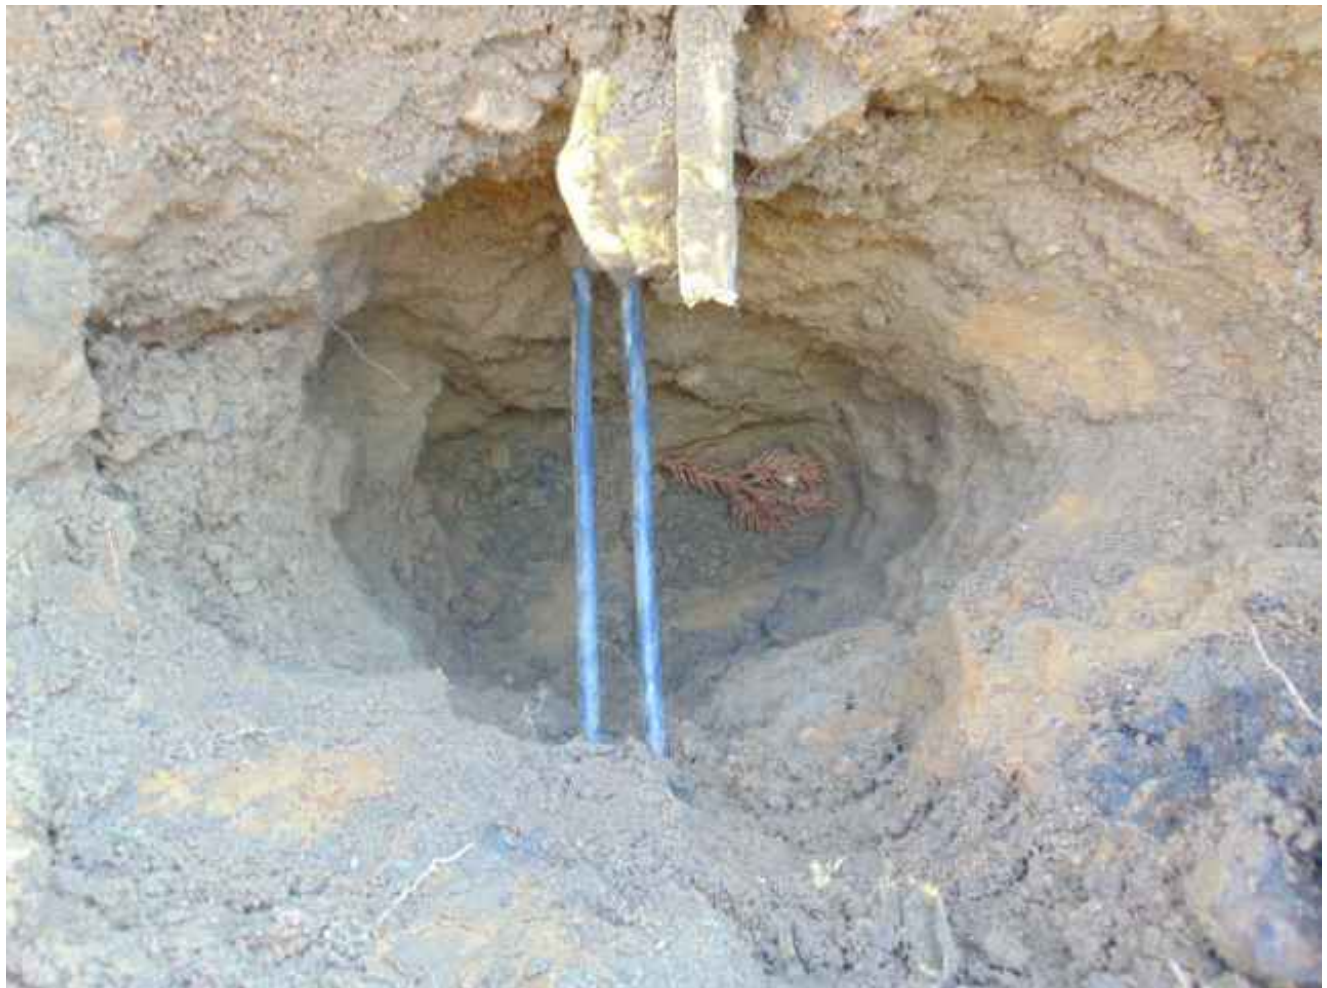
TEST HOLE EXCAVATION OBSERVATION

| Test Hole Number: 62 | Utility Condition: Poor <input type="checkbox"/> Fair <input checked="" type="checkbox"/> Good <input type="checkbox"/> See Notes <input type="checkbox"/> |
| Utility Found: Unknown | |

| Hub and tack set over center of utility configuration. | | |
