# ***ASBESTOS- CONTAINING MATERIALS SURVEY***

**Building 1  
Department of Veterans Affairs  
Michael Crescenz VA Medical Center  
3900 Woodland Avenue  
Philadelphia, PA 19104**

**August 1, 2022**

**212842**

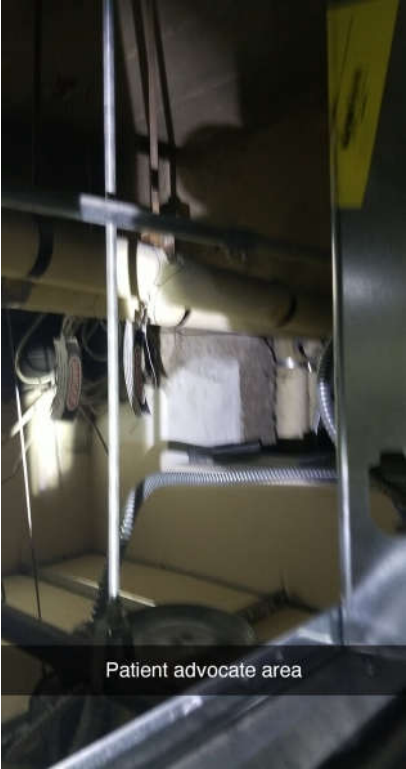
Patient advocate area

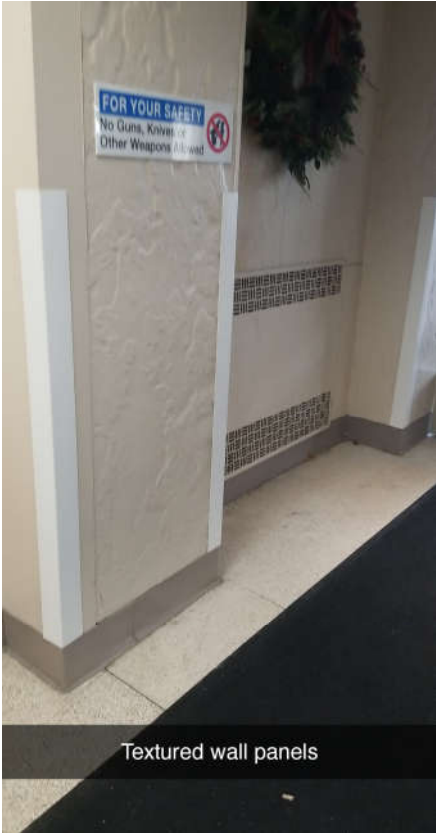
Textured wall panels

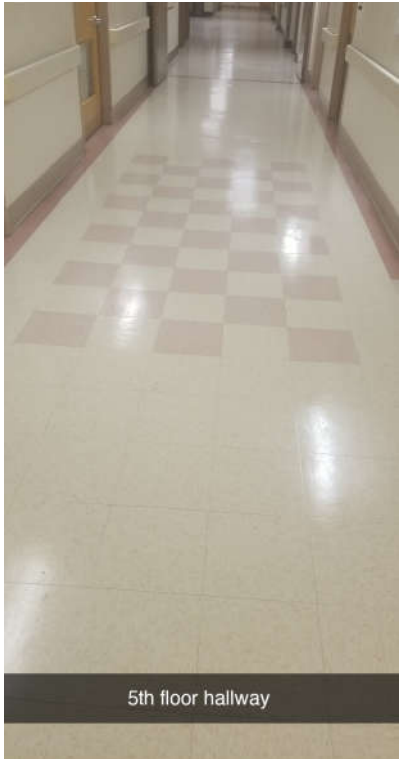
5th floor. Tan w/streaks 12x12 w/Black Mastic

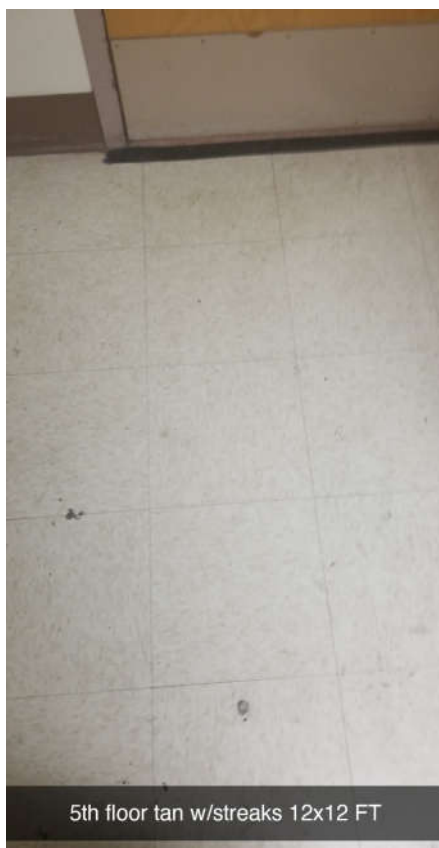
5th floor tan w/streaks 12x12 FT

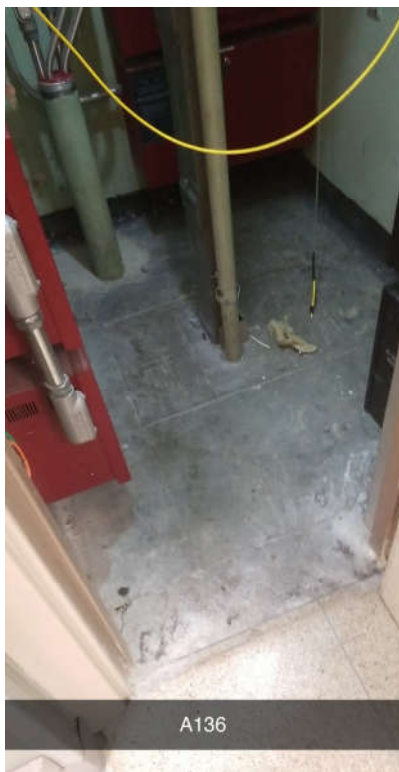
a160 pipe in wall

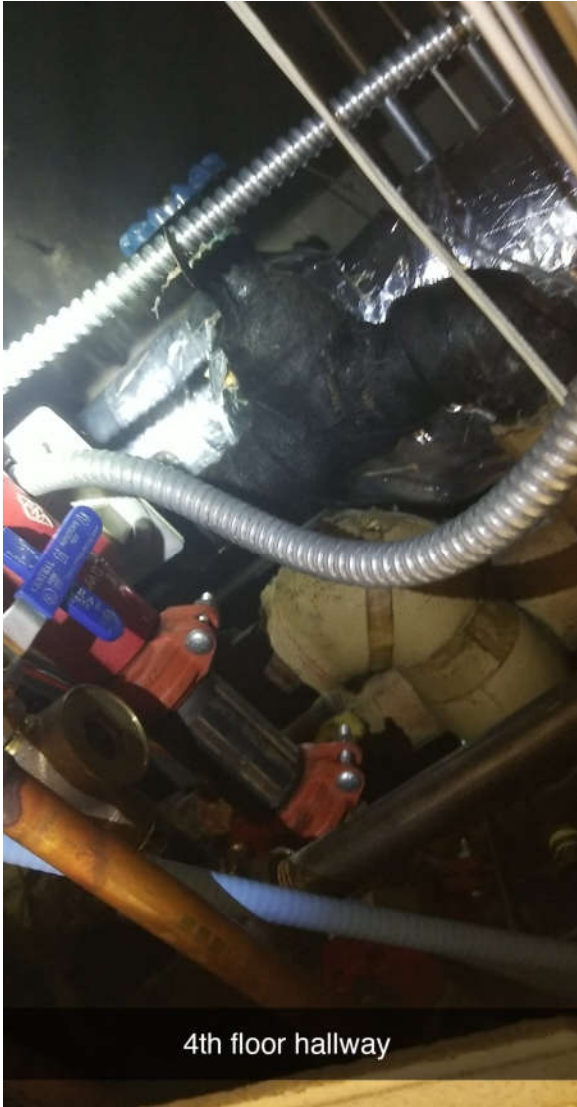
black condensate wrap

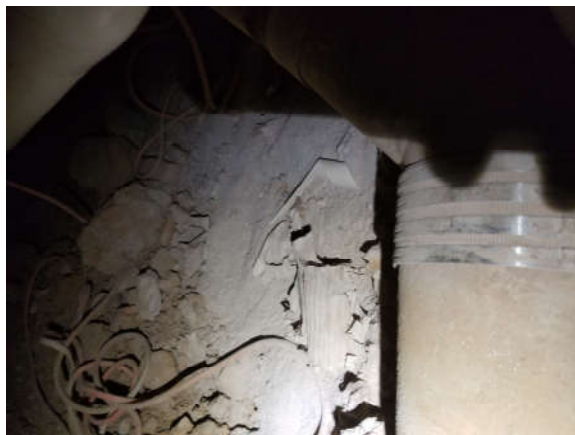
crawl space 3 corrugated debris

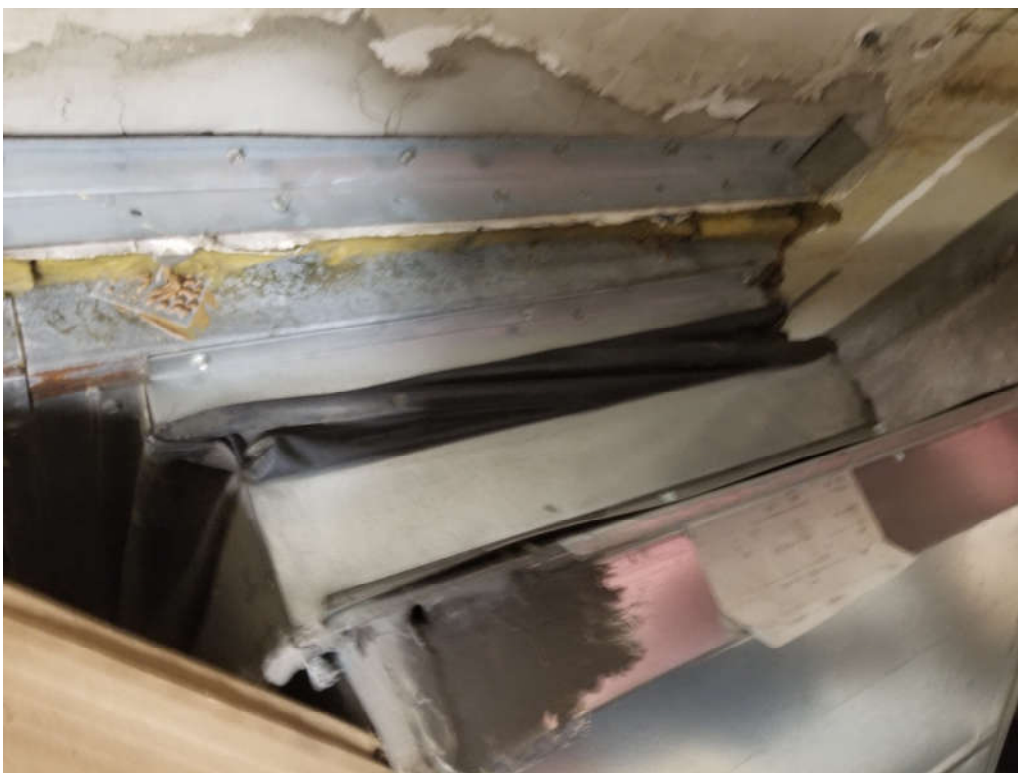
room b9 vibration cloth

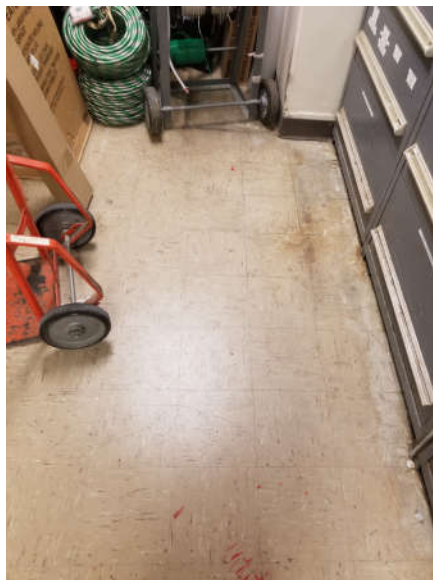
room b28 9x9 floor tile

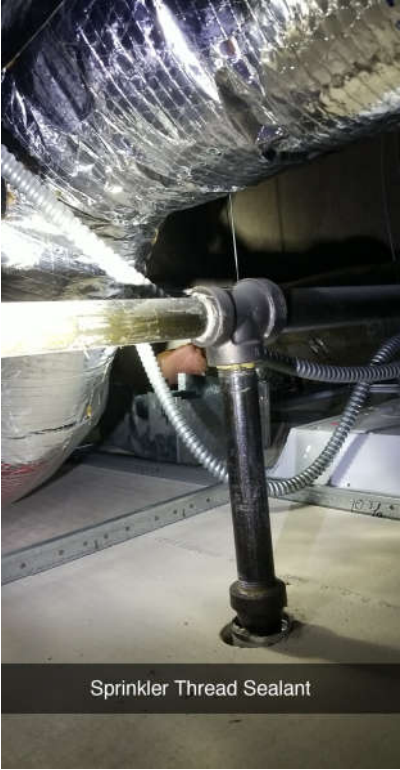
Sprinkler Thread Sealant

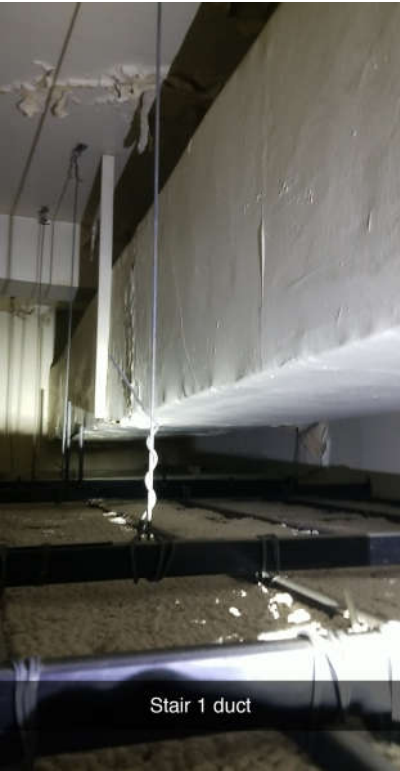
Stair 1 duct
